1996 44' Sea Ray 440 Express Bridge

## "Quiet Thyme"

# Condition & Value Report of Marine Survey

**Date Of Survey:** Inspection performed on: 09/19/24.

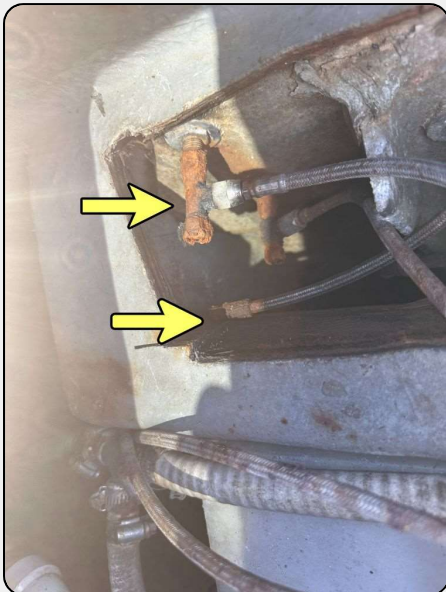
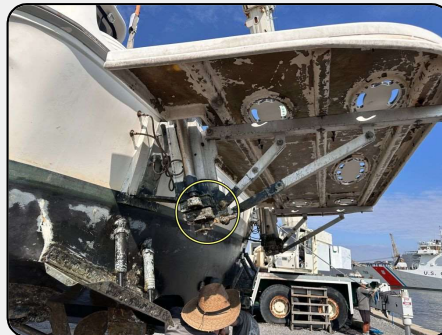
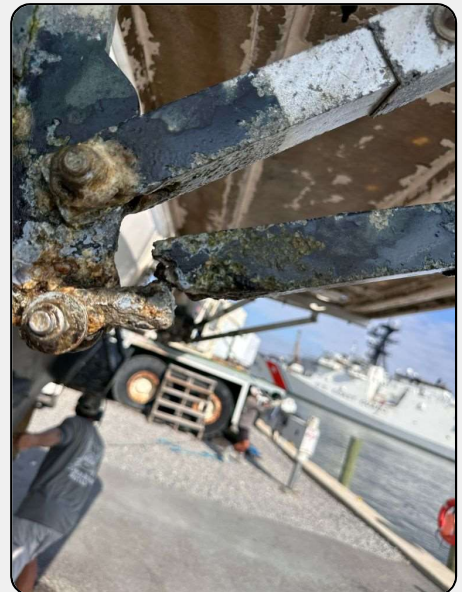
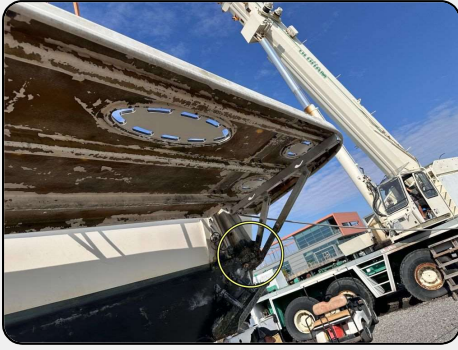
TNT Marine Lift Systems electro-hydraulic swim platform/tender lift with dinghy chocks. Note: The swim platform is not in operational condition, hydraulic hoses and fittings are corroded out and the base of the hydraulic arm mounts have corroded through.

The swim platform appeared to be in poor condition and was not operational.

Investigate further, and service, refit, repair or replace as necessary.

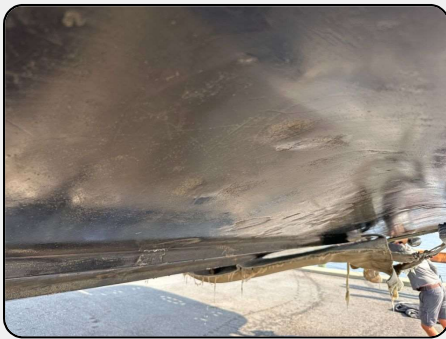
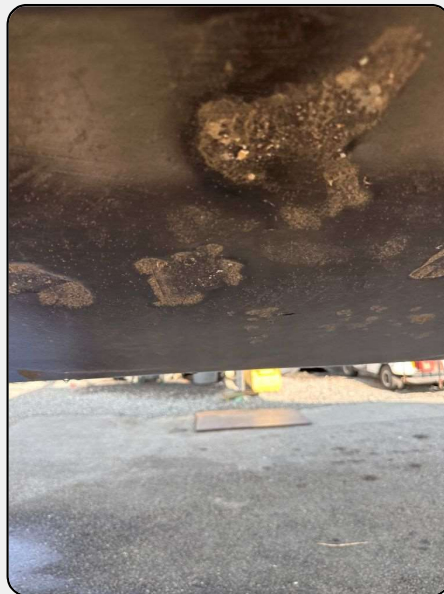
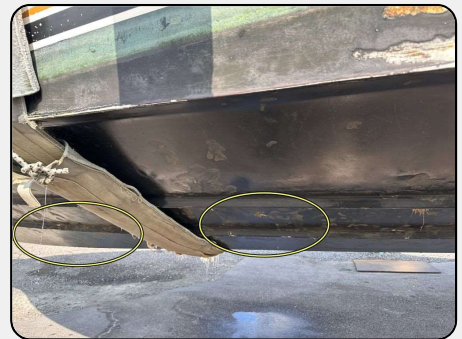
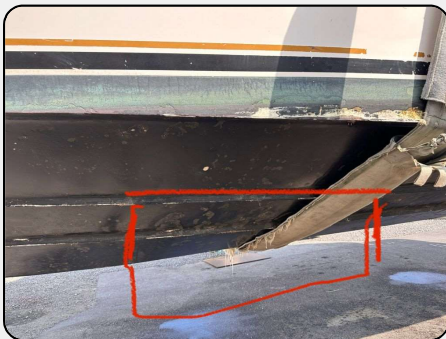
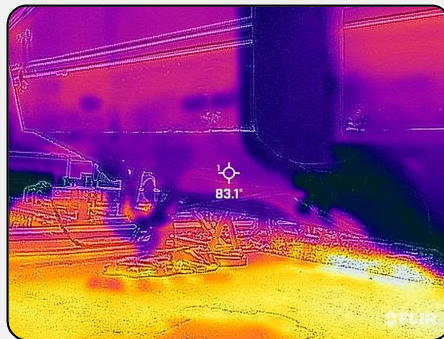
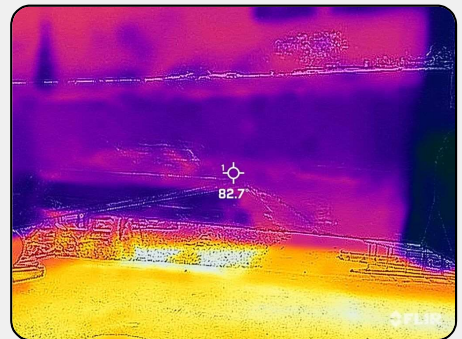
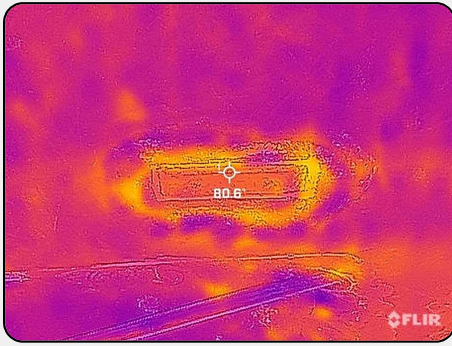
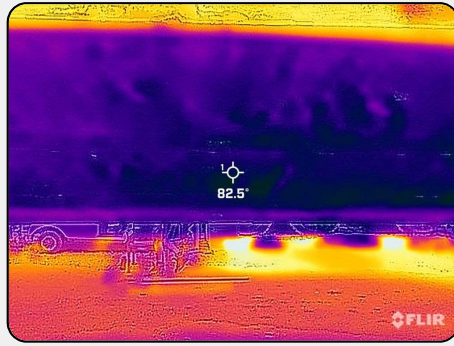
Some areas of the hull side's laminates have separated from their sandwich coring. Cracks were observed around the engine exhaust's transom discharge tube connections. Some exceptions were observed (see Findings Appendix).

Some areas of the hull side's laminates have separated from their sandwich coring. Several anomalous percussion hammer sounds were observed at various areas of the hull.

Thermal Imaging or destructive testing may be required to determine the extent of the findings and recommend repairs.

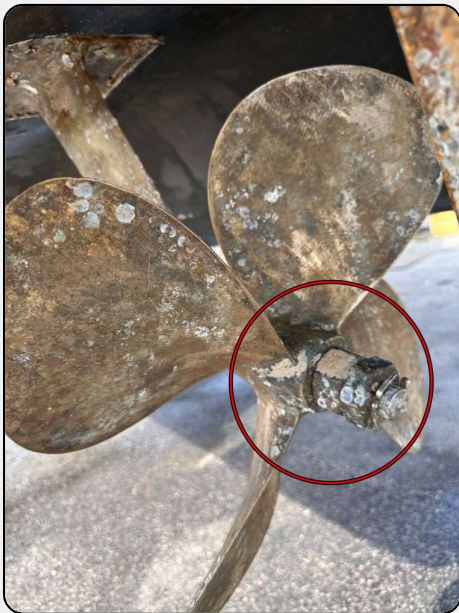
**FINDING B-4 PROPELLERS**

The propeller's compression and lock/jammed nuts were installed in reverse order.

Properly refit the propeller nuts to comply with ABYC Standards as necessary. ABYC P-6 Ap. 6.2, SAE J755 (thin nut in front and thick nut behind).

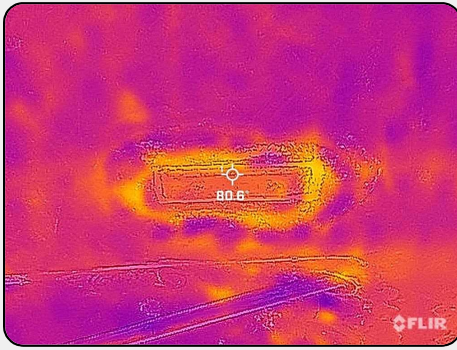
There was a though hull transducer installed on the starboard side, aft hull bottom. Its fairing block was in poor condition. The transducer mounting area appeared in poor visual condition.

The transducer mounting area appeared in poor visual condition.

Investigate further, and service, repair or replace as necessary.

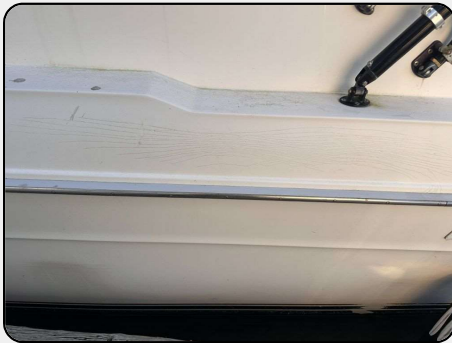
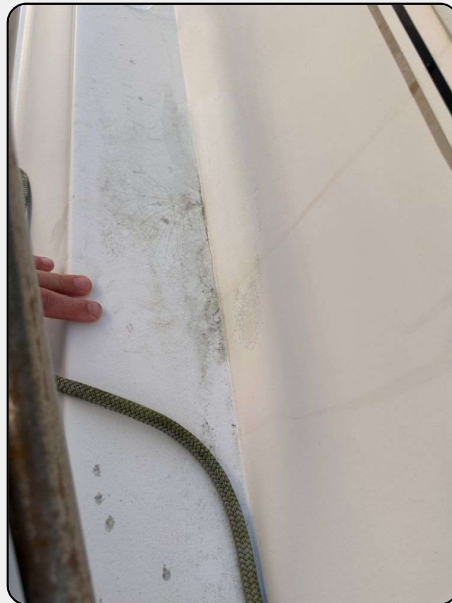
**C: SURVEYOR'S GENERAL FINDINGS, NOTES AND OBSERVATIONS****FINDING C-1 GENERAL EXTERIOR CONDITION**

General wear & tear, spider cracking and oxidation was observed on some of the exterior surfaces.

Refinish the gelcoat, as necessary.
