Survey Report Date: 1/27/2025 Survey Completed: 1/27/2025

Purpose: contribution, condition and value

Vessel: "Shammy's Baby", 2008 Regal 2400 bowrider

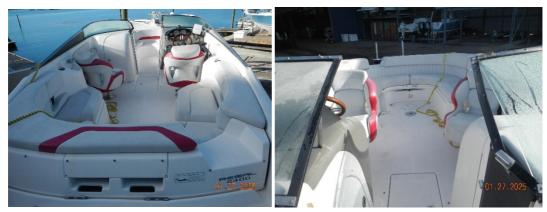
Superstructure: is mainly the windshield. The windshield is clear and intact while the center hinged panel is missing and the hinge is damaged*.

- 1. Reinstall center wind shield panel, repair hinge
- 2. Reinstall head
- 3. Replace missing rub rail screw starboard bow

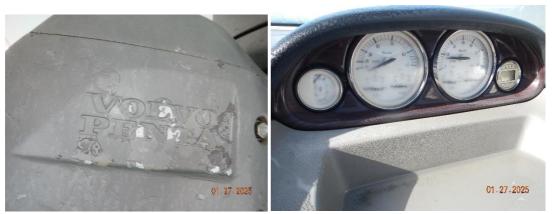
The gasoline engine is a Volvo, 270 HP I/O with duoprops. Engine hours on the gauge is **300.9**. The lower drive appeared in good condition without signs of leaks or damage. Instrument panel has analog speed, Tach/rpm, volt, temp,

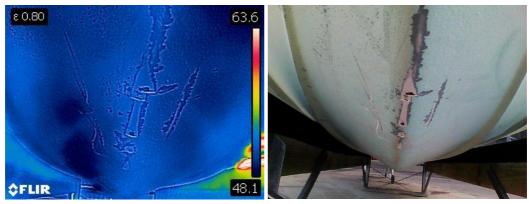
Wetted surface at bow no signs of moisture, voids or delamination.
