# Underwriter's C&V Survey Report

## "SEA CHASE"

**1984 32' Carver Convertable**

**Date Of Survey:** 07/31/2024

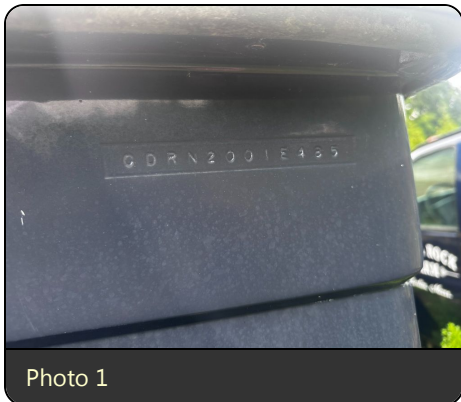
Photo 1

The vessel's HIN (Hull Identification Number) displayed on the starboard transom was properly affixed and formatted as per 33 CFR 181. Damage to the gel coat was sighted, hindering the legability of the HIN\*. Hin was referenced from the title.

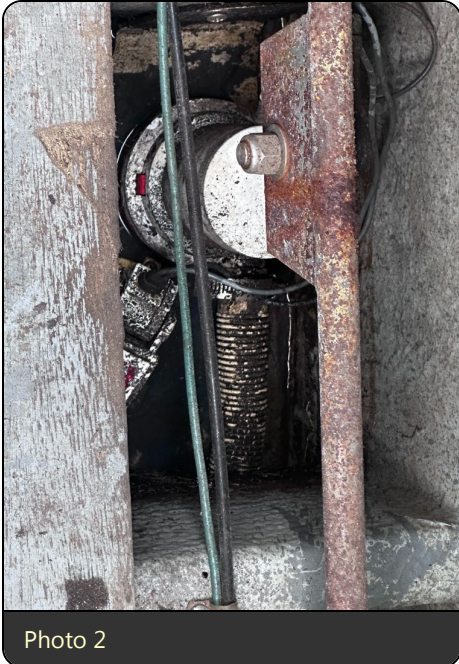
The vessel was fitted with a single Rule 1500 GPH, 12-volt DC-powered electric submersible pump with a separate float switch for automatic operation. The pump is mounted in the aft bilge and was not tested.

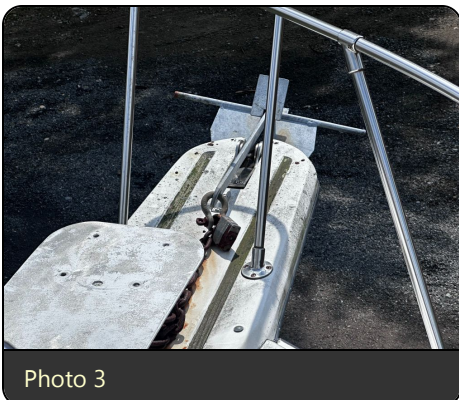
A galvanized steel Danforth type anchor was rigged from the bow anchor storage locker. The Anchor had minimal surface corrosion and was noted to be of adequate size for the vessel and in serviceable condition.

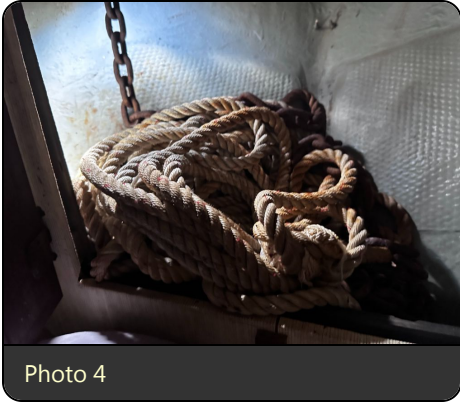
The vessel was equipped with an unidentified length of galvanized chain and stranded nylon line. The anchor rode was noted to be of adequate size for the vessel and was fit for the intended use.

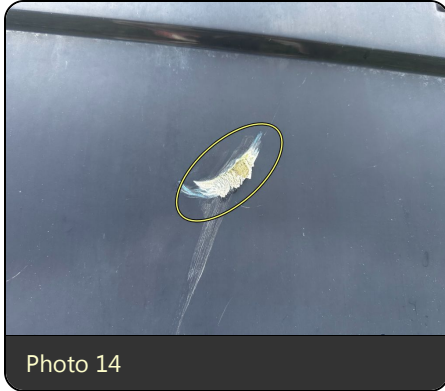
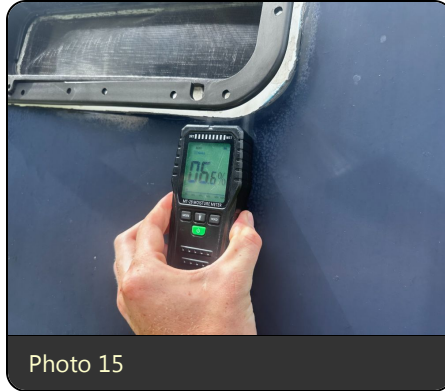
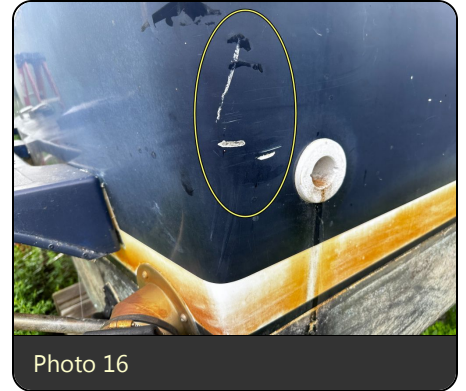
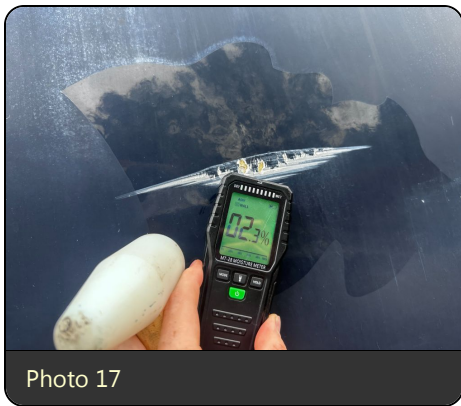
Damage to the STBD top side laminate was sighted mid hip and at the transom corner

The Port side midship hatch framing was not secured to the hull, and the fastener holes were exposed.

The Port side mid hip hatch framing was not secured to the hull and the fastener holes were exposed

Have a qualified Fiberglass technician Investigate further, and repair as necessary.

Re fasten and seal the framing to prevent water intrusion

Re-fasten and seal the framing to prevent water intrusion.

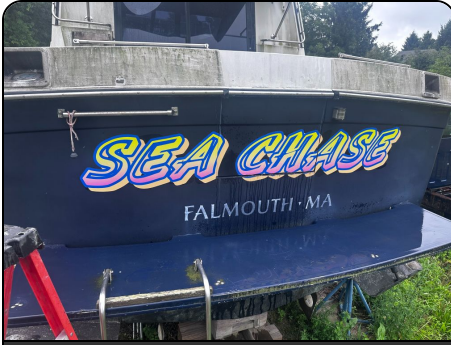
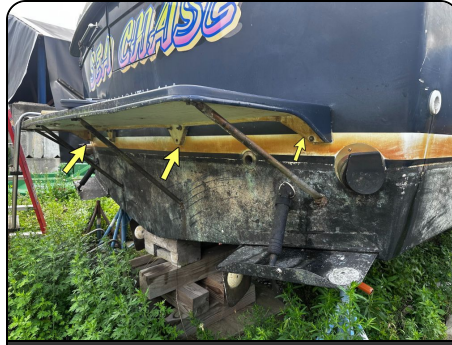
The transom is constructed of fiberglass (the presence of coring was not determined) and was visually examined and percussion tested approximately every six inches with a phenolic hammer. Conductivity (moisture) readings were taken with no elevated readings noted.

The swim platform was not secured to the transom.

Tighten the fasteners and install the missing one to secure the swim platform

Tighten the fasteners and install the missing ones to secure the swim platform.

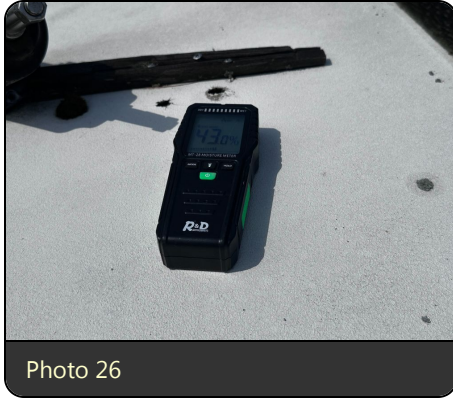
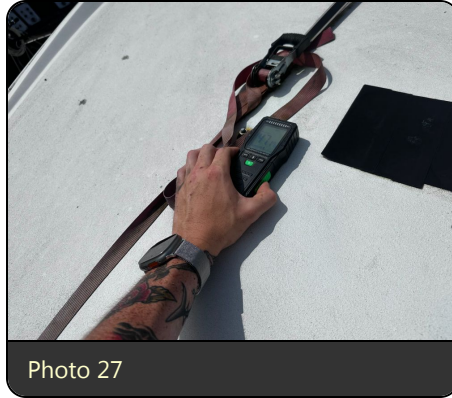
The cockpit deck was constructed of fiberglass (the presence of a coring material is not known) and covered with a diamond pattern with a textured non-kid gel coat. The deck was visually inspected and periodically sounded with a phenolic hammer with no indications of voids or delamination noted. Conductivity (moisture) did show high readings along the bow toe rail from the midship to the anchor roller. The flybridge deck was soft, and conductivity readings were high.

The Flybridge cockpit deck was soft and wet.

The Flybridge was removed for transport. All electronics and operational controls were disconnected.

The flybridge cockpit deck was soft and wet.

The flybridge was removed for transport; all electronic and operational controls were disconnected.

Have a qualified fiberglass technician investigate further and repair in accordance with good marine practice as necessary.

Re-install the flybridge and all corresponding controls and electronics using good mariner practice.

Have a qualified fiberglass technician investigate further, and repair in accordance with good marine practice as necessary.

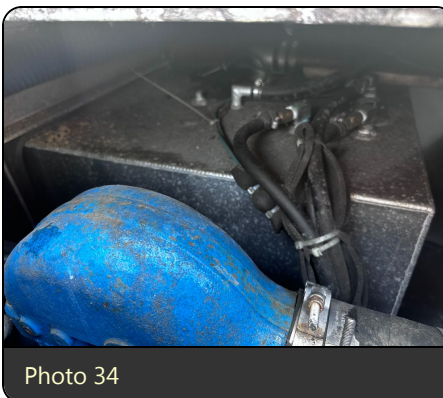
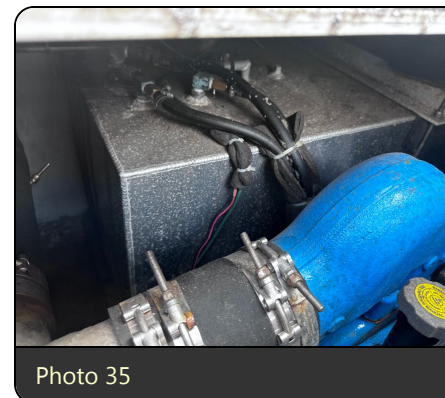
Two aluminum fuel tanks were sighted midship on either side of the engine bilge. The fuel tanks appeared to be in good condition and did not show signs of leakage or termination. All fuel fill, supply, and vent hoses were noted to be in serviceable condition where sighted. The fuel fill O-rings were no longer serviceable.

The fuel fill vacuum seal O ring was past its service life

The fuel fill vacuum seal O-ring was past its service life.

Remove and replace the O-ring.

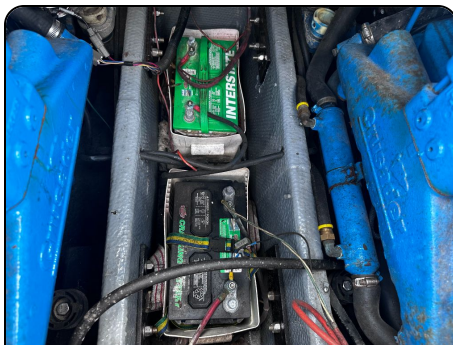
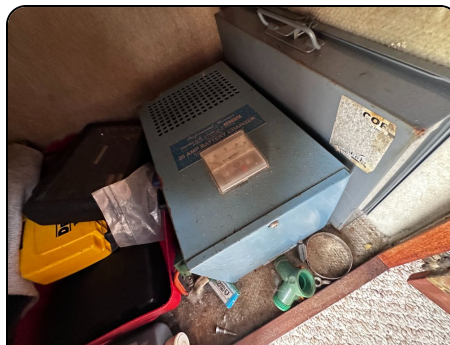
The vessel was fitted with two 12 volt lead acid batteries. The batteries were properly secured and all conductors were fastened to the terminals within ABYC regulations but did not have protective boots over the terminals. Sighted port side of the cabin within seat storage was a single 35 amp battery charger. The DC system was not tested.

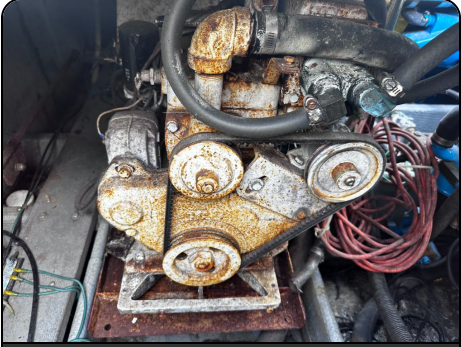
Photo 38

A generator was located aft of the engines in the bilge. An ID tag for the unit was not sighted.
