1998 30'6" Bayliner Avanti Command Bridge

Report of Condition & Value Marine Survey

Date Of Survey: 6/7/2024

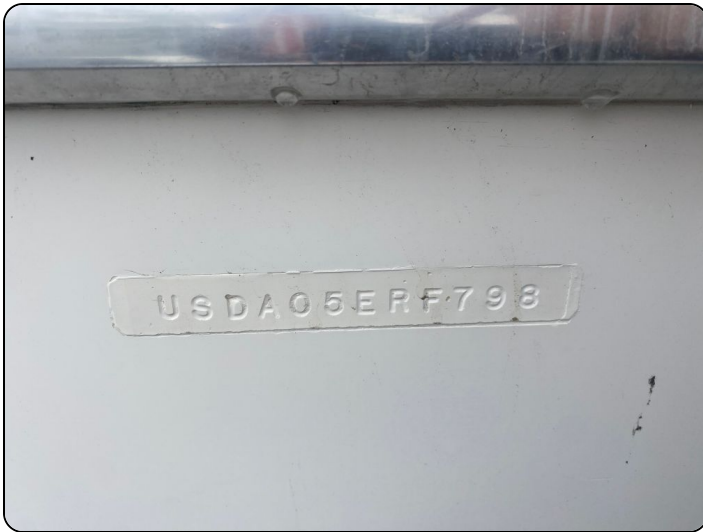
HIN (HULL IDENTIFICATION NUMBER) VERIFICATION COMMENTS

The vessel's HIN (Hull Identification Number) was visually verified during the survey inspection.

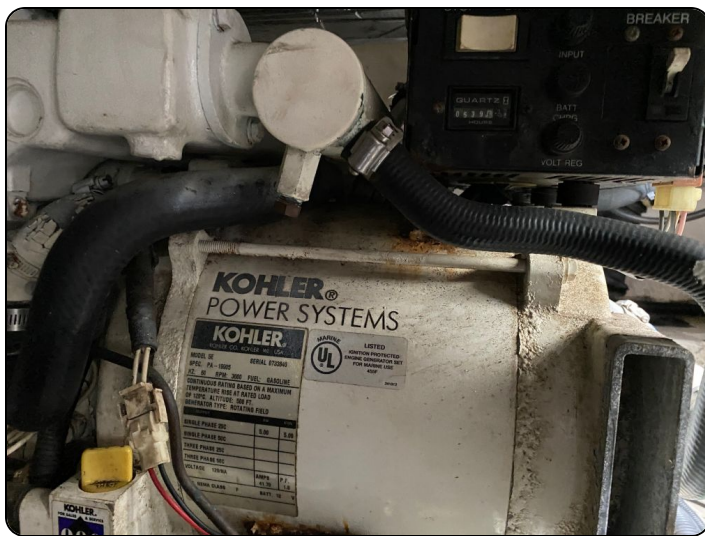
GENERATOR SPECIFICATIONS

The subject was fitted with a Kohler gas generator
Engine Serial Number 0733840
Model Number E5
Hours 19.3
Cylinders 2
RPM 3,600
KW 5.0
Volts 120 AC
Hz 60
AMPS 41.7
HP 16
Phase Single
Starting Volts 12

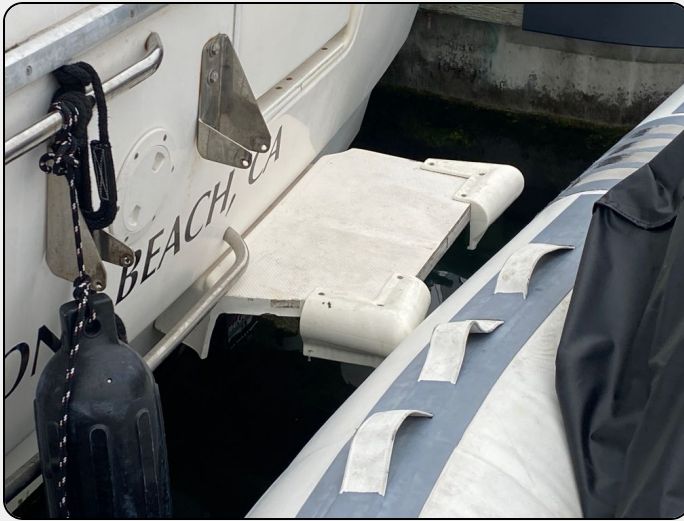
The swim platform was broken with sections missing and the remaining portion having exposed sharp edges.

Repair or replace in accordance with good marine practice and ABYC standards

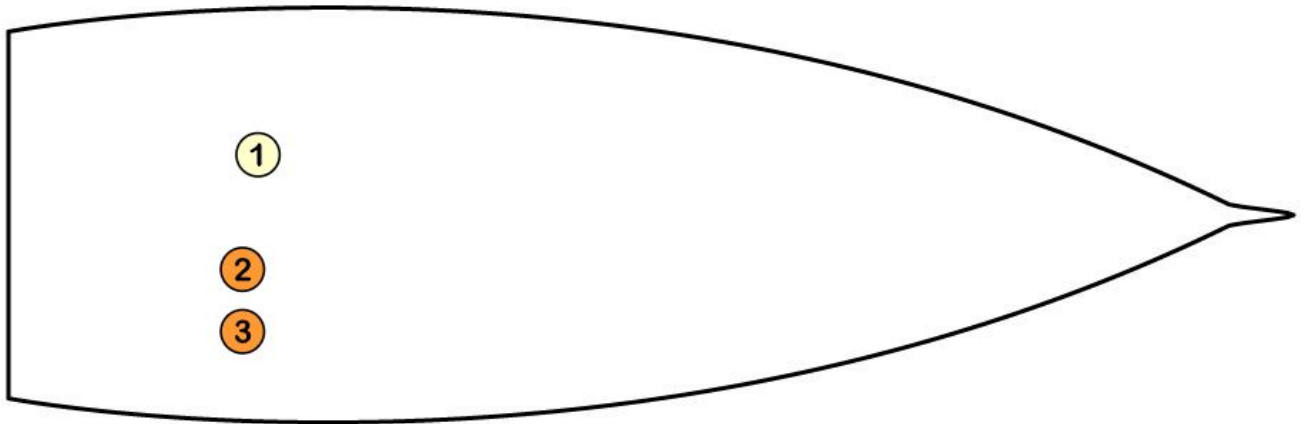
Diagram of thru-hulls:

- 1) Raw water intake for the generator cooling system
- 2) Transducer
- 3) Transducer
