This marine survey of the vessel

“Gator Done”

2019 Scout 210 Dorado

Report file #: SLP190124CV

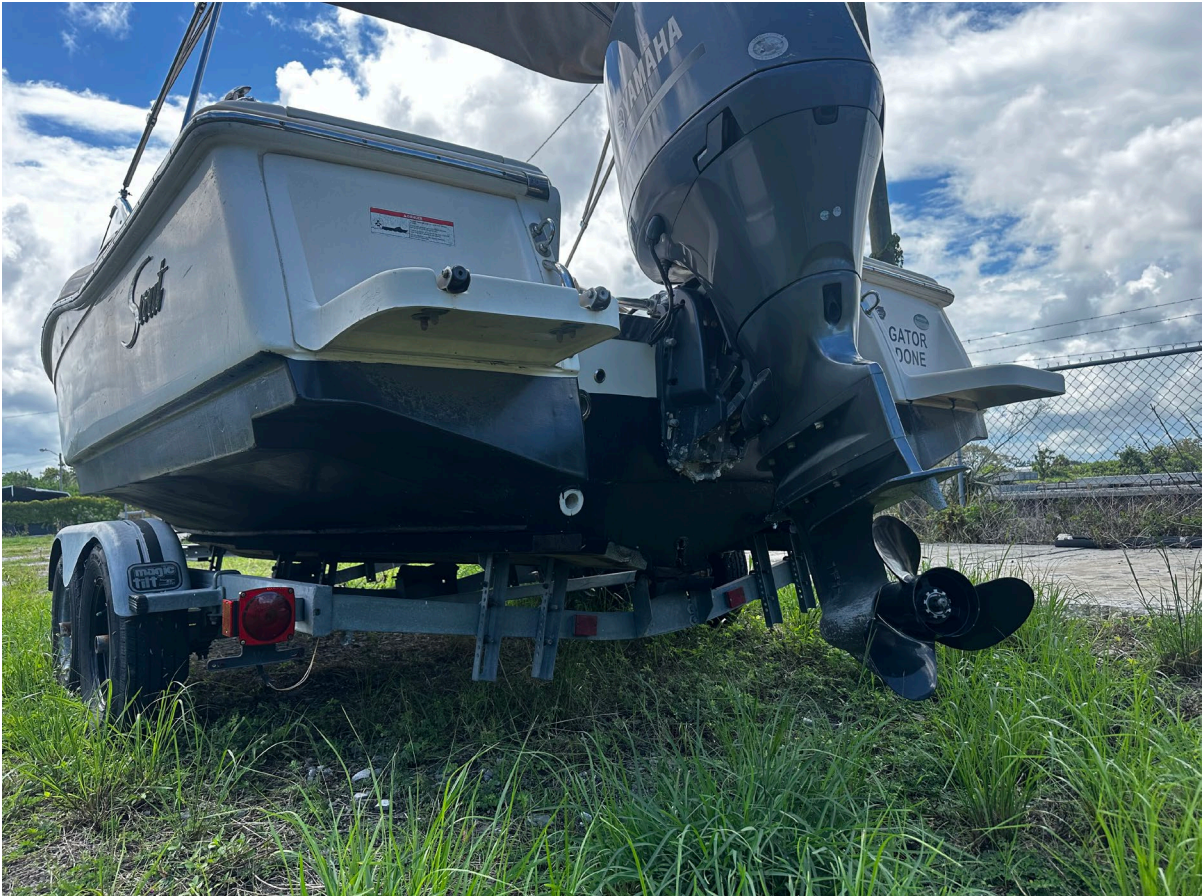
Below Waterline

The vessel was inspected out of the water on its trailer for signs of damage or delamination, none were found. The bottom is painted with black anti-fouling bottom paint that appears to be in good condition where viewable. The thru hulls are plastic and one bronze thru hull and seacock for the live well in serviceable condition. The vessel is not equipped with trim tabs.

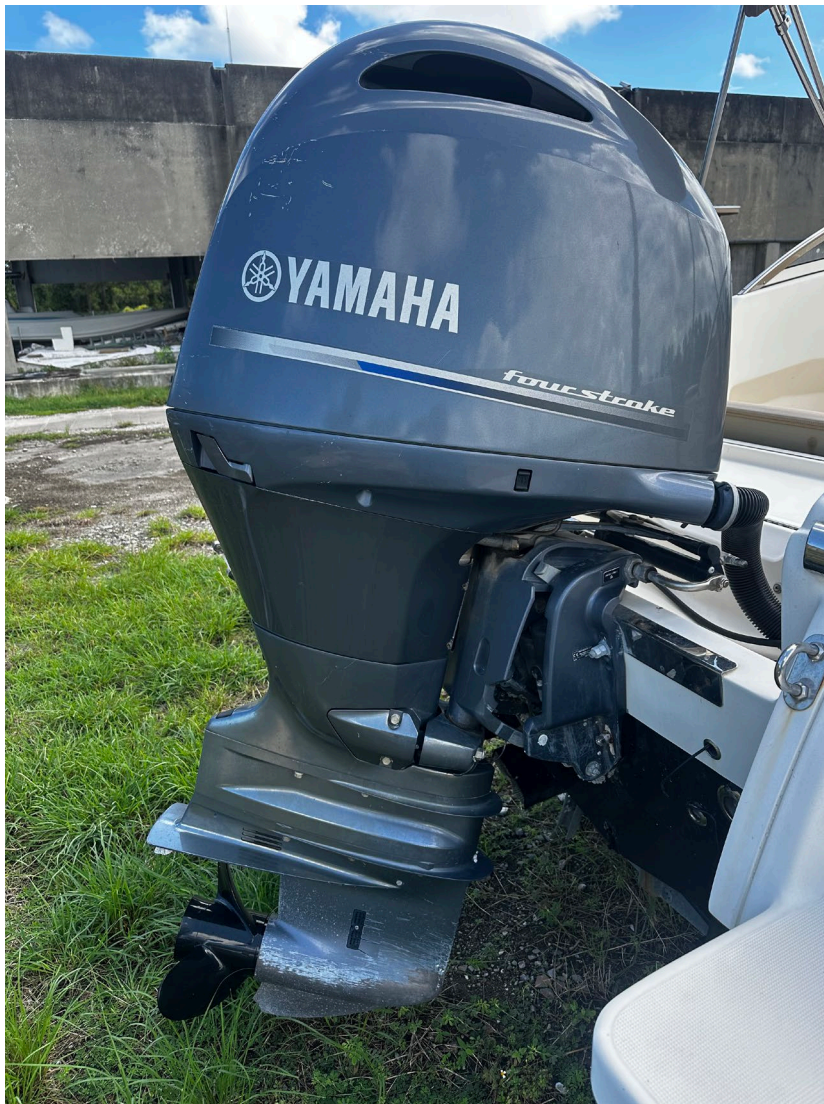
Outboard Engine

The outboard engine is mounted on the fiberglass transom and appears to be in fair cosmetic condition. (It was noted that the lower unit had a small section missing out the skeg and was heavily scratched) The engine hours could not be determined due to the 12 volt battery being dead.

1. Repair or replace compass.
2. Charge 12 volt battery to confirm proper operation of 12 volt system and to confirm engine hours.
3. Cover positive posts on battery.
4. Repair scratched and missing section of lower unit skeg.

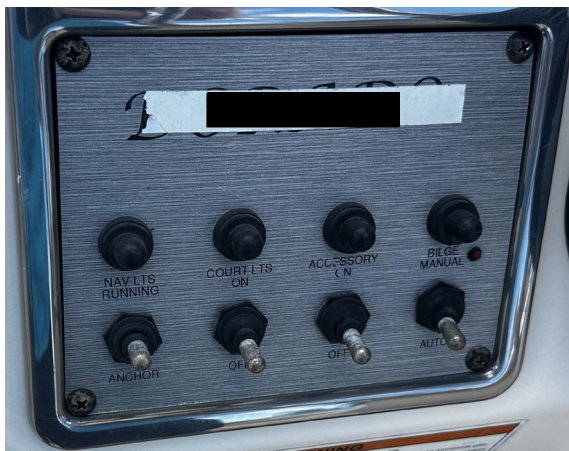
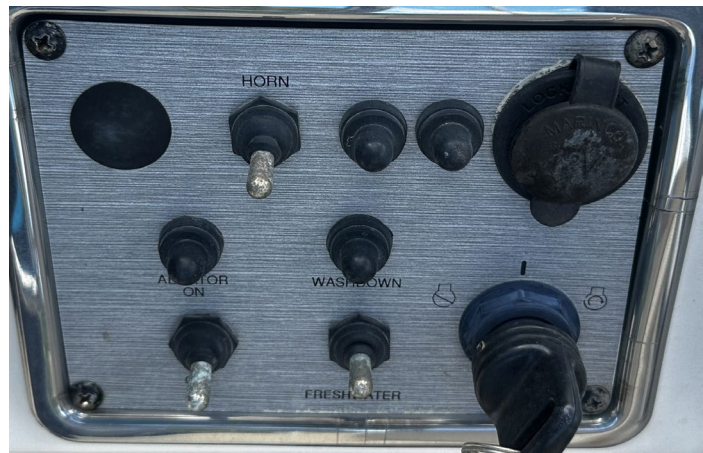
DC switches located at helm

The **DC** system is 12 volts and consists of one group 24 battery for engine start and house service. (The 12 volt battery was dead at time of inspection therefore 12 volt systems could not be proven) The battery is mounted underneath the starboard aft guest seat in the cockpit. (It was noted the positive post was not covered). The DC system is protected by vapor proof On/Off switch and individual system breakers on the panels at the helm. The system is charged by engine driven alternator only.

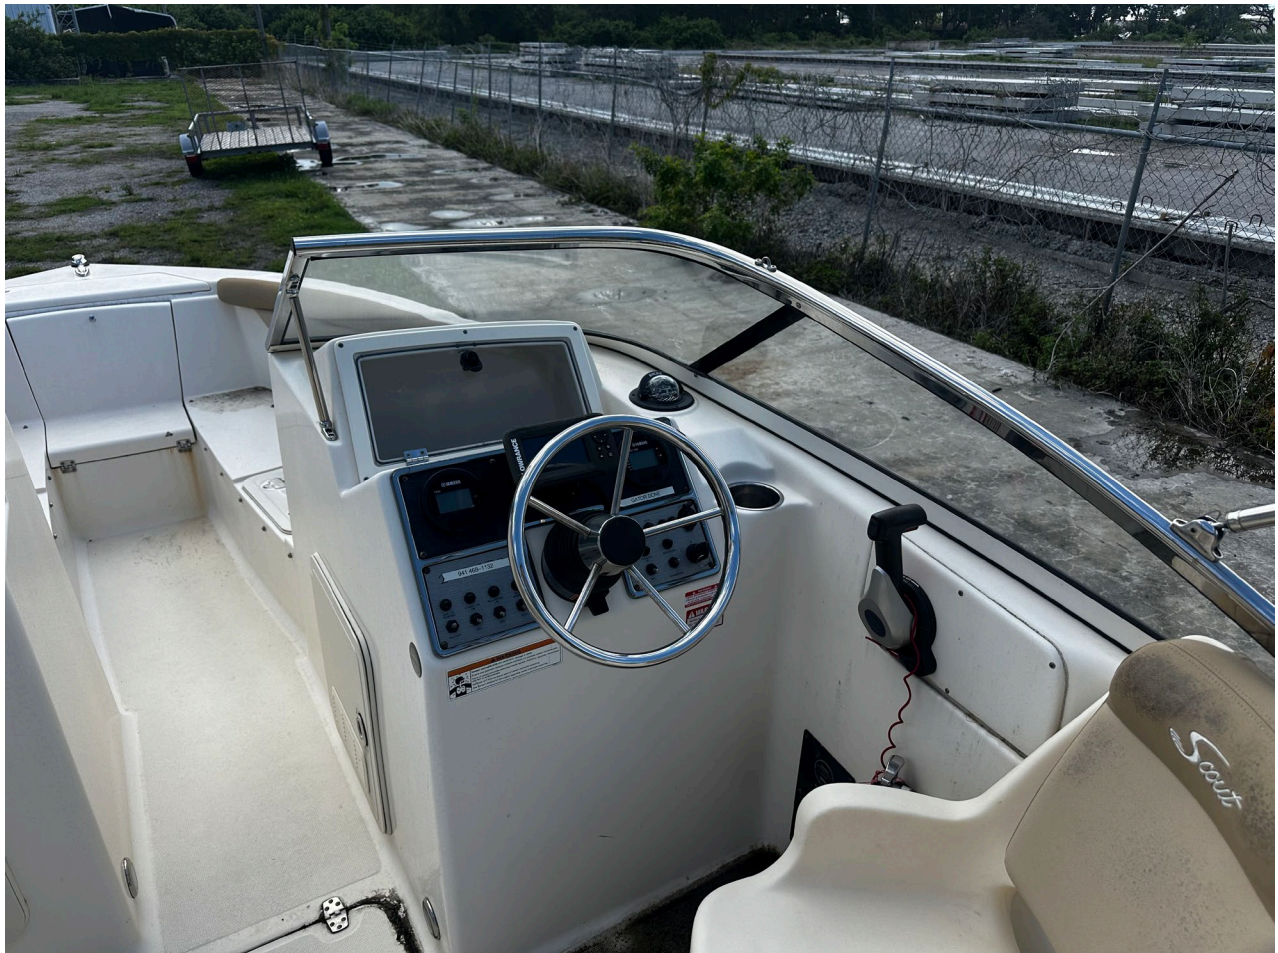
Helm & Electronics

| COMPASS | 4" Ritche flush mounted at helm. (No fluid and lense star crazed) |

(The electronics could not be proven due to dead 12 volt battery).
