**1980 Norbelle 37 Custom Sloop**

***Pearly Gates***

**Report of Marine Survey**

**April 1st 2024**

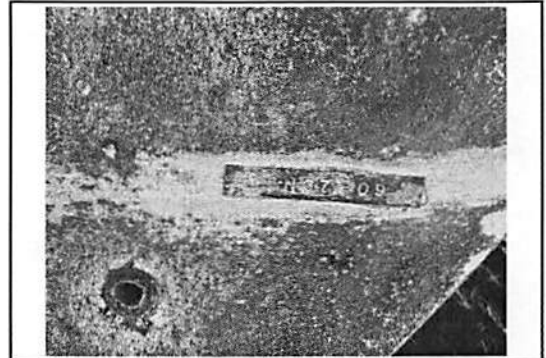
**Hull ID**

Displacement hull, fin keel and rudder on skeg.  
USCG document not viewed and appears to be expired.

FINDINGS	RECOMMENDATIONS
Documentation number	<i>U.S.C.G. documentation number not affixed to hull. The vessel must have the official number permanently affixed in block-type Arabic numerals of not less than 3 inches in height, preceded by the letters "NO ." on some clearly visible interior integral structural part of the vessel. Recommend to obtain current document and keep a copy onboard.</i>

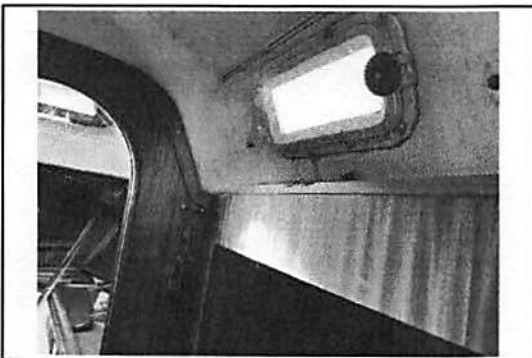
**Portlights**

Opening aluminum ports. Gaskets worn, missing hardware.

FINDINGS	RECOMMENDATIONS
Portlights	<i>Recommend to replace seals on portlights and replace any missing hardware.</i>

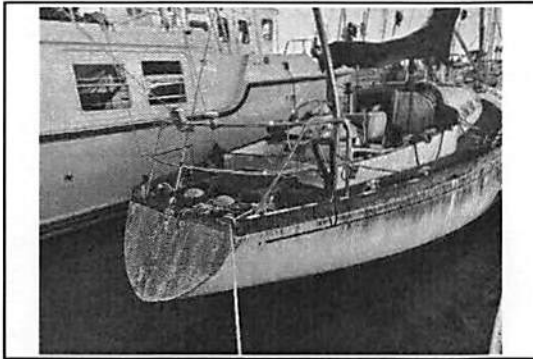
**Stern View**

Transom appears serviceable. There are open fastener holes from what appears to be a wind vane that was mounted on transom. Recommend to fill the holes to avoid water intrusion.

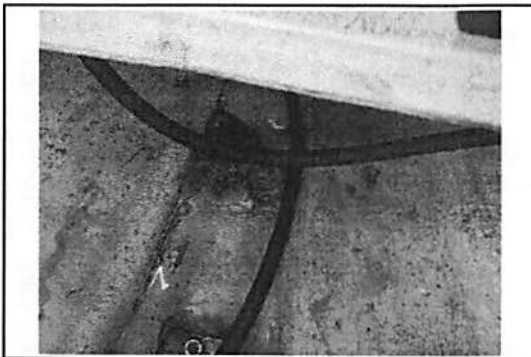
**Keel bolts**

Stainless keel bolts appear serviceable. Recommend to follow manufacturers guidelines for keel bolt maintenance and replacement timelines. Complete inspection not available.

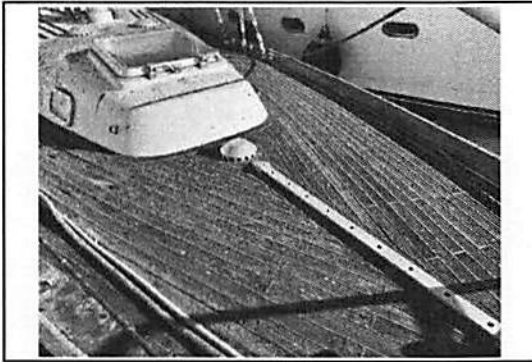
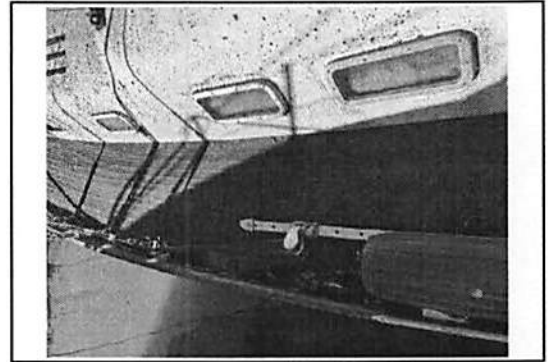
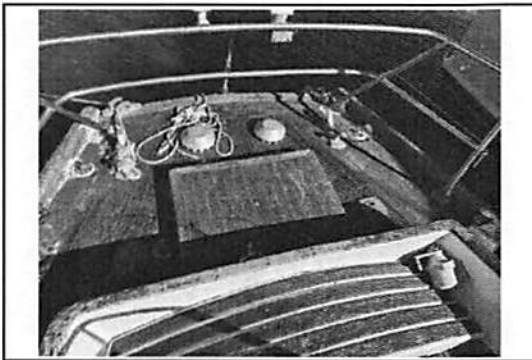
Teak overlays on fiberglass over plywood. The decks show signs of wear. The teak was found to be tight to the decks. Some bungs missing on fasteners. Water channel teak overlays at toe rails in poor condition.

FINDINGS	RECOMMENDATIONS
Teak deck overlays	<i>Investigate further and repair or renew as necessary.</i>

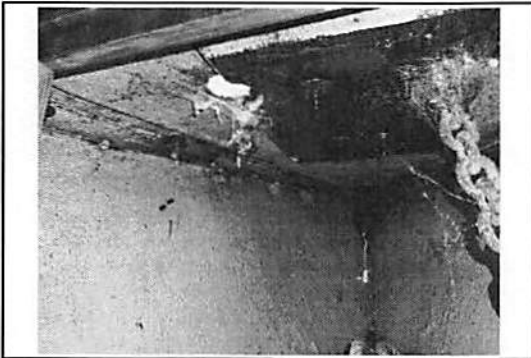
Hull to deck joint

The hull to deck joint appeared serviceable where sighted.  
Condensation sighted on joint and areas of water intrusion sighted.

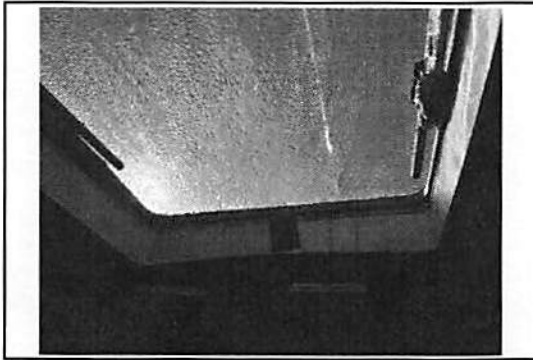
Escape hatch

Opening hatches are worn with worn seals.

FINDINGS	RECOMMENDATIONS
Hatch seals	<i>Investigate further and repair or renew as necessary to achieve watertight seal when shut.</i>

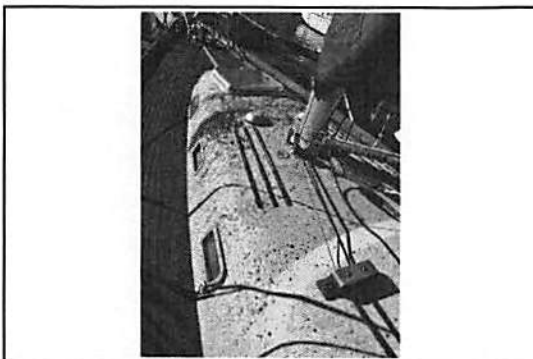
Cabin top

Fiberglass cabin top. The cabin top needs to be pressure washed to remove moss and mold.

FINDINGS	RECOMMENDATIONS
Moss and mold	<i>Recommend to pressure wash topsides to clean.</i>

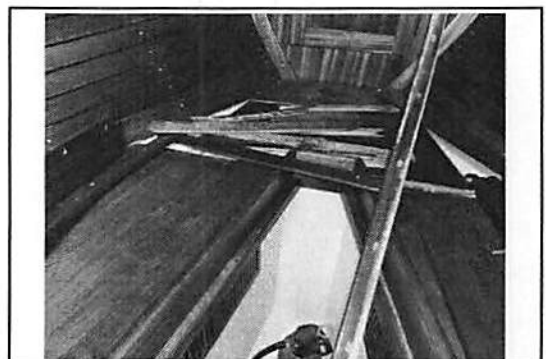
Trim removed

Teak interior has mold build up. Many trim pieces are removed  
Various teak panels and pieces are in good condition.

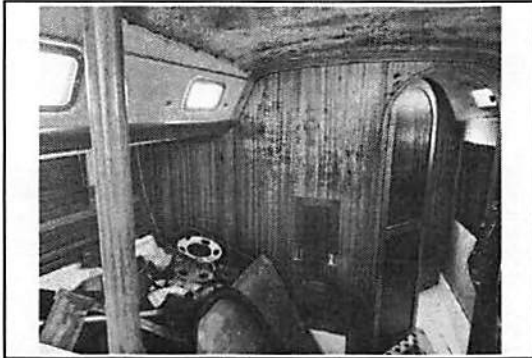
**Mold in Cabin**

The interior is in process of restoration with many systems and structures disassembled. Mold and mildew through out and needs to be cleaned and sanitized.

FINDINGS	RECOMMENDATIONS
Interior cleaning	<i>Clean and sanitize all interior surfaces to remove mold and mildew. Recommend a dehumidifier or Air dryer with fan to help eliminate stagnant air.</i>

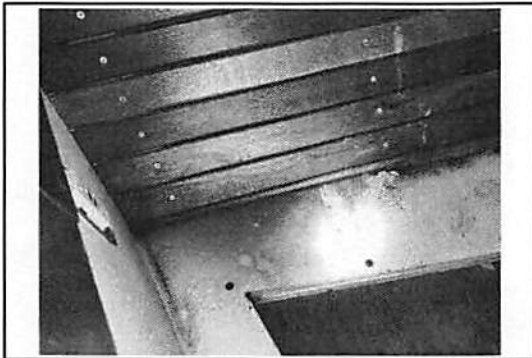
As previously noted there are several areas of deck leaks.

**Rain water intrusion**

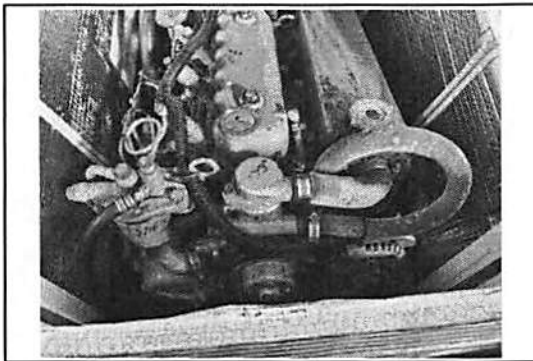
Engine

The engine was not able to be started due to battery condition.

There is corrosion on the back of the engine that should be addressed. Recommend to clean, treat and paint as corrosion prevention.

Full service to the engine would be recommended.

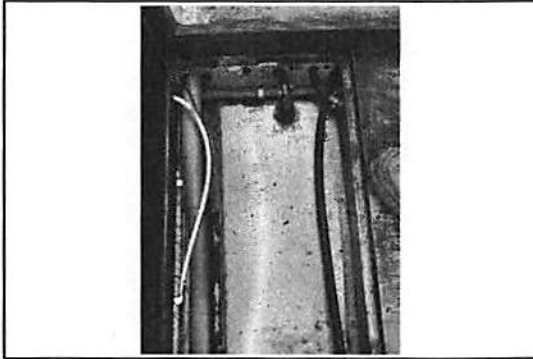
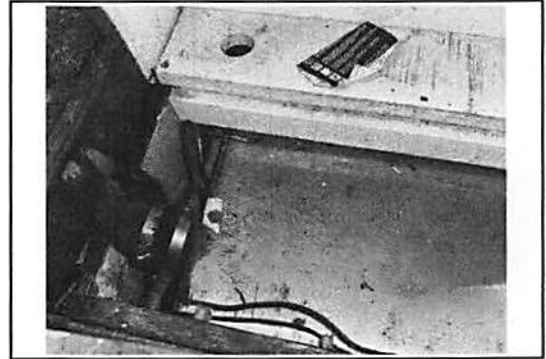
Stainless Steel fuel tank mounted under cabin sole.  
Some surface corrosion sighted. appears serviceable

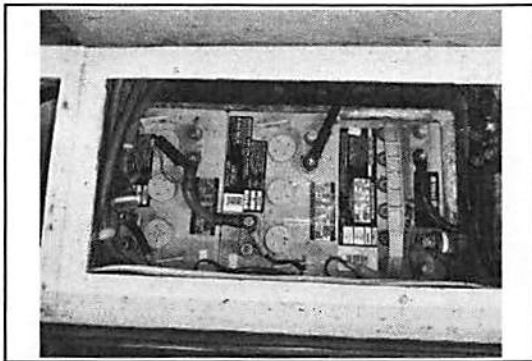
**Batteries**

Battery condition.

Replacing batteries is recommended.

FINDINGS	RECOMMENDATIONS
Battery condition.	<i>Recommend to charge batteries with appropriate charger and determine if usable. Replace if necessary.</i>

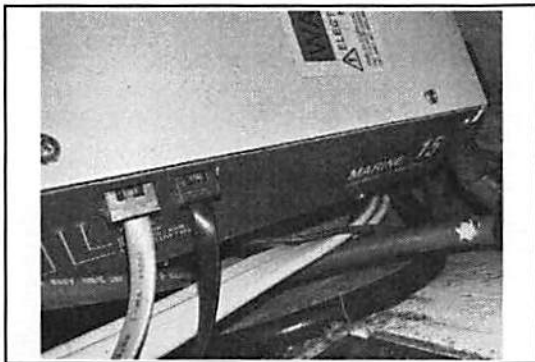
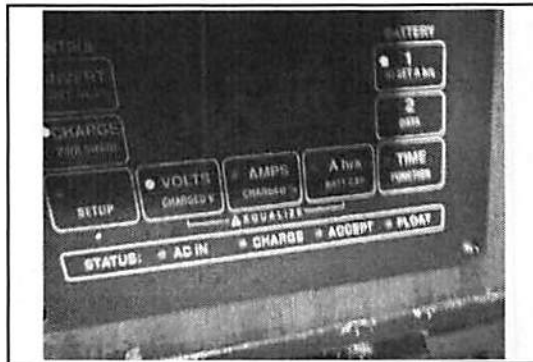
Xantrex Freedom 15 Inverter Charger. Powers up, not tested due to error message.

FINDINGS	RECOMMENDATIONS
Inverter/Charger error code	<i>Investigate further and repair or renew as necessary.</i>

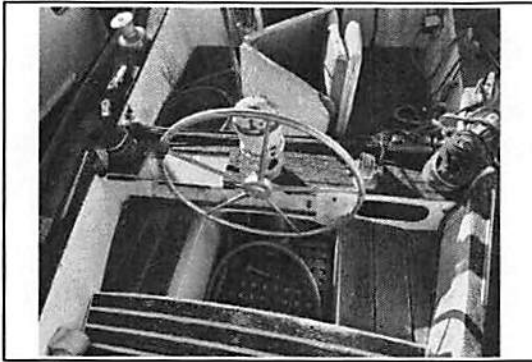
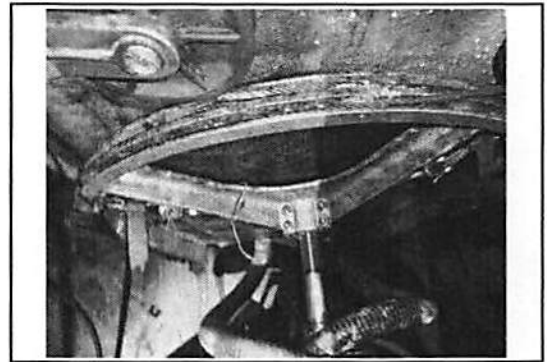
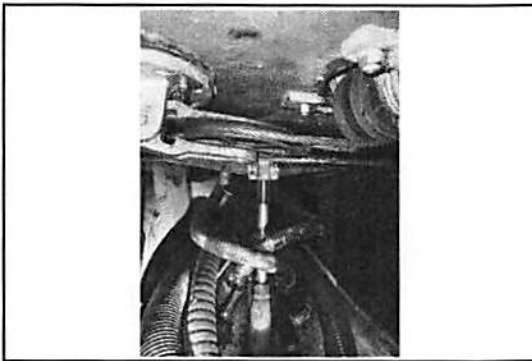
Pedestal helm with Cable over quadrant. The steering cables were loose.

Steering cables loose

FINDINGS	RECOMMENDATIONS
Steering cables loose	<i>Tighten steering cables.</i>

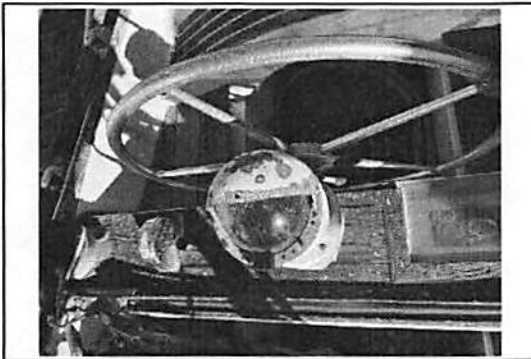
**Compass**

Compass appears to be dry. Recommend new compass or service.

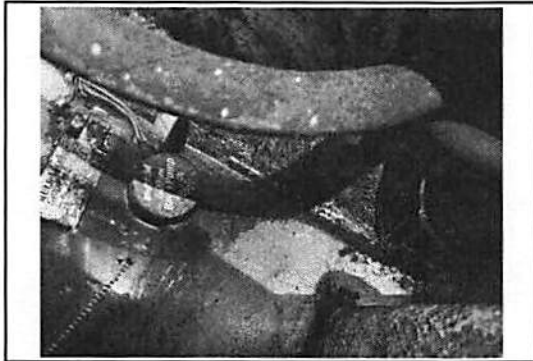
Bilge pump

Two (2) Rule automatic with float switch. Low voltage would operate pumps, but not pumping water due to low voltage.

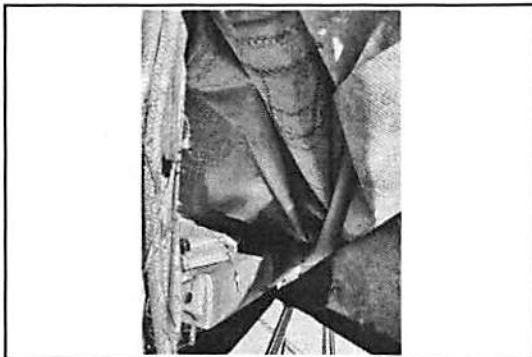
Main sail

Mainsail with cover on boom. The sail is showing signs of age.
