2008 51 Heritage Boatworks

Renegade

Report of Marine Survey

Conducted by
AMEC Marine Surveyors

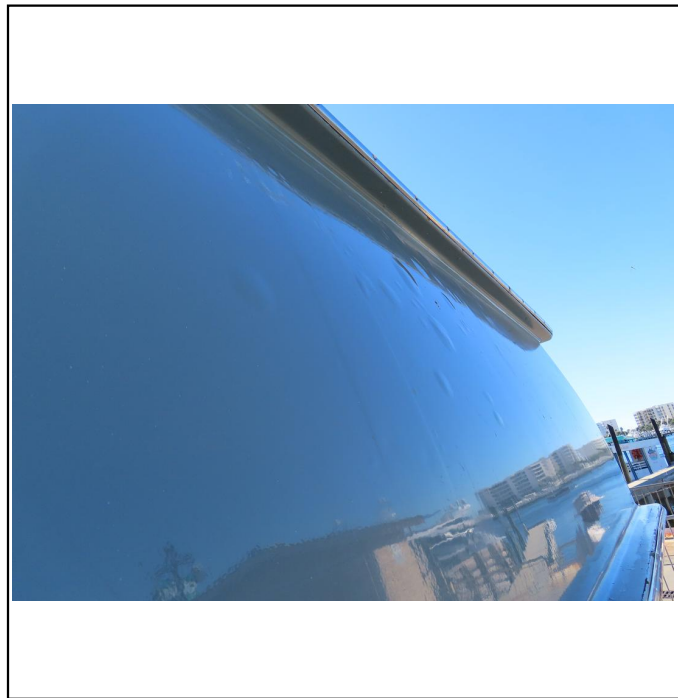
* **HULL: [B1]** Modified deep-v planing type hull. Cold molded hull painted gray with maroon/gold boot stripe and black bottom paint. The hull sides have some blisters in the paint in various areas with paint fading and discoloration with the bow hull having some paint scratches. The bottom paint is in poor condition with bottom paint wearing off in several areas. There are areas on the bottom where the fiberglass is starting to chip off as well. The stainless steel rub rail screws are rusting in various areas.

Hull sides blisters

FINDINGS	RECOMMENDATIONS
B.1 (PAGE 4) HULL: Modified deep-v planing type hull. Cold molded hull painted gray with maroon/gold boot stripe and black bottom paint. The hull sides have have some blisters in the paint in various areas with paint fading and discoloration with the bow hull having some paint scratches. The bottom paint is in poor condition with bottom paint wearing off in several areas. There are areas on the bottom where the fiberglass is starting to chip off as well. The stainless steel rub rail screws are rusting in various areas.	<i>Investigate further and repair or renew as necessary.</i>
B.2 (PAGE 4) BULKHEADS/STRINGERS: Athwartships reinforcement enhanced by wood bulkheads bonded to the hull with FRP (fiber reinforced plastic). Note: The forward starboard stringers appear to have some wood rot and the starboard engine stringer on the inboard side of the stringer is cracked on the surface.	<i>Investigate further and repair or renew as necessary.</i>

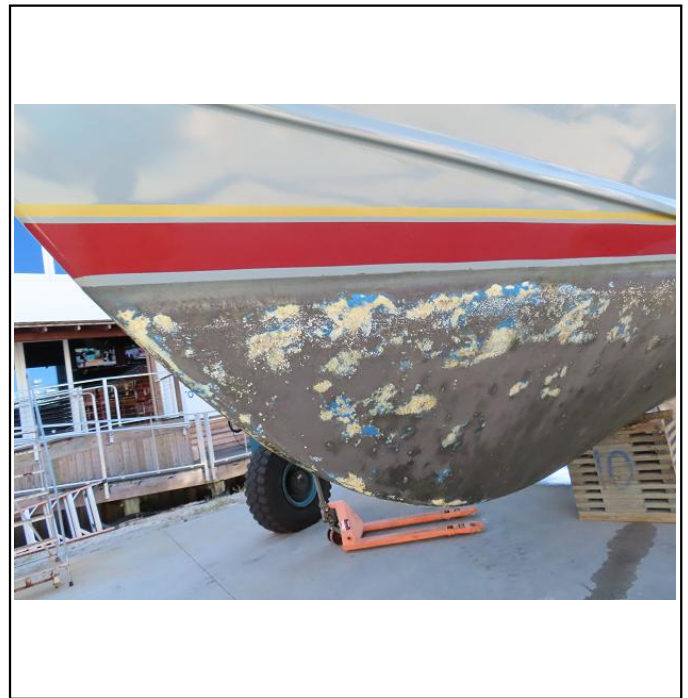
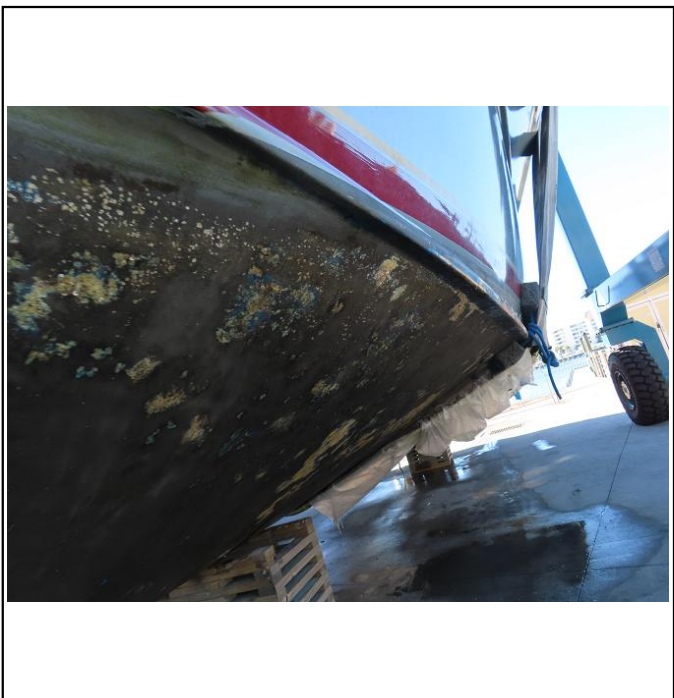
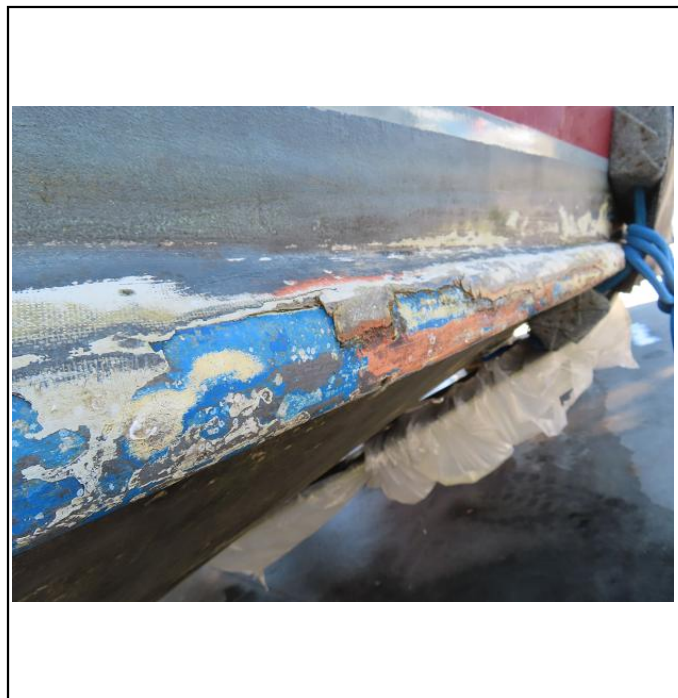
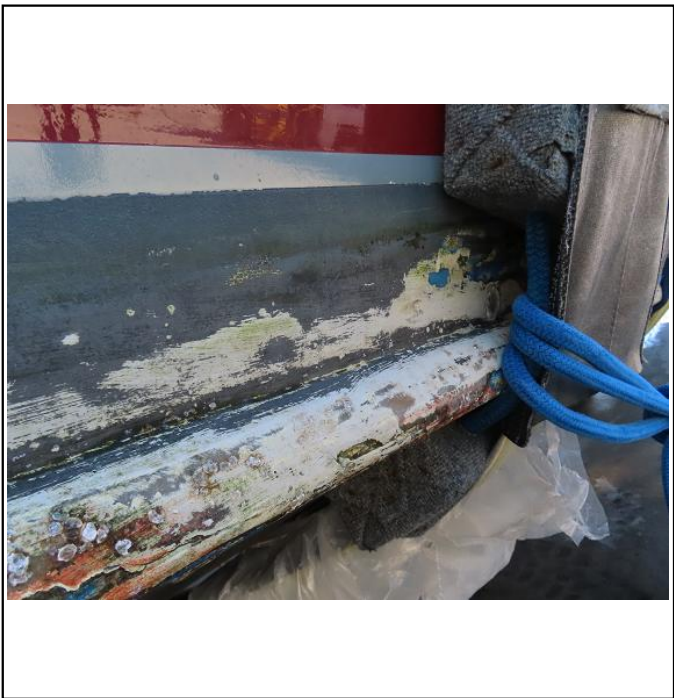
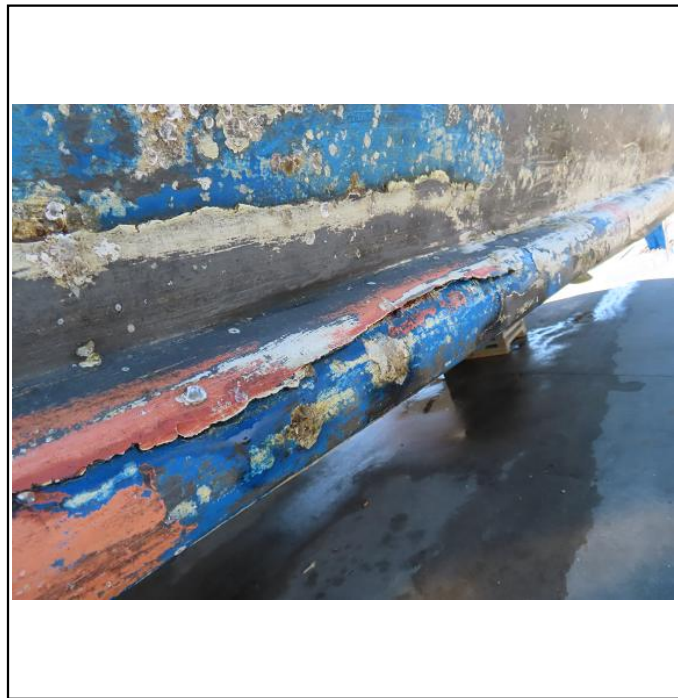
CONDITION OF BOTTOM PAINT: Poor condition (see photos).

Bottom

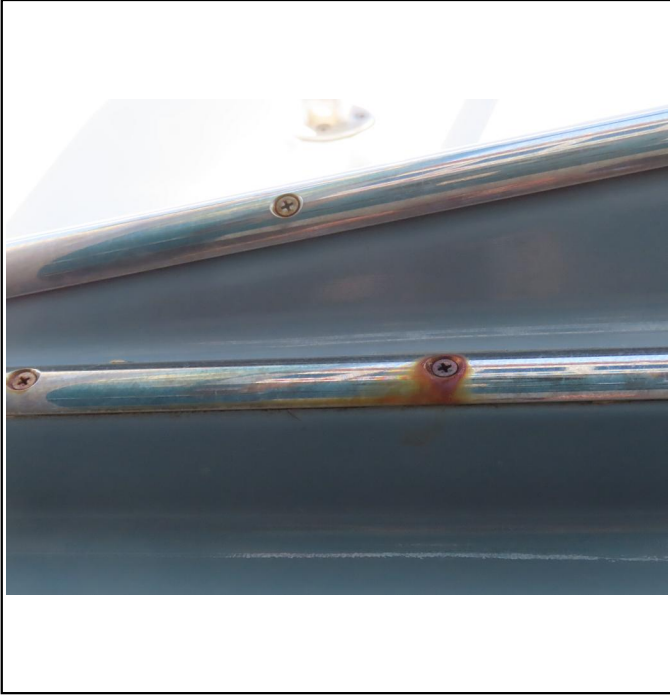
Rub rail

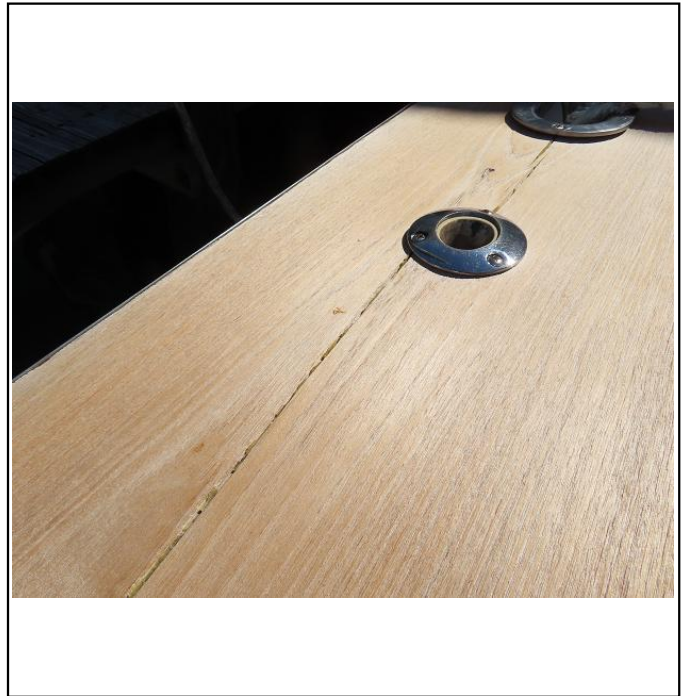
OTHER: Cockpit gunwales are teak wood and are wearing with some cracking but in as good condition as possible given their condition.

Cockpit gunwale

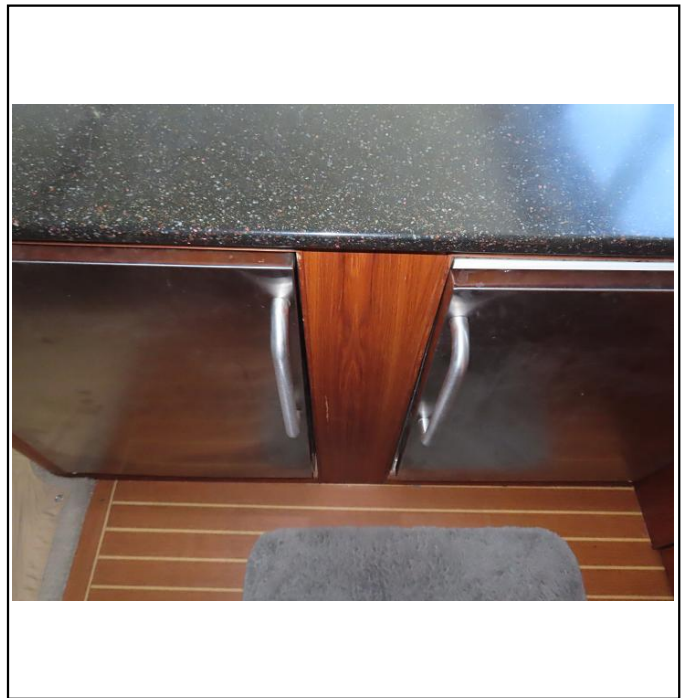
Note: The refrigerators were not secure in their holes.

Galley refrigerators

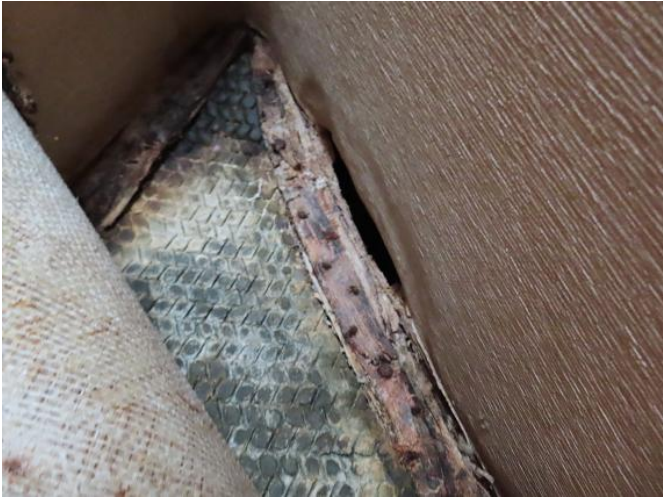
Note: The forward starboard stringers appear to have some wood rot and the starboard engine stringer on the inboard side of the stringer is cracked on the surface.

Bow cabin wood rot

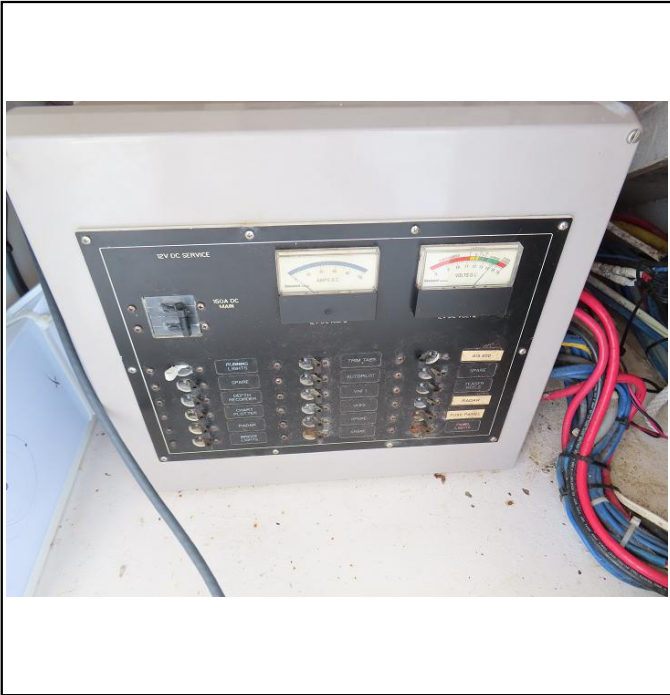
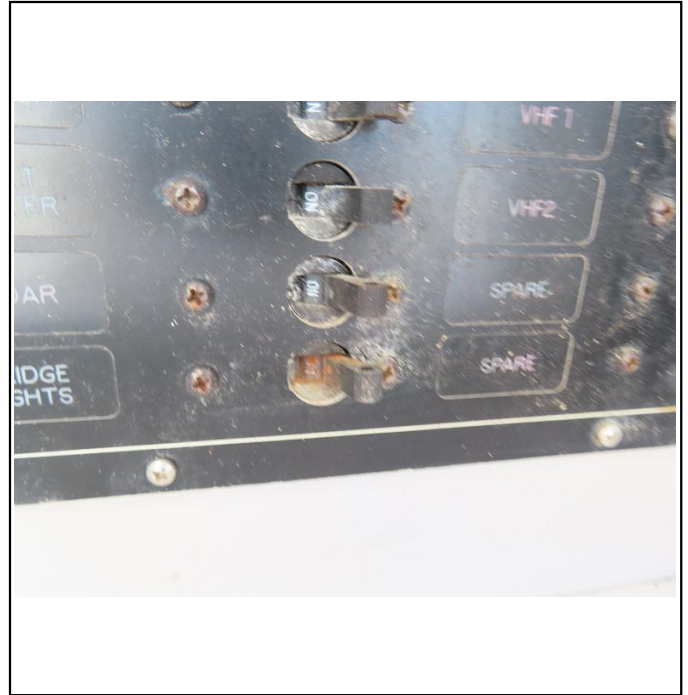
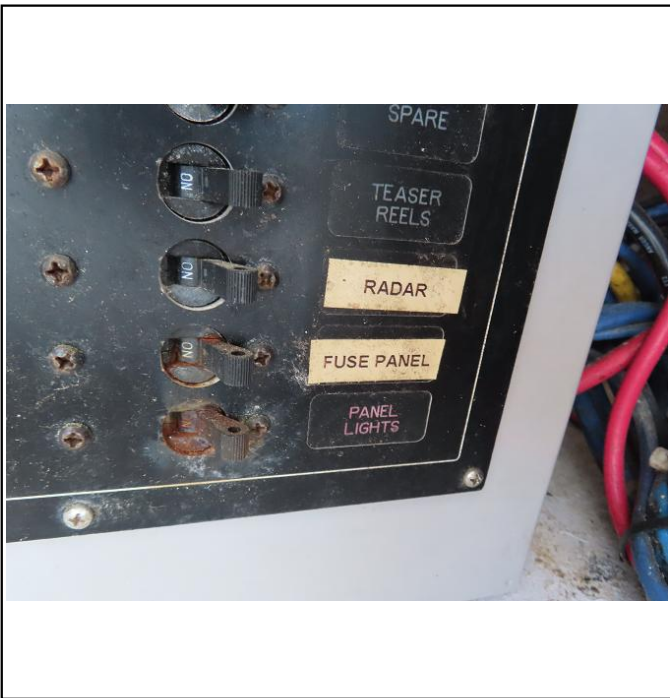
* **OTHER: [B3]** The bridge breaker panel for the 12 volt system there is a few of the breakers that are rusty and have a poor connection.

Bridge breakers

B.3 (PAGE 6) OTHER: The bridge breaker panel for the 12 volt system there is a few of the breakers that are rusty and have a poor connection.	<i>Investigate further and repair or renew as necessary.</i>
B.4 (PAGE 9) GROUNDING PLATES: Aft bilge grounding plate is corroded with another electrical box that has no cover. Both were in the aft bilge area.	<i>Investigate further and repair or renew as necessary.</i>
B.5 (PAGE 10) LIST: Three (3) Rule 1500 and 2000 GPH bilge pumps with float switches. All pumps were operable. The float switch for the engine room bilge pump is not operable.	<i>Investigate further and repair or renew as necessary.</i>

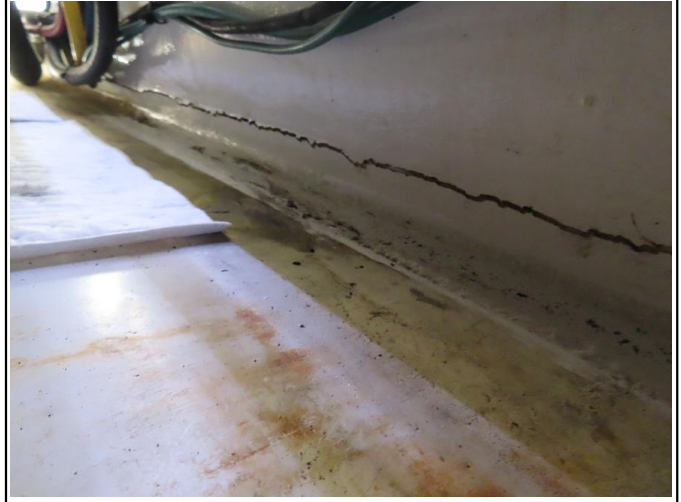
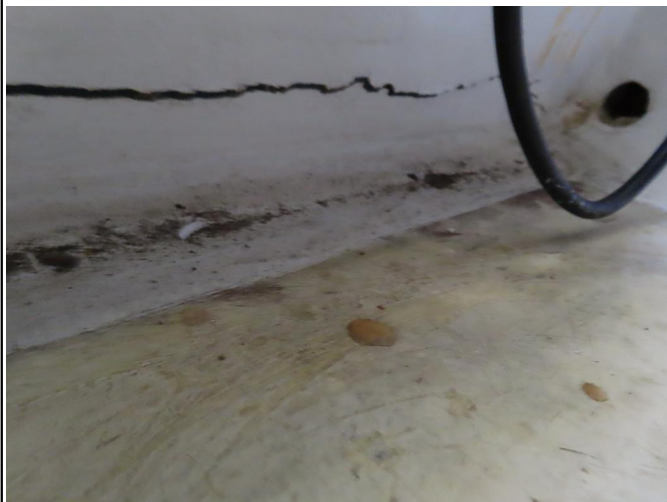
Starboard engine stringer crack
