**MARINE SURVEY REPORT ABOARD THE VESSEL**

**2006 Bennington 2275 FSi**

<b>FILE NUMBER &amp; STATUS</b>	No. 1402   Complete As Of 05/16/2024
<b>MARINE SURVEY INSPECTION TYPE</b>	Condition & Valuation Survey
<b>MARINE SURVEY REPORT PREPARED EXCLUSIVELY FOR</b>	[REDACTED]
<b>DATE OF MARINE SURVEY INSPECTION(S)</b>	05/13/2024
<b>VESSEL YEAR, MAKE, MODEL &amp; HULL IDENTIFICATION NUMBER</b>	2006 Bennington 2275 FSi   ETW43240B606
<b>VESSEL NAME, HAILING PORT, GROSS &amp; NET TONNAGE</b>	N/A
<b>US COAST GUARD DOCUMENTATION &amp; REGISTRATION NUMBERS</b>	SC 9088 BV
<b>OVERALL VESSEL RATING</b>	<b>POOR CONDITION</b>
<b>FAIR MARKET VALUE OF VESSEL</b>	<b>\$8,000.00 USD</b>
<b>ESTIMATED REPLACEMENT COST OF VESSEL</b>	<b>\$60,000.00 USD</b>
<b>MARINE SURVEY INSPECTION &amp; SEA TRIAL LOCATION(S)</b>	[REDACTED], North Charleston, South Carolina 29405, USA
<b>MARINE SURVEY DAY WEATHER &amp; SEA STATE CONDITIONS</b>	78°F, partly sunny, zero precipitation, wind S @ 4 MPH, calm sea state, 74°F sea water and excellent visibility

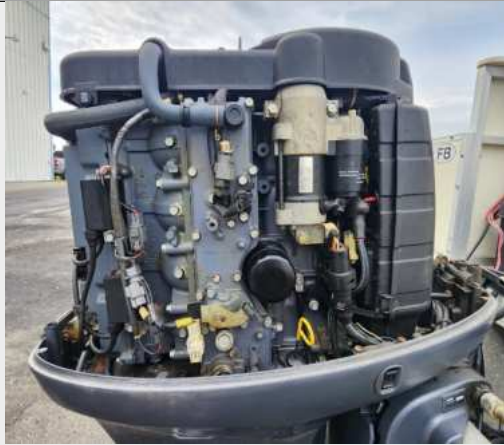
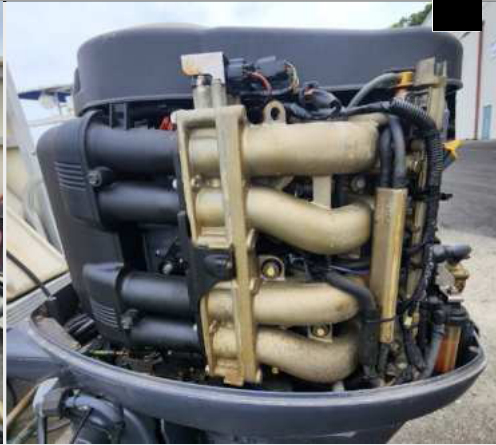
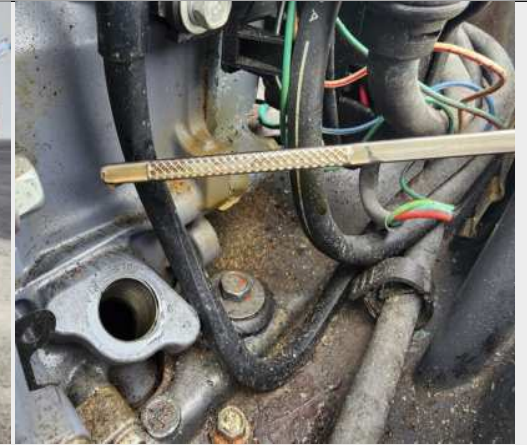
1x Yamaha 115HP outboard, power head, electrical components, and fuel system are in fair condition. The Yamaha engine had been recently serviced and the oil is in like new condition.

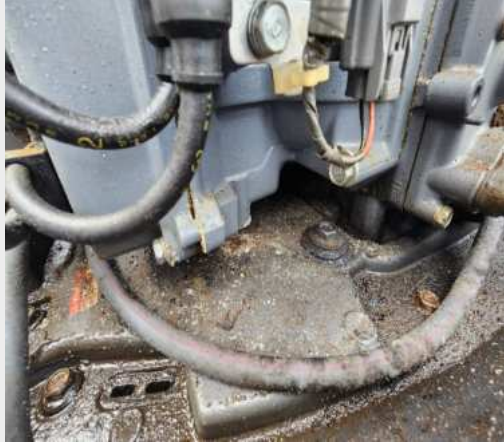
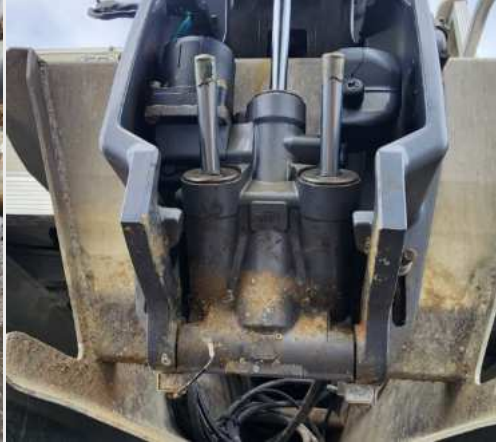
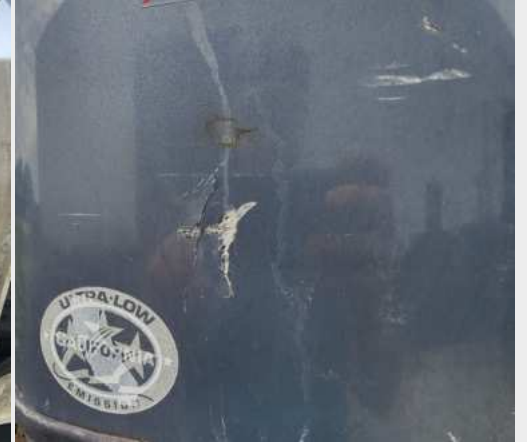
Minor corrosion and dirty was observed at the base of the power head. 1x aftermarket trim and tilt system operates properly. 1x transom anode of cut off. 1x engine cowling is cracked through on the aft side.

**ENGINE CONDITION, ENGINE ROOM SPACE, SOUND INSULATION & BLOWER SYSTEMS** The 1x 2006 Yamaha F115TLR 1.7L 115HP inline 4-cylinder 4-stroke EFI gasoline outboard engine, engine oil, gear lube fluids and all related propulsion systems are in functional condition for the age and use of the vessel without pitting, metal wear or fatigue, pinking to the metals, galvanic or stray current corrosion, active oil, raw-water, fuel, or gear lube fluid leaks throughout the cold-check visual inspection. The 1x engine powerhead and block, air intakes, oil fills, oil lines, dipsticks, valve covers, spin-on fuel/oil filters, inline fuel filters, belt, all pulleys, belt tensioner, exhaust, fuel pumps, US Coast Guard approved type-A2 fuel lines, gaskets, returns, shut-off valves, hoseclamps, seals, alternators, starters, conductors, harnesses, engine motor mounts, pencil zinc sacrificial anodes and grounding wires are in operative shape without critical corrosion. All propulsion system fluids were in useful shape at suitable levels and were not distinctively milky, watery, burnt or contaminated by noticeable metal wear, freshwater, raw-water, coolant or fuel intrusion. *Minor corrosion is present at the base of the 1x Yamaha powerhead. The transom bracket sacrificial zinc anode has been cut away.\**

7. **On the aft starboard section of the rubrail the rubber insert has fallen out.** Reinstall rubrail insert.
8. **Minor corrosion is present at the base of the 1x Yamaha powerhead. The transom bracket sacrificial zinc anode has been cut away.** Clean powerhead and replace anode.

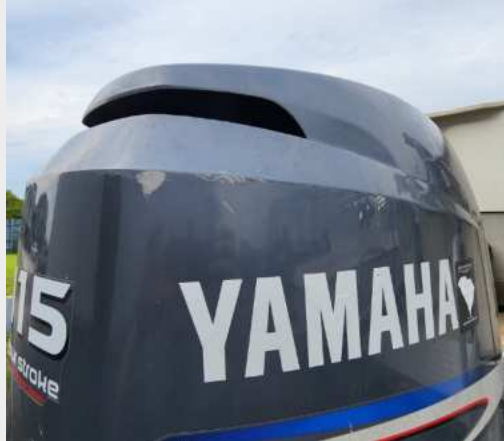
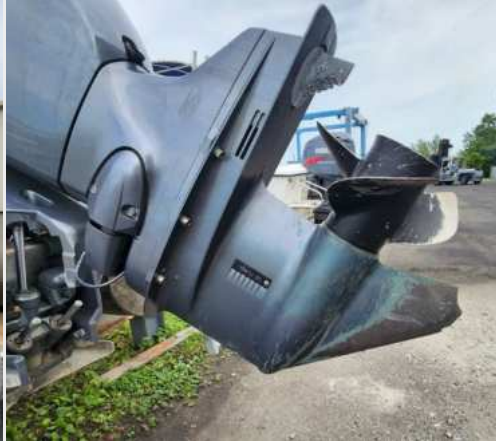
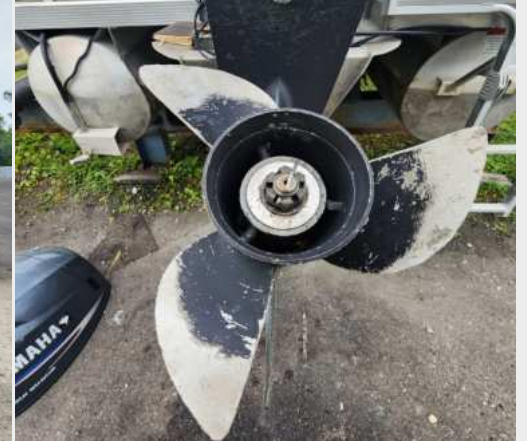
Cosmetic damage to the 1x engine cowling. 1x lower unit has cosmetic paint wear and scratches. 1x 3-blade propeller is damaged on the leading edge of each blade.

**PROPELLER QUANTITY, SIZE & MATERIAL** The 1x 3-blade aluminum propeller blade tips have noticeable damage. The ages, internal conditions and service histories of the propellers are unverified.

<b>ENGINE TRANSOM ASSEMBLIES, MIDSECTIONS &amp; LOWER UNITS</b> 1x mid sections and lower units are in functional condition. <i>The silver cosmetic paint finish on the 1x Yamaha engine lower unit is in poor condition and worn off. The skeg has 2x areas that have broken on the bottom edge*</i>
<b>ENGINE BEDS, MOUNTING BRACKETS &amp; MOTOR MOUNTS</b> The 1x FRP engine beds on the transom, 1x mounting brackets, 4x motor mounts, rubber inserts, bolts, washers and hardware are in fair condition without defects and did not noticeably. Ages, internal conditions and service histories of the motor mounts are unverified.
<b>ENGINE ROOM HATCH &amp; COWLING</b> The 1x engine cowlings, 2x latches, and components are in serviceable cosmetic and structurally condition, unobstructed and operate routinely. <i>1x Yamaha engine cowling is cracked through on the aft side and have cosmetic paint wear through out.*</i>

9. **The silver cosmetic paint finish on the 1x Yamaha engine lower unit is in poor condition and worn off. The skeg has 2x areas that have broken on the bottom edge.** Repair skeg and repaint as needed.

10. **The Yamaha engine cowling is cracked through on the aft side and was cosmetic paint finish is worn.** Repair crack and refinish if desired.
11. **3x voltmeter, fuel level and trim level indicator gauges have cloudy lenses and 1x trim level indicator gauge is inoperable.** Repair or replace gauges.

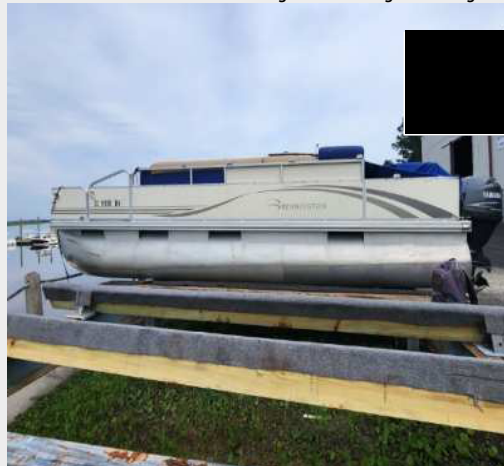
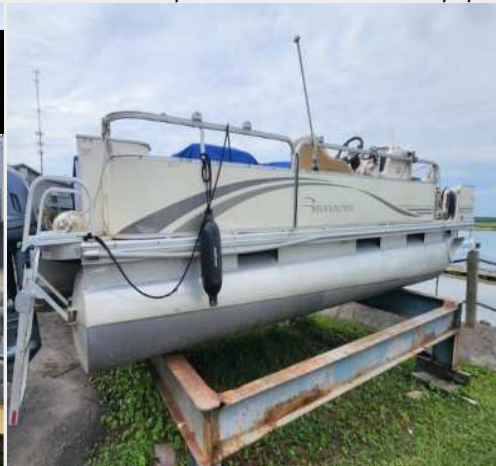
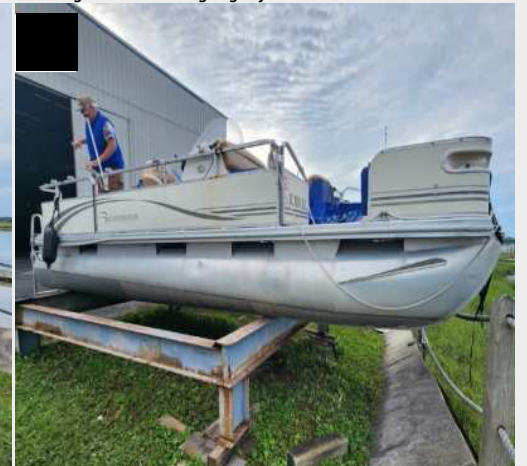
The port and starboard aluminum fence paneling are structurally and cosmetically sound and well-supported. 2x cosmetic dent on the starboard aft and port forward corners.

**HULL TOPSIDES, EXTERIOR FINISH, COATINGS, HULL-TO-DECK JOINT & SPRAY RAILS** The port and starboard aluminum fence panels with tan and grey graphic finish and hardware are in average and serviceable structural condition, well-supported and structurally sound for a vessel of this age, size and use. Hull topsides were scrutinized for structural loss, deterioration, saturation and detached bonding without discovery. *Moderate cosmetic wear and tear for a vessel of this age, size and use was discovered throughout the aluminum fence panels with tan and grey graphic finish including isolated and cosmetic dents.\**

4. **Moderate cosmetic wear and tear for a vessel of this age, size and use was discovered throughout the aluminum fence panels with tan and grey graphic finish including isolated and cosmetic dents.** Routinely monitor and renew cosmetic finish of the aluminum paneling as needed.

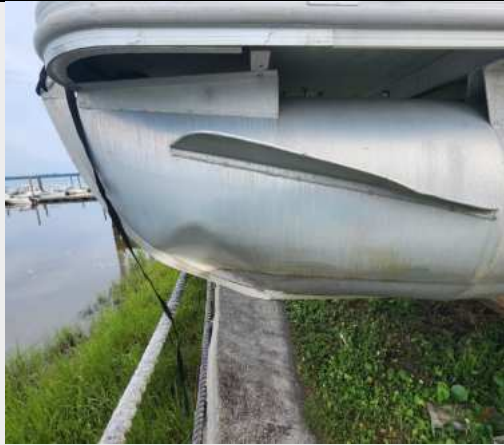
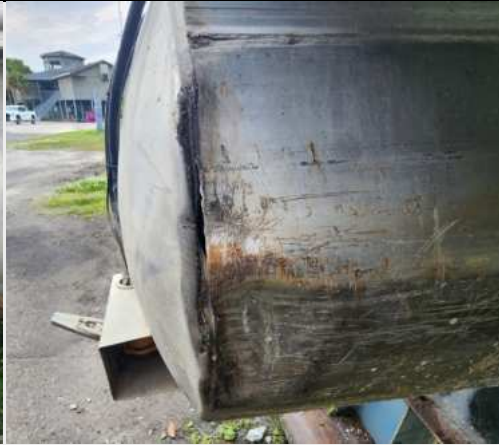
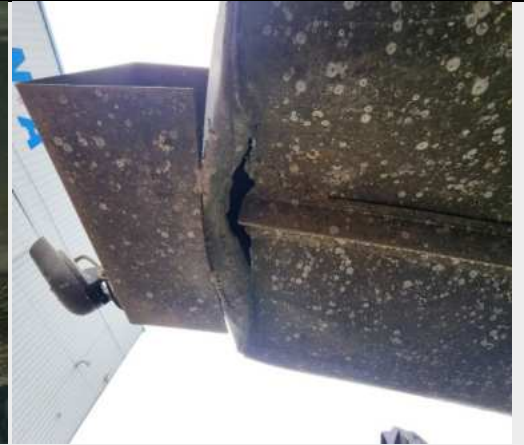
*The port 25" diameter aluminum pontoon is in poor condition with dents, and 2x ruptures at the aft cap welds.*

**HULLS WETTED SURFACE AREA, CHINE, BOTTOM PAINT & BARRIER COAT** *2x 25" diameter aluminum pontoons are in poor overall condition with widespread dents, scratches, bent sections and 2x ruptures on the portside pontoon aft cap welds rendering the vessel not watertight.\**

1. **2x 25" diameter aluminum pontoons are in poor overall condition with widespread dents, scratches, bent sections and 2x ruptures on the portside pontoon aft cap welds rendering the vessel not watertight.** Replace the pontoons.
2. **4x aft pontoon mounting brackets for the engine supports cross members are heavily corroded and bent.** Clean and repair mounting brackets and hardware as needed.
3. **Zero US Coast Guard approved aerial or handheld visual distress signal flares are kept onboard.** Install valid flares and keep in a dry easily accessed location.

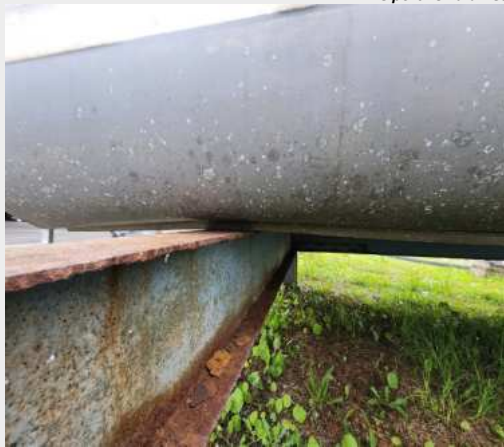
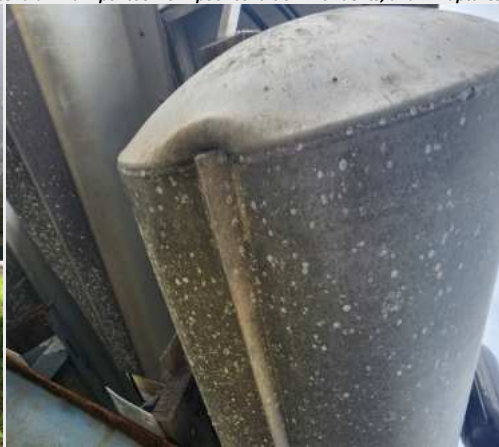
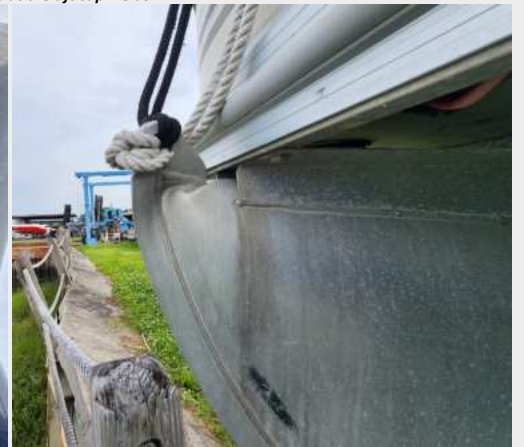
*The starboard 25" diameter aluminum pontoon appears water tight but is dented, bent, and scratched.*

**KEEL STRUCTURE, KEEL BOLTS, KEEL JOINT, CENTER & DAGGERBOARDS** *2x pontoons are bent in on the keels where they rest on the dry stack racks.\**

5. **2x pontoons are bent inward on the keels where they rest on the dry stack racks.** Repair or replace pontoons as needed.
6. **2x lift support actuators for the large aft storage compartment are broken.** Replace actuators.

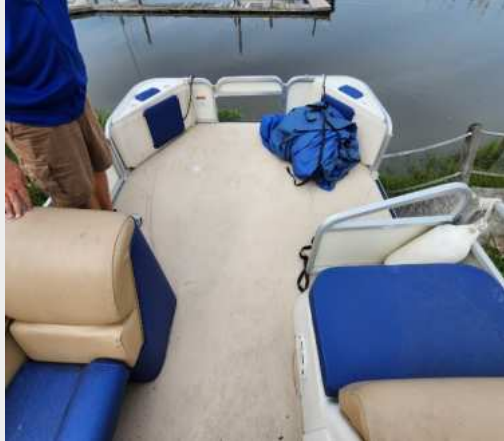
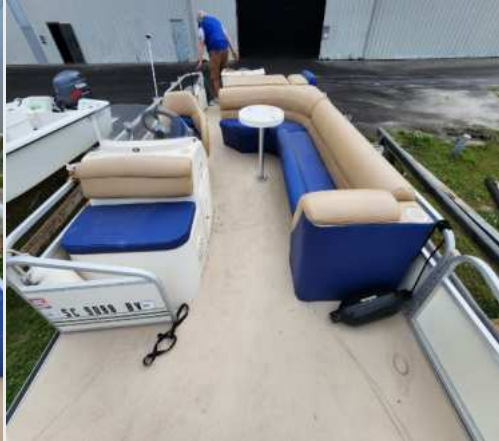
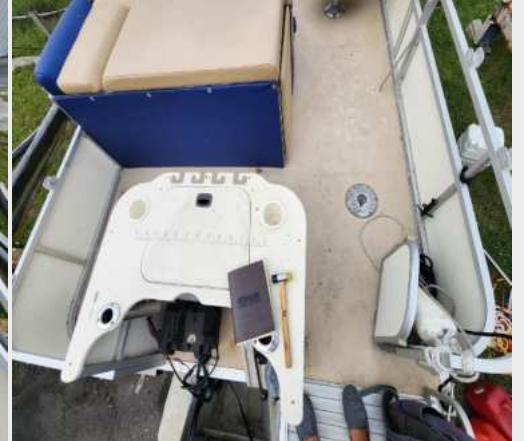
*The marine plywood and vinyl foredeck, main deck, and aft deck, are structurally and cosmetically sound and well-supported.*

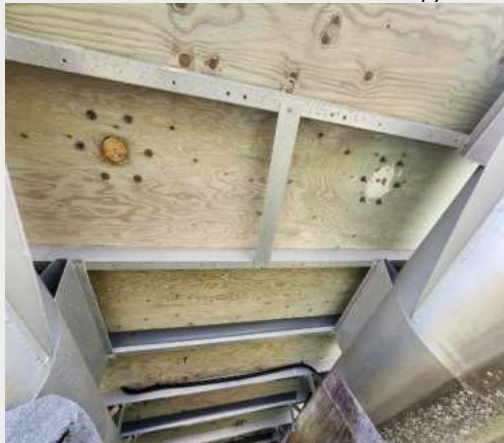
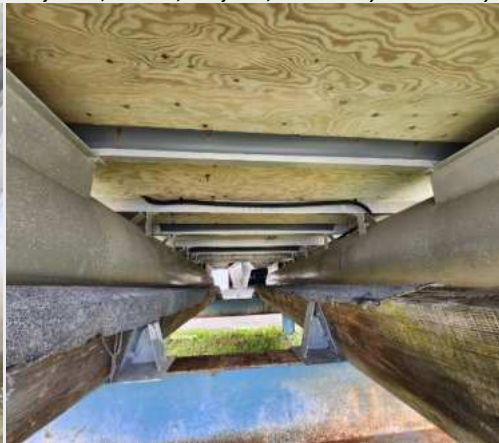
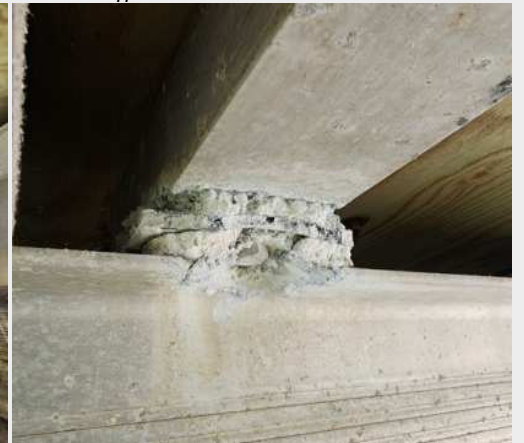
*The marine grade plywood decks are sound with no evidence of saturation or rot from the underside. 4x aft pontoon engine support brackets are heavily corroded and bent.*

**STRINGERS, FRAMING, TABBING, BULKHEADS & FASTENERS** *Due to limited access caused by vessel construction, a comprehensive inspection of all structural support systems was not accomplished. Core samples, ultrasonic thickness and destructive testing was not performed on the hull and fasteners were not pulled for inspection. 4x aft pontoon mounting brackets for the engine supports cross members are heavily corroded and bent.\**

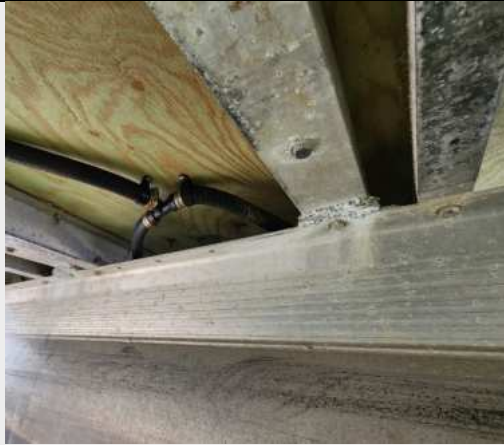
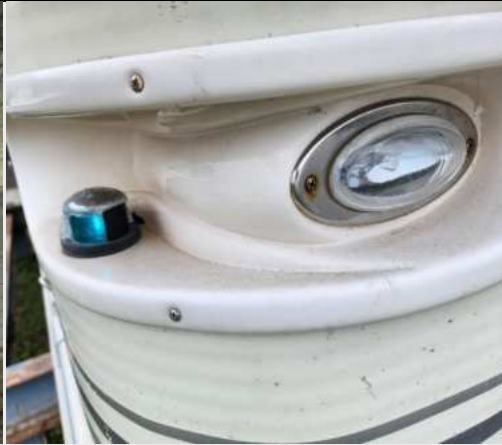
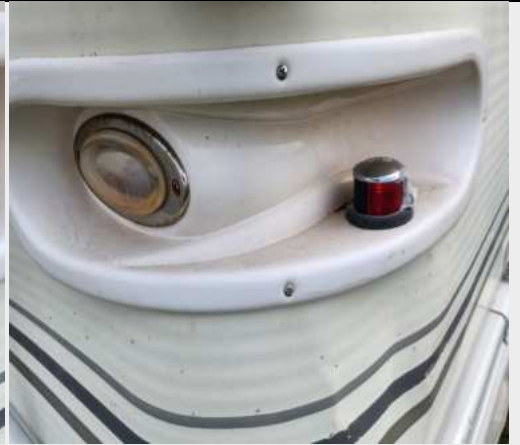
2x examples of the corrosion on the pontoon engine support brackets. 2x red and green nav lights power on. 2x bow docking lights do not power on.

<b>GALVANIC ISOLATOR &amp; ISOLATION TRANSFORMER SYSTEMS</b> Zero galvanic isolator or isolation transformer systems were discovered onboard.
<b>ALTERNATORS, SOLAR POWER PANELS &amp; WIND GENERATING SYSTEMS</b> The 1x engine 12V DC 35amp charging stator and conductors appears in functional condition and was charging the engine is running. Ages, internal conditions and service histories of the alternator systems are unverified. Zero solar power panels and wind generating systems are installed.
<b>AC SYSTEM VOLTAGE, DOCKSIDE INLET &amp; SHOREPOWER CABLE</b> Zero AC system voltage, dockside inlet, or shorepower cables are installed.
<b>MARINE GENERATOR QUANTITY, YEAR, MAKE &amp; MODEL</b> Zero generators are installed.
<b>MARINE GENERATOR SERIAL NUMBER &amp; RUN HOURS</b> N/A
<b>COURTESY, SPREADER, DOCKING &amp; UNDERWATER LIGHTS</b> <i>1x courtesy light on the side of the helm console and 2x docking lights on the bow are inoperable.*</i>

12. **1x Yamaha engine flush port is missing the rubber gasket.** Install new gasket.
13. **1x courtesy light on the side of the helm console and 2x docking lights on the bow are inoperable.** Repair or replace lights.

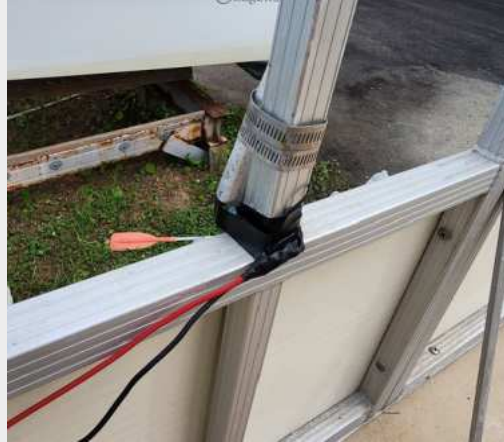
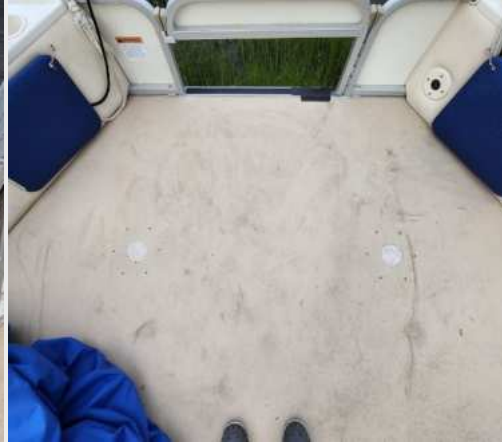
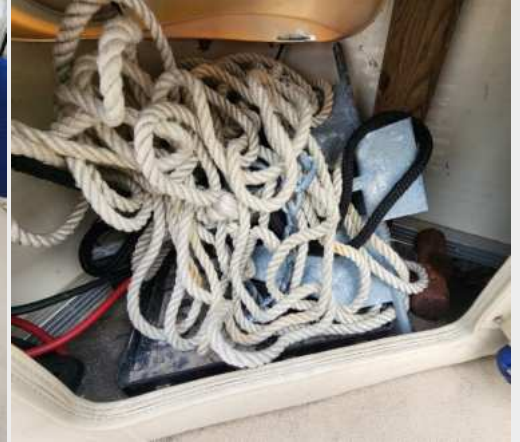
1x anchor light powers on but is mounted with tape and hose clamps. 2x bow casting chairs and mounts have been removed. 1x Danforth anchor and rode are in serviceable condition.

16. **1x Kidde type BC regular dry chemical fire extinguisher onboard is missing an annual inspection tag.** Annually inspect and tag each unit.
17. **1x 12V DC white anchor light on the starboard side rail powers on but is mounted with electrical tape and hoseclamps.** Properly mount the anchor light.

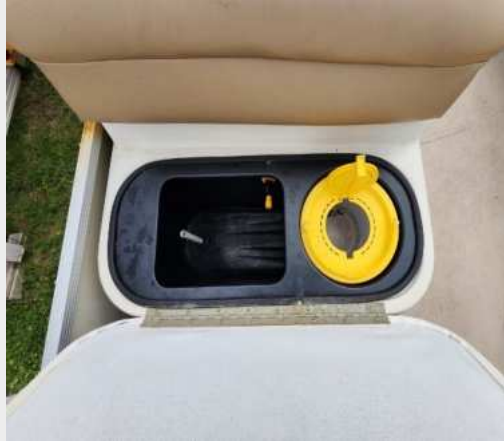
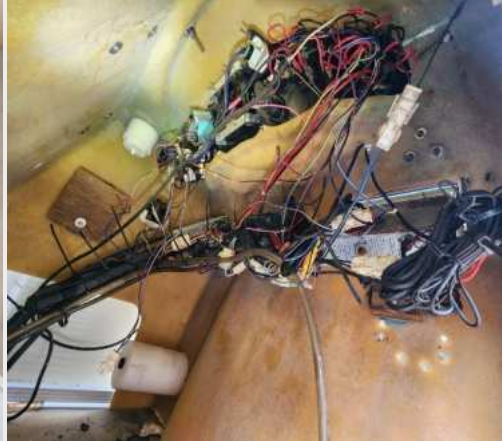
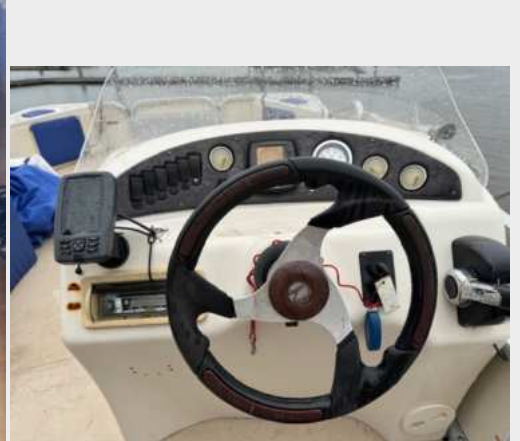
1x livewell in front of the helm console is structurally sound but not functional. The helm rigging is mostly organized and supported. FRP helm station is structurally sound and well-supported.

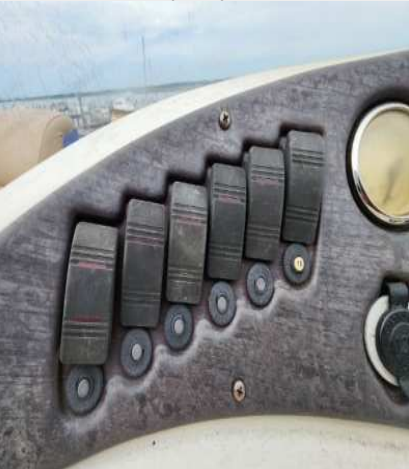
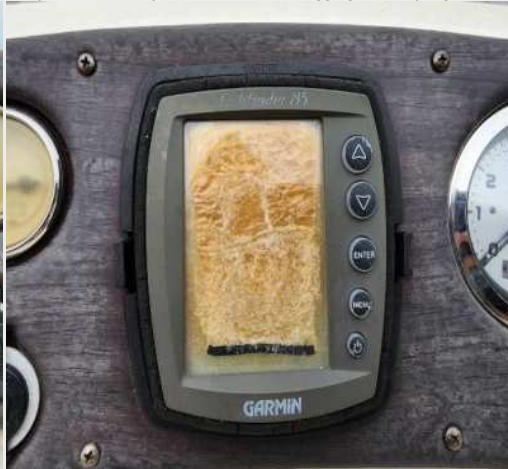
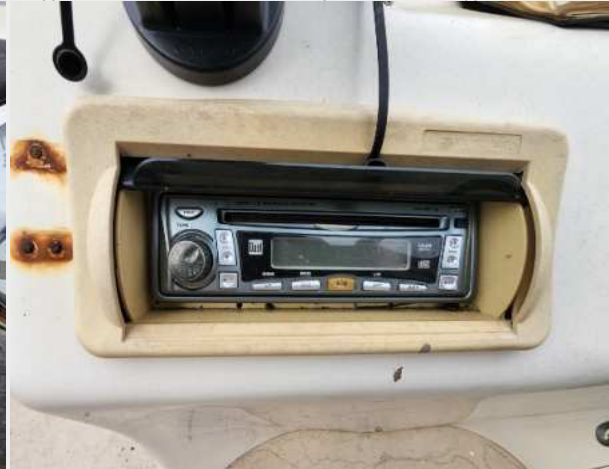
6x vessel control switch labels are difficult to read. 1x Garmin Fishfinder 85 does not operate. 1x Dual stereo does not function.

14. **1x 12V DC Dual XDS110 stereo at the helm does not power on.** Repair or replace stereo.
15. **1x 12V DC livewell pump is inoperable.** Replace livewell pump.

18. **1x 12V DC Garmin Fishfinder 85 installed on the 1x helm station dash is inoperable.** Replace fishfinder display as needed.

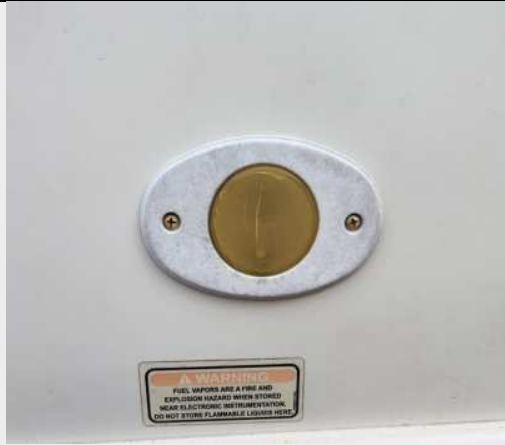
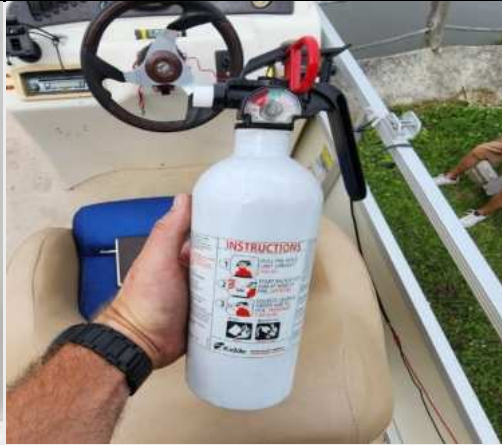
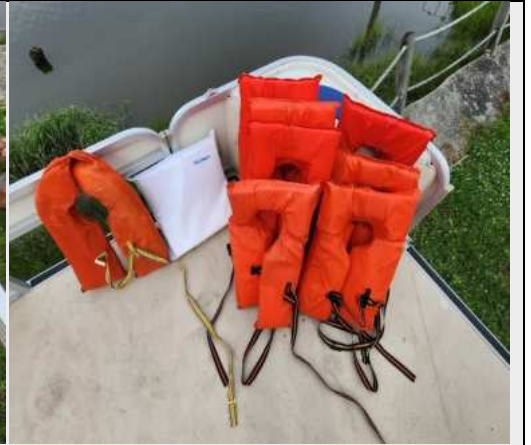
1x courtesy light on the side of the helm console does not power on. 1x Kidde fire extinguisher, 1x type-IV throwable & 8x type-II PFDs, in operational condition.

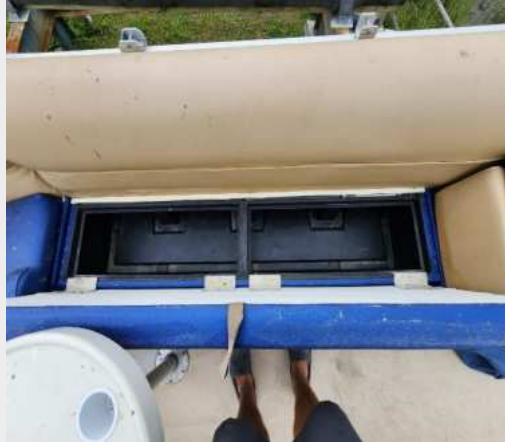
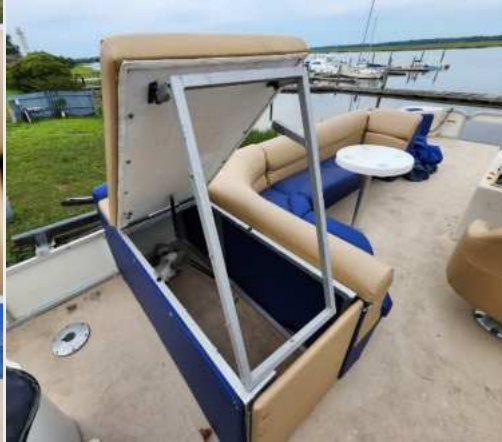
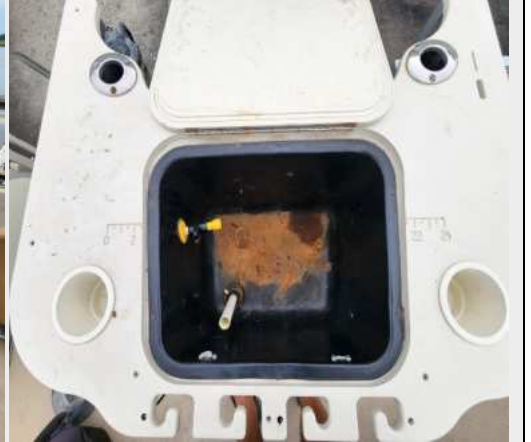
1x portside storage compartment is functional. 1x aft storage compartment lift supports are broken. 1x aft livewell is in sound condition but does not operate.

**CABINHOUSE, INTERIOR SPACE, HEADLINER, STORAGE & VESSEL VENTILATION** The 6x storage compartments are structurally sound and functional. *The 2x lift supports for the large aft storage compartment are broken.\**

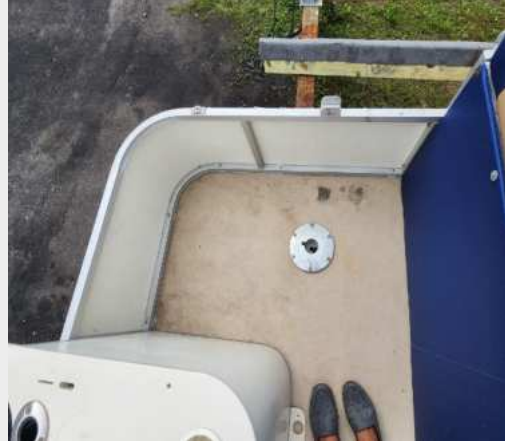
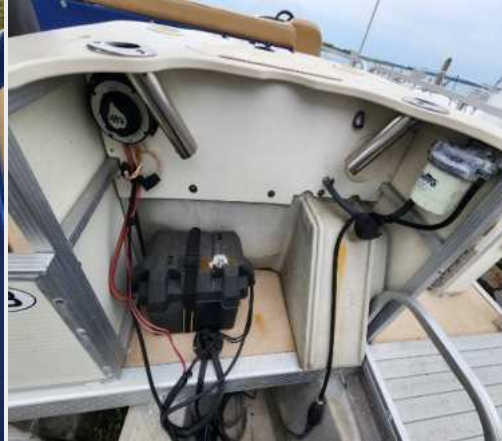
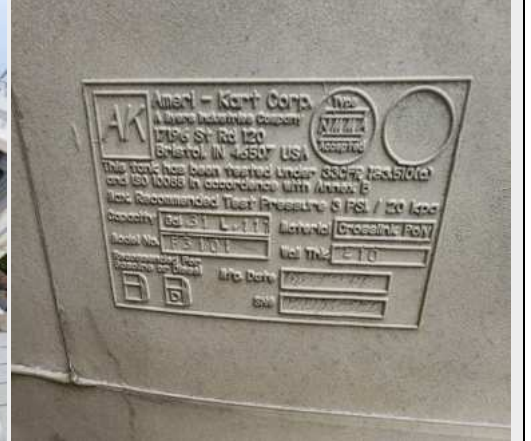
1x aft casting chair is not onboard. In front of the motor is 1x 31-gallon crosslink poly fuel tank and fuel filter in serviceable condition.

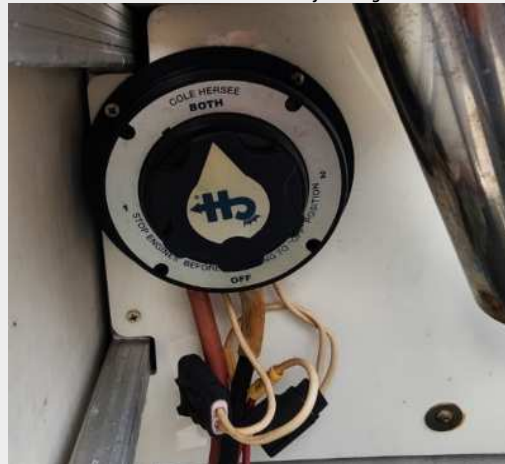
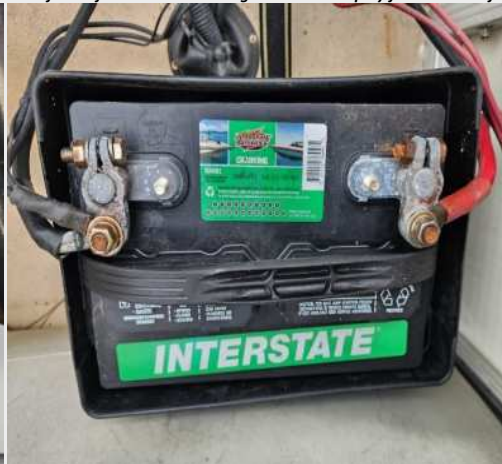
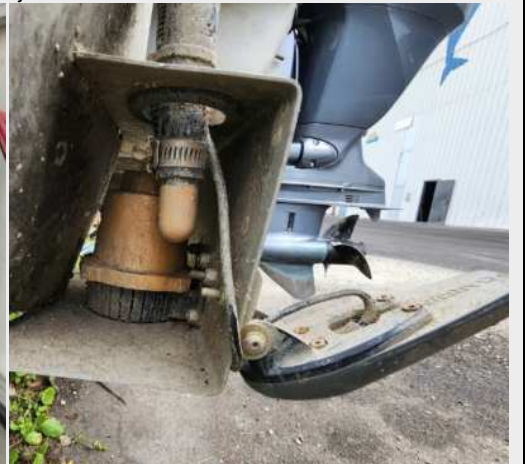
1x Cole Hersee battery switch is functional. 1x Interstate 24M-XHD battery in serviceable condition. 1x unverified manufacture livewell pump does not power on.
