EBB TIDE SERVICES

VALUATION / APPRAISAL SURVEY

"Surfs Up"

2002 Rinker 270 Fiesta Vee.

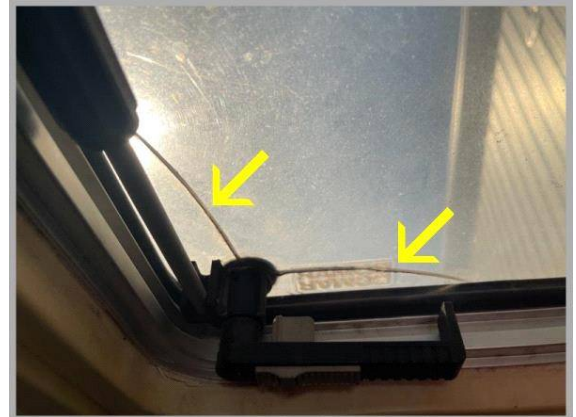
*The deck hatch is cracked.
Recommendation: repair or
replace the deck hatch as
necessary to maintain the value
and appearance of the vessel.*

Cracked deck hatch

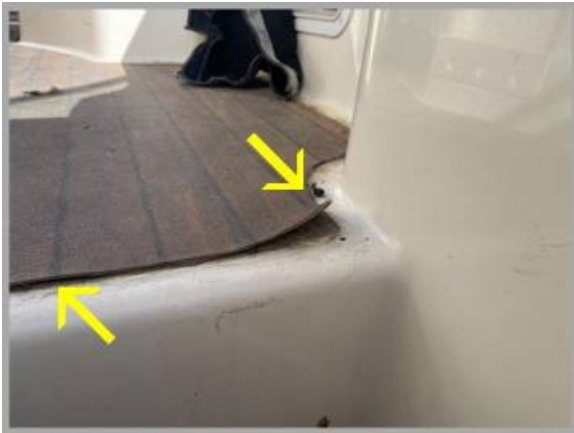
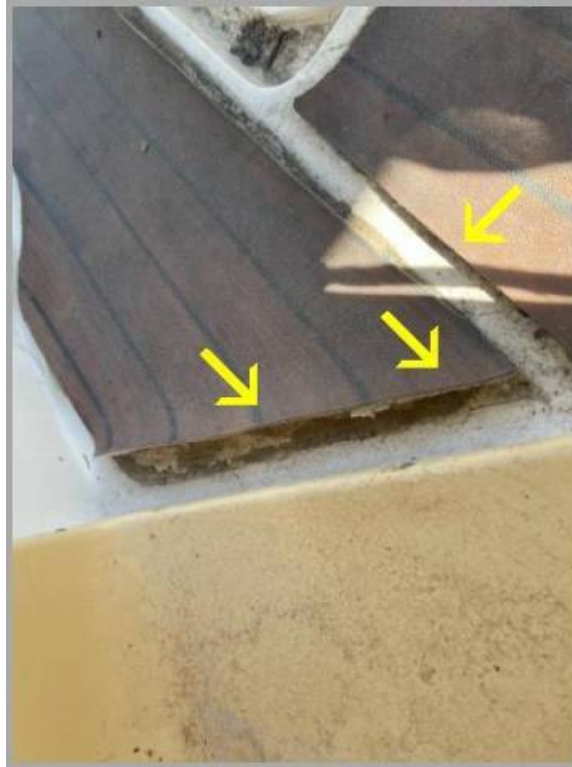
The cockpit sole and the swim platform are covered with a linoleum-type faux teak material that is peeling in numerous places. Recommendation: Repair or replace the sole covering as necessary to maintain the vessel's appearance and value.

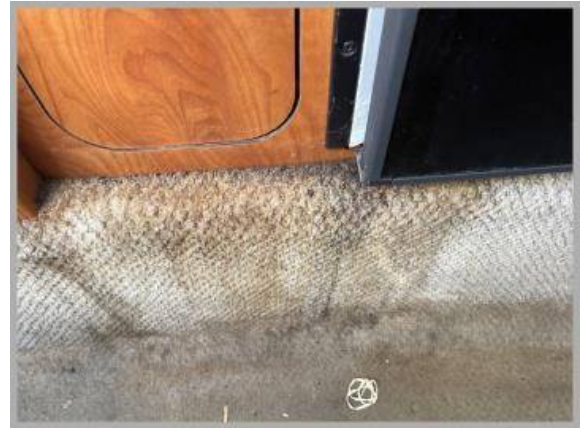
*Carpeting installed throughout.
Carpet is dirty and stained.
Recommendation: Replace
carpet to enhance appearance
and maintain the value of the
vessel.*

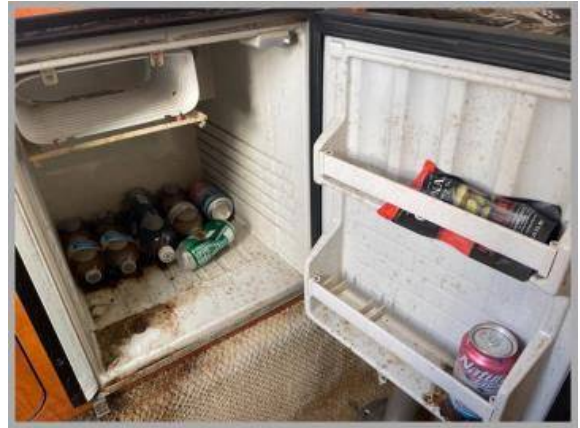
Mold was sighted in the refrigerator. Recommendation: Remove and remediate mold as necessary to ensure the health and safety of crew and passengers.

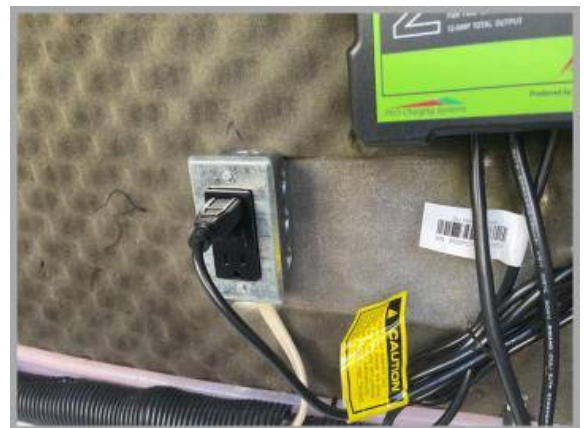
An electrical outlet was sighted in the engine room. All it takes to ignite fumes is a little spark. No matter how big or small the spark is, if there are enough flammable fumes in the air, the tiniest spark will light up the sky. Therefore, having AC outlets in an engine compartment with gas engines is a BIG no no. Plugging an item into or pulling an item out of an outlet doesn't cause a spark every time. A spark will only occur if the load you are plugging in/out is turned on.

will draw power as soon as it gets a chance and will keep drawing it until it is completely disconnected from the outlet. As we know, electricity can and will jump through the air to get to where it wants to go. The bigger the power draw the further it can jump. With all of this in mind, the problem isn't with an item that is already plugged in and working, it arises when we plug in or unplug an item. This action can create a spark inside the outlet between the pins of the plug and the contacts of the outlet. If there are enough fumes in the surrounding area, Bang! To get around this, all AC powered items in an engine compartment with gas engines should be hard wired (connected directly to supply cable). This will help avoid any fiery moments. As per normal, a licensed electrician should be consulted.

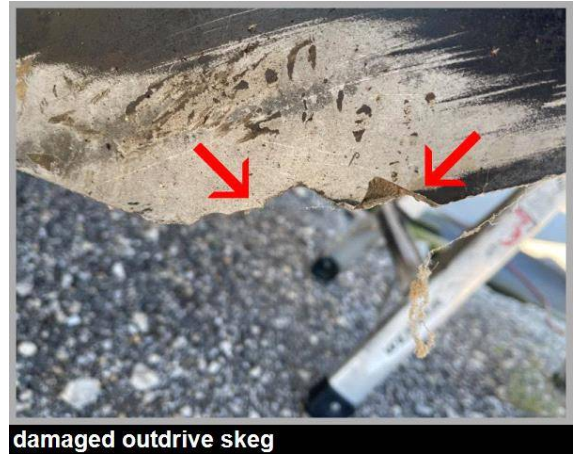
The skeg is damaged as shown in photo. Recommendation: Repair skeg as necessary.

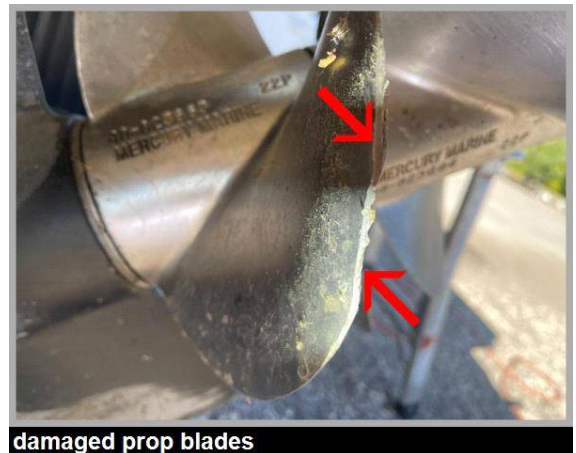
Prop blades are nicked or bent and should be serviced. RECOMMENDATION: Have prop(s) repaired and balanced to prevent excess vibrations.

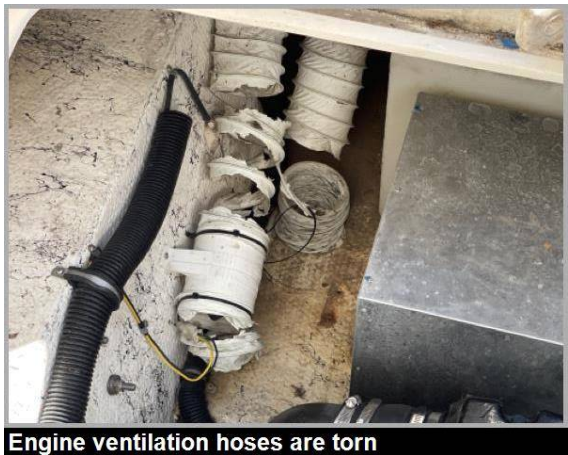
The engine ventilation hoses are torn. Recommendation: Repair or replace the hoses as necessary to provide oxygen to engine and to prevent fume buildup in engine compartment.

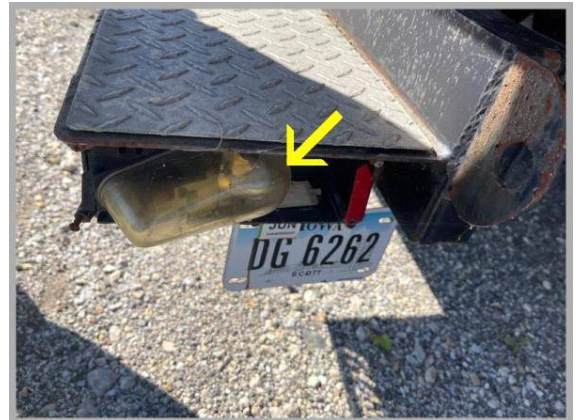
*The left light lens is broken.
Recommendation: Repair or
replace the lens to ensure that
the trailer conforms to state law
as required.*

left tail light lens broken

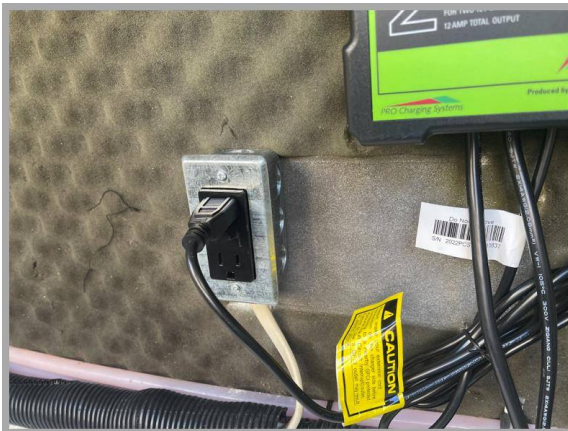
2. An electrical outlet was sighted in the engine room. All it takes to ignite fumes is a little spark. No matter how big or small the spark is, if there are enough flammable fumes in the air, the tiniest spark will light up the sky. Therefore, having AC outlets in an engine compartment with gas engines is a BIG no no. Plugging an item into or pulling an item out of an outlet doesn't cause a spark every time. A spark will only occur if the load you are plugging in/out is turned on.

When an item is turned on it wants to draw power to work. It will draw power as soon as it gets a chance and will keep drawing it until it is completely disconnected from the outlet. As we know, electricity can and will jump through the air to get to where it wants to go. The bigger the power draw the further it can jump. With all of this in mind, the problem isn't with an item that is already plugged in and working, it arises when we plug in or unplug an item. This action can create a spark inside the outlet between the pins of the plug and the contacts of the outlet. If there are enough fumes in the surrounding area, Bang! To get around this, all AC powered items in an engine compartment with gas engines should be hard wired (connected directly to supply cable). This will help avoid any fiery moments. As per normal, a licensed electrician should be consulted.

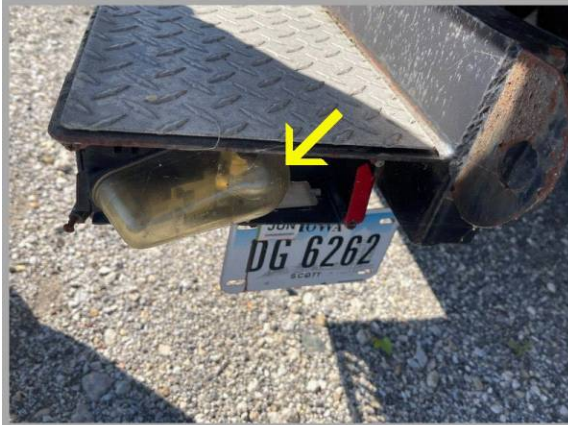
4. The left light lens is broken. Recommendation: Repair or replace the lens to ensure that the trailer conforms to state law as required.

left tail light lens broken

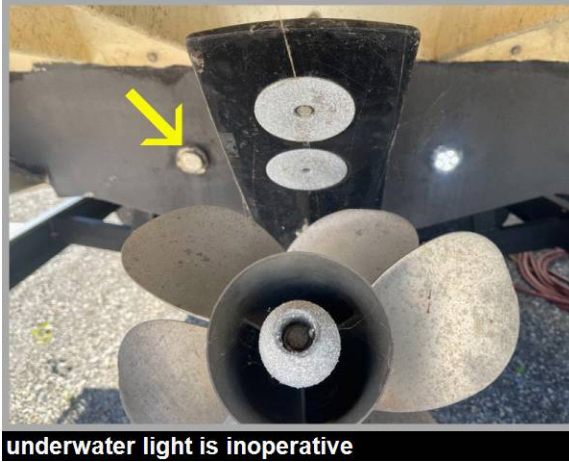
1. The underwater transom light on the port side did not power up at the time of survey. Recommendation: Repair or replace underwater lights as necessary to maintain the value of the vessel.

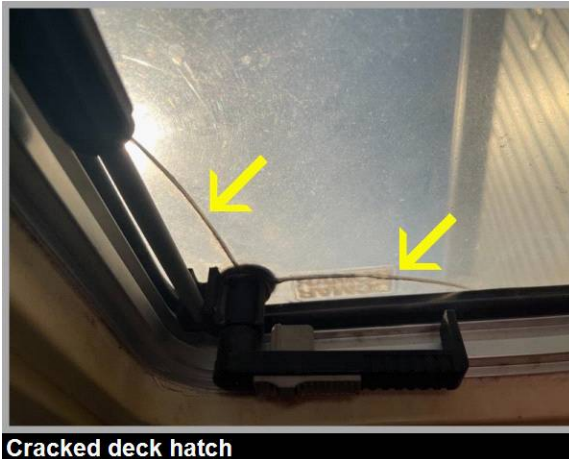
2. The deck hatch is cracked. Recommendation: repair or replace the deck hatch as necessary to maintain the value and appearance of the vessel.

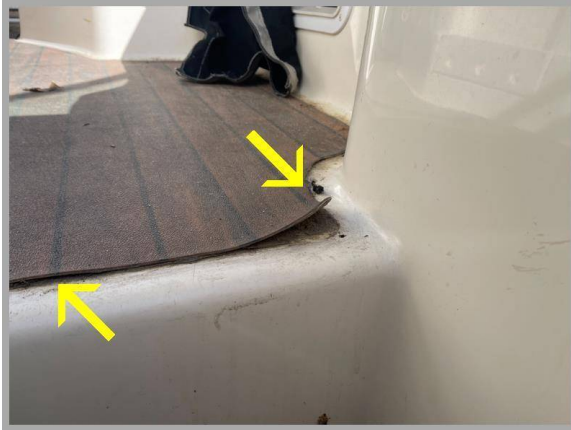
3. The cockpit sole and the swim platform are covered with a linoleum-type faux teak material that is peeling in numerous places. Recommendation: Repair or replace the sole covering as necessary to maintain the

vessel's appearance and value.

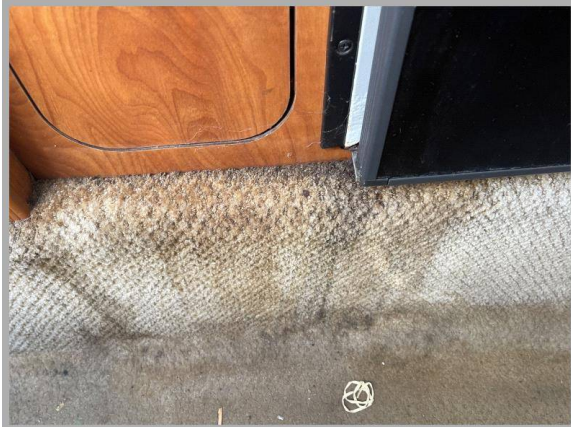
4. Carpeting installed throughout. Carpet is dirty and stained. Recommendation: Replace carpet to enhance appearance and maintain the value of the vessel.

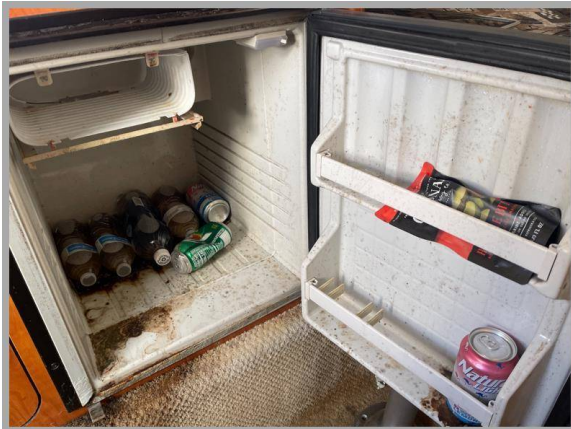
5. Mold was sighted in the refrigerator. Recommendation: Remove and remediate mold as necessary to ensure the health and safety of crew and passengers.

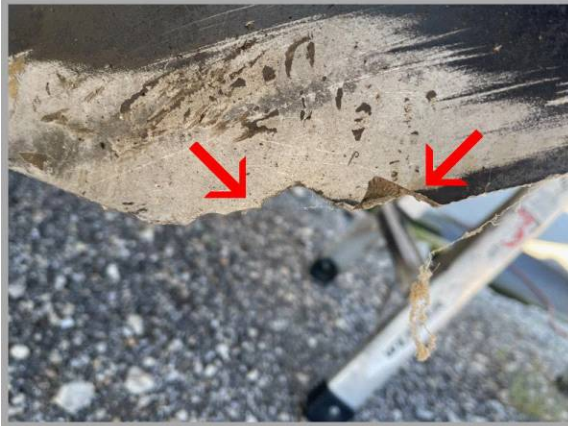
6. The skeg is damaged as shown in photo. Recommendation: Repair skeg as necessary.

damaged outdrive skeg

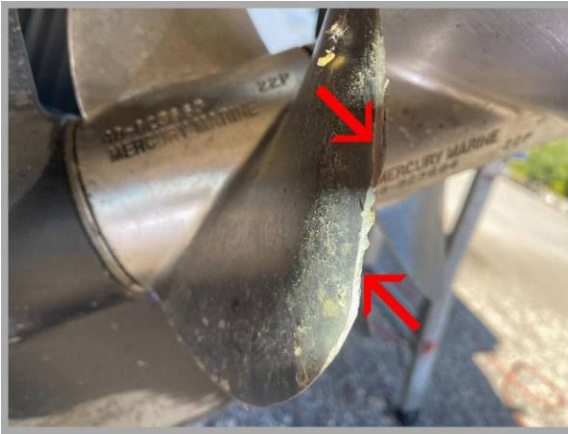
7. Prop blades are nicked or bent and should be serviced. RECOMMENDATION: Have prop(s) repaired and balanced to prevent excess vibrations.

damaged prop blades

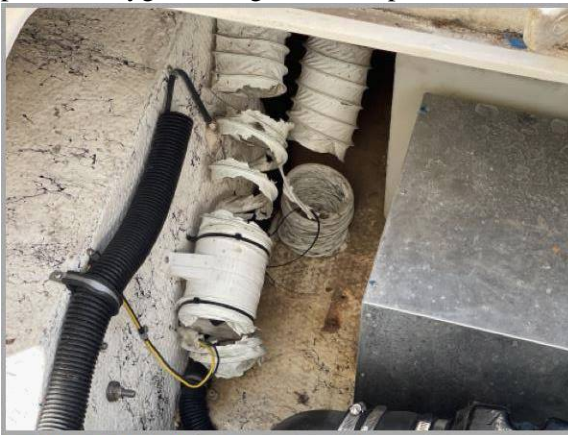
8. The engine ventilation hoses are torn. Recommendation: Repair or replace the hoses as necessary to provide oxygen to engine and to prevent fume buildup in engine compartment.

Engine ventilation hoses are torn
