MARINE CONDITION & VALUATION SURVEY

FINAL REPORT
Condition and Valuation for Donation
S/V: 1984 29' C&C Sloop Rig MK II

“MANA KAI”

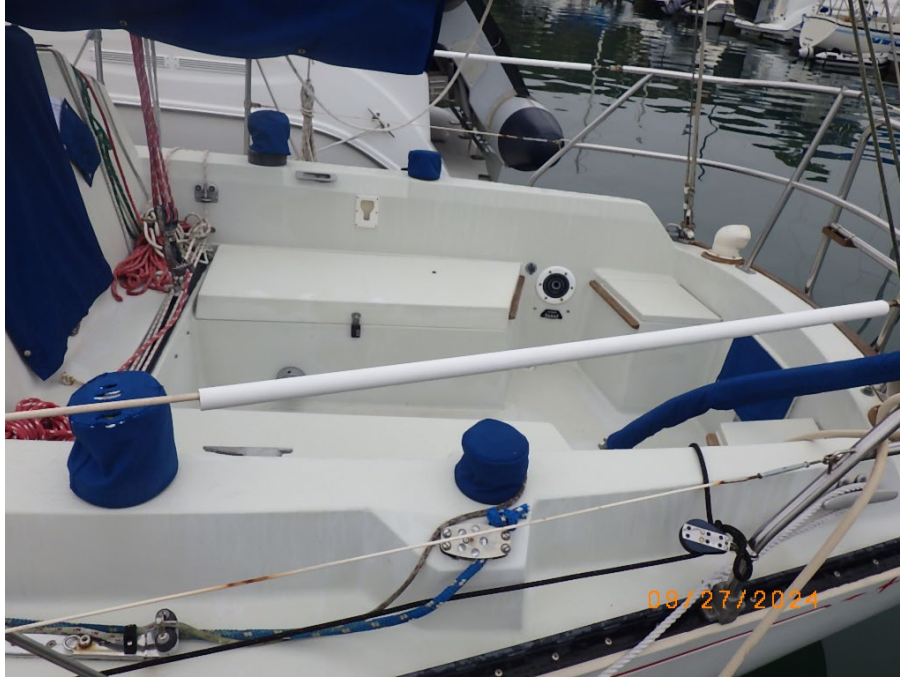
3 – Cockpit – Cushions stored in vee berth.

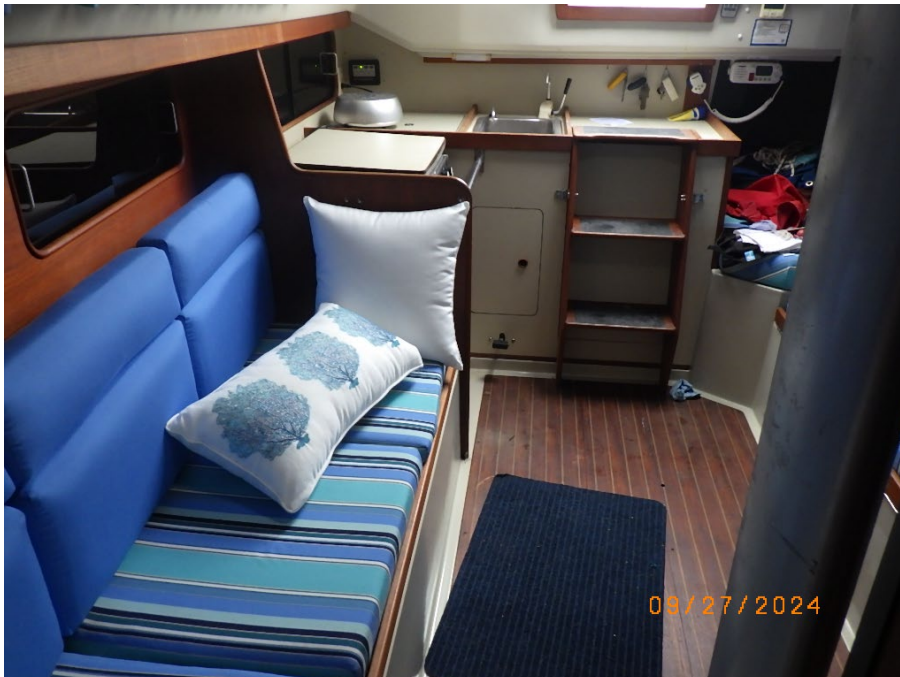
4 - Salon

Original canvas cushions were in good condition for the interior and the exterior of the vessel seating area – Serviceable

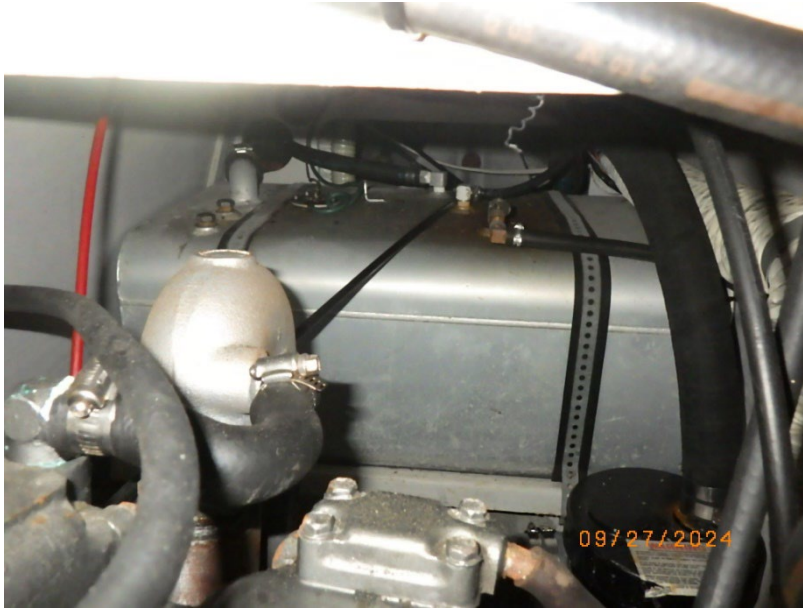
5 – Motor and fuel tank

Yanmar 2GMF – Clean with no leaks or observed issues - Serviceable.

Gas – aft cockpit – under decking – aluminum tank, adequately grounded and strapped down. – Serviceable.

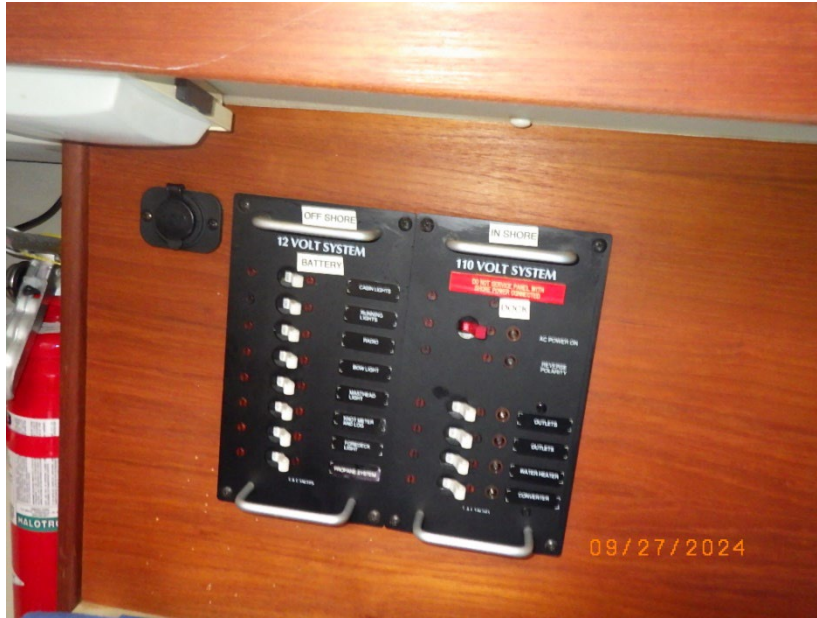
7 – AC/DC

The main distribution panel is located inside and outside of the weather per **ABYC E-11** standards. – Serviceable

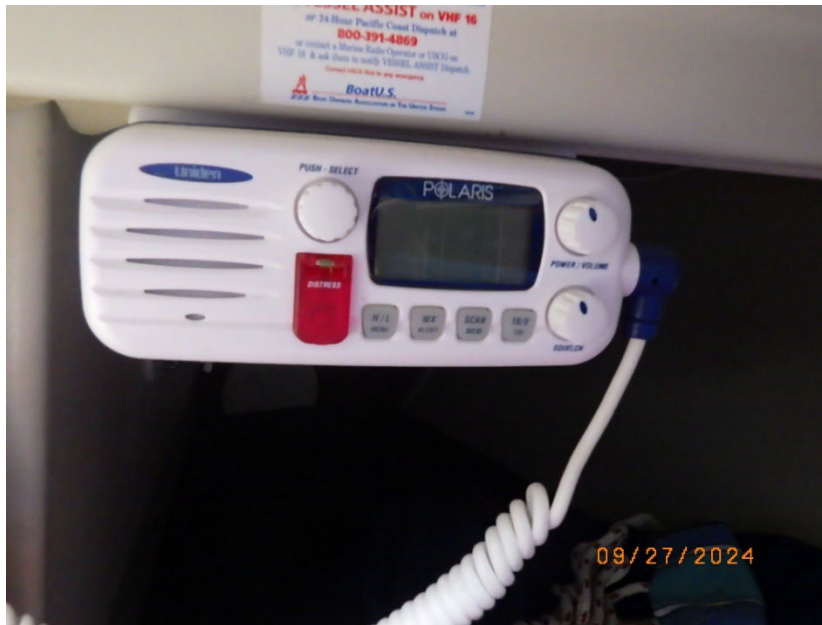
8 – VHF Radio

Uniden Polaris – Serviceable

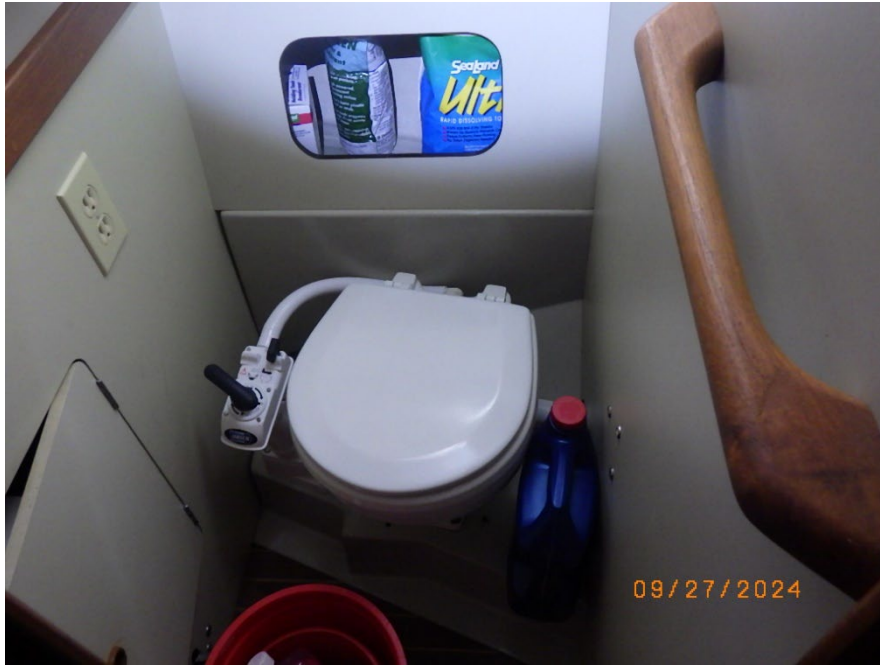
9 – Head

Jabsco manual pump operated when tested – Serviceable.

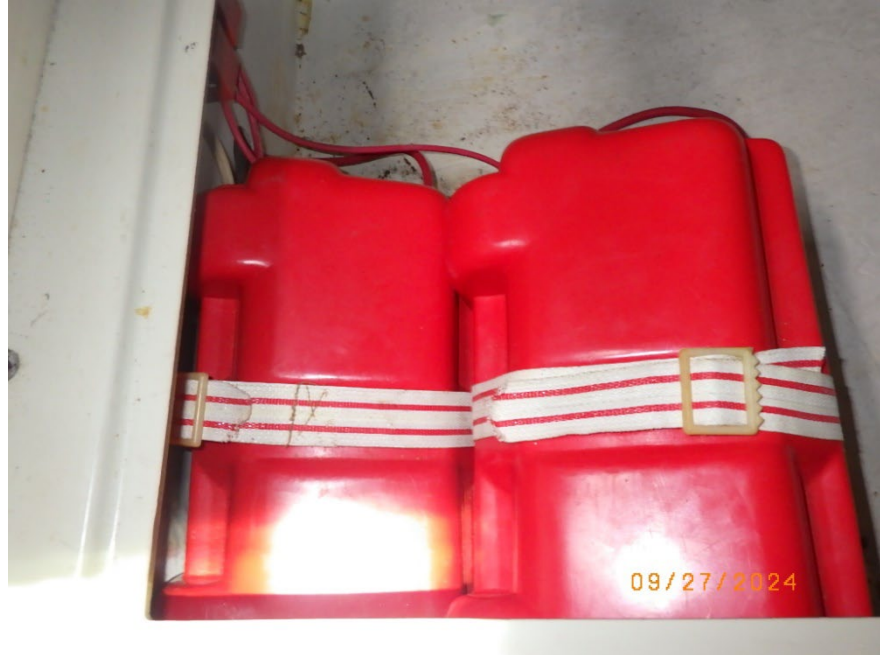
10 – Batteries

Two (2) batteries were under the bunk of the port aft area, and the property was covered and secured – serviceable.
