# REPORT OF MARINE SURVEY

**1986 30 Ticon Sailboat**

**JOHN BOMMARITO**  
ACCREDITED MARINE SURVEYOR

May 2, 2024

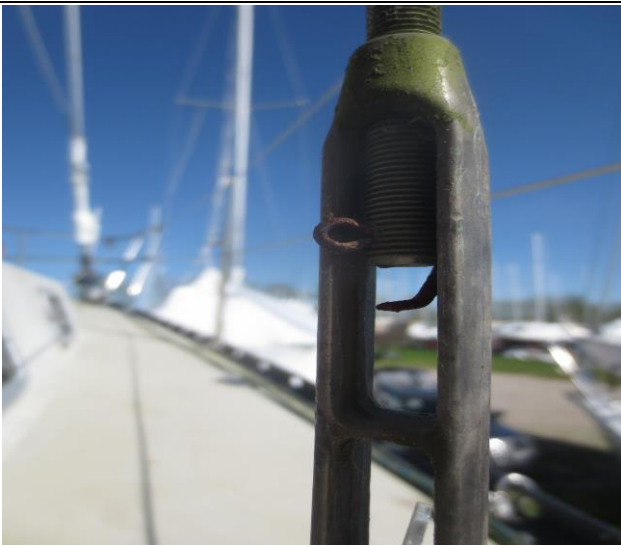
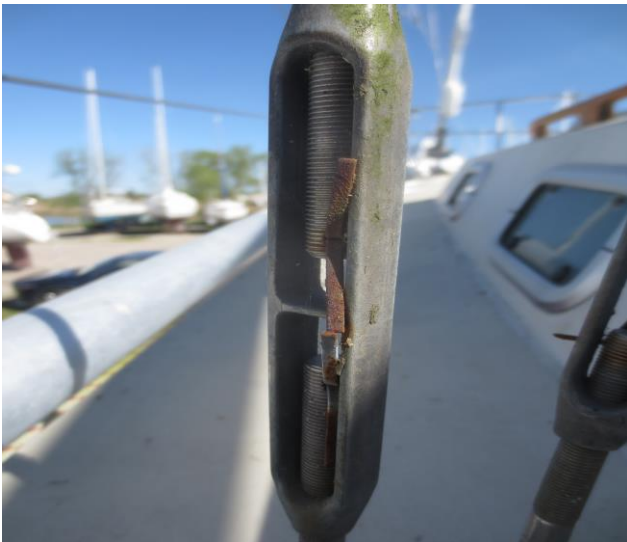
Aluminum MAST and BOOM were visually inspected  
**(Ref. A1 Standing Rigging) Findings /Recommendations – Shroud Turnbuckles Cotter Pins ALL in need of proper set and size Stainless Steel Cotter Pins ( Many showed RUST on curret in place cotter pins ) (See Photos A001 and A002)**

All Swaging Visually inspected at deck level and appear good. All attaching Turnbuckles appear Good with no visual issues seen, unless noted. ALL in **NEED of proper sized Cotter Pins or Cotter Rings. And Proper Cleaning . Many show signs of Algae growth and in need of cleaning and re inspections.** (See Photos A001 and A002)

**(Ref. A3 Rigging) Findings /Recommendations – ALL STANDING rigging Shroud Turn buckles are in NEED of proper sized Cotter Pins or Cotter Rings.**

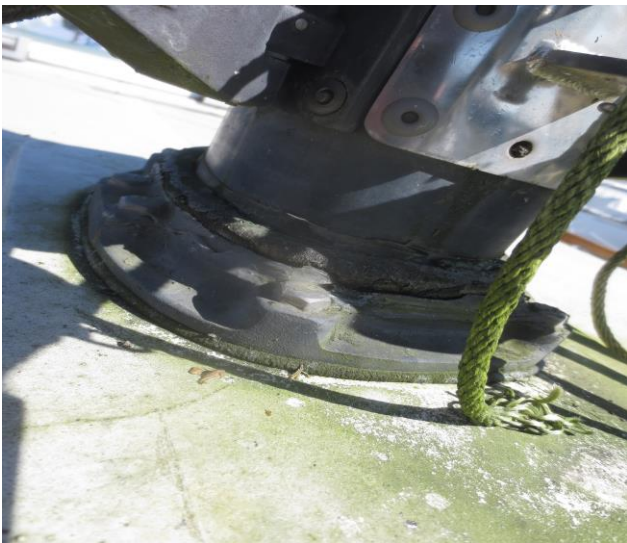
**PICTURE A003**

**(Ref. A2 Mast Mountings) Findings /Recommendations – Mast Through Cabin Top/Deck Seal POOR and aged Most likely leaking water, Also part of the Mast mounting system with a Keel Step Mast Setup (See Photo A003)**

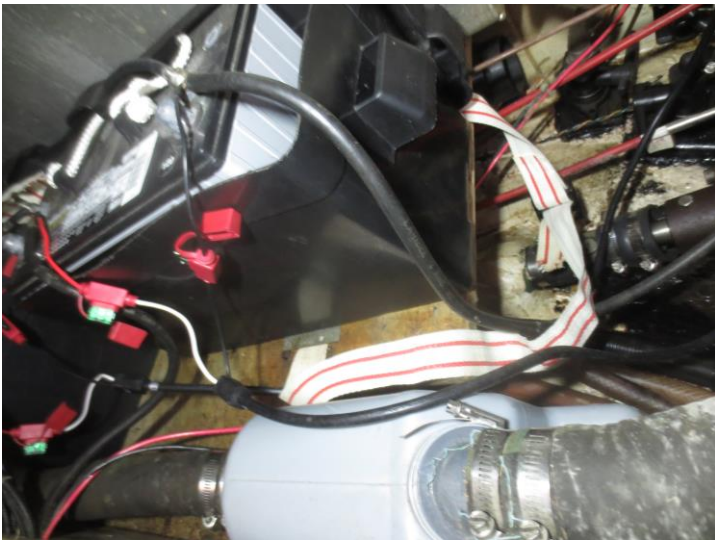
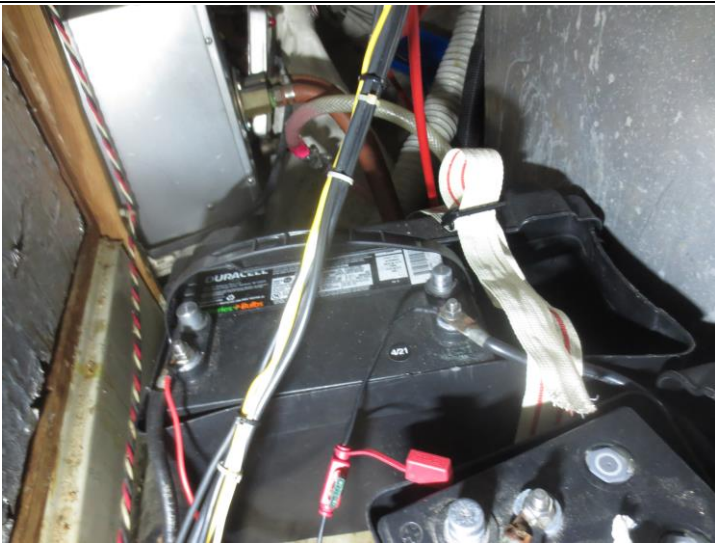
A6 -Battery Tied downs not attached Battery NOT secured : Recommendations: (Reference Photo (A006 and A007) Battery need to be safely seared

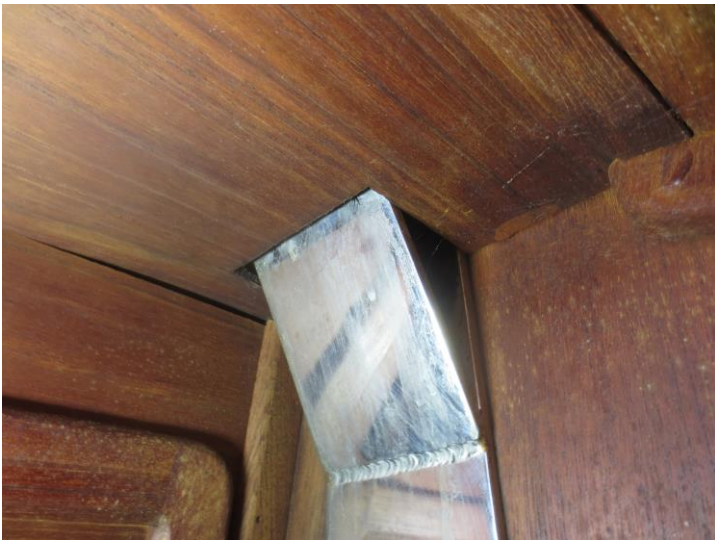
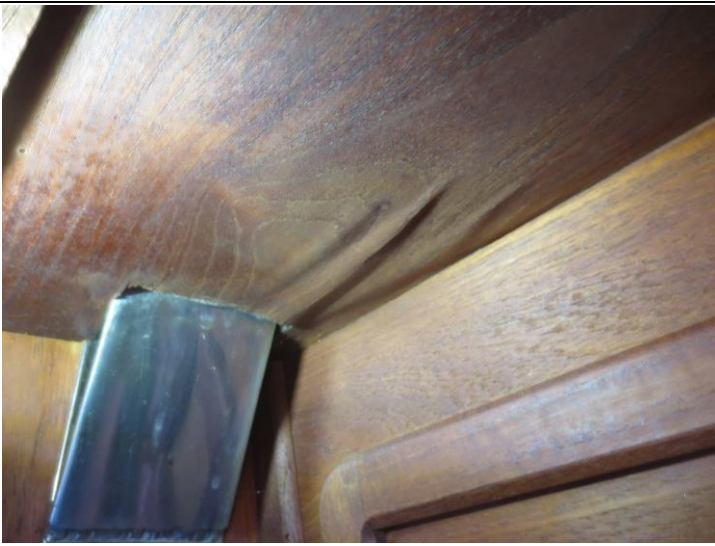
A6	A6 -Battery Tied downs not attached Battery NOT secured	<p>Recommendations: (Reference Photo (A006 and A007) Battery need to be safely seared</p> <p>(A006 and A007)</p>		
A7	A7-Helm Steerage System Binnacle Below Cockpit Floor Pulley Wiring Rubbing On Pulley will chaff through possible shorting out of wiring	<p>Repair Wire Mounting away from Pulley</p> <p>SEE PICTURE A008</p>		
B1	<p>Chain Plate System inspected as much as possible and appear to be in good order. (Ref B1 Rigging ) Some Possible Signs of water leaks/ staining/ warping or aging concerns Apparent at time of inspection at Shrouds interior area Chain Plates at bulk heads. This is visible on Bottom of Cabinet Wood at Port and Starboard Chain plate area. Does not appear to be any structural degradation.</p>	<p>Re-inspect in details removing what is needed to assure structure is good. Repair as is needed.</p> <p>SEE PICTURE B001 and B002</p>

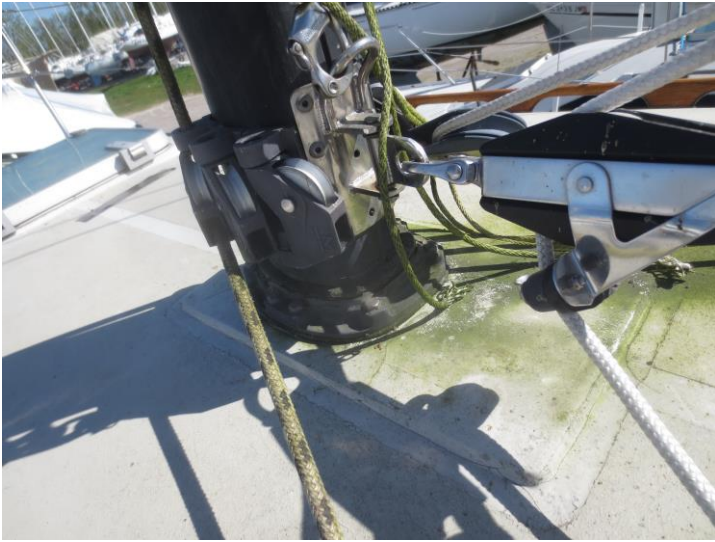
**PICTURE B003**

All running rigging lines inspected where possible, and appear many if not all will need replacements, due to aging exposure, and chaffing from use, and many have green Algae on them Other then were noted in Reference below:

**(Ref. B2 Rigging) Recommendations: All running rigging ages with time, environment exposure and normal Usage. Replacement is always suggested whenever any signs of any deterioration become apparent.**

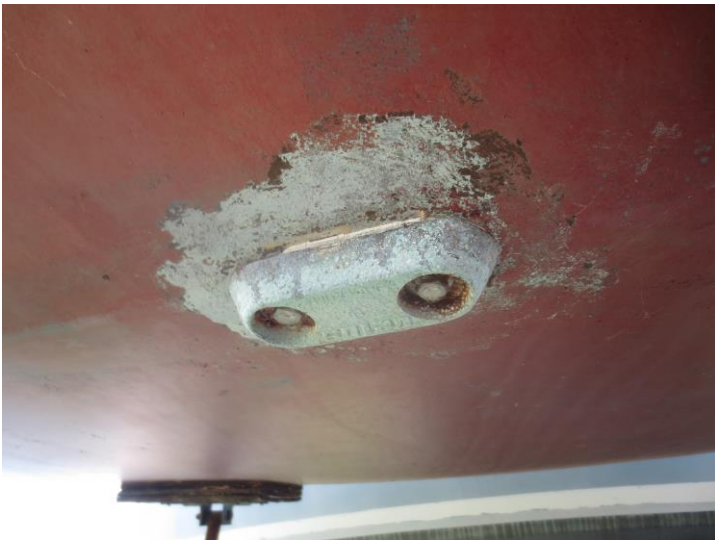
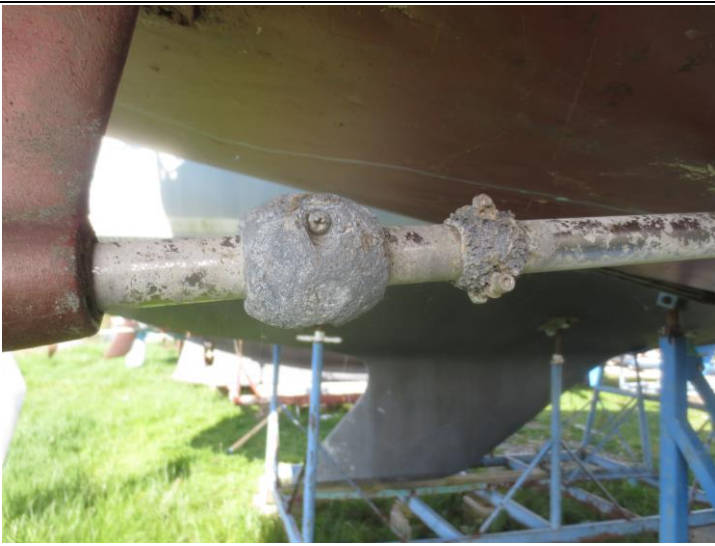
All Prop Shaft Anodes in need of replacement as does the Vessels Main Anode on bottom of hull aft of keel

<p><b>B3</b></p>	<p>(Ref. B3 Rudder) Findings /Recommendations: <b>RUDDER:</b> Visual inspection of Rudder attachment, and system appear to be in good order With no apparent issues present. Visually appear true and perpendicular to vassal's hull. Rudder lower 5 inches on both port and starboard side</p>	<p>Moisture Meter Reading showing HIGH, ( IN RED Range of meter) may be in need of draining and repairs after drying out. Possible draining of any possible water in rudder.</p>		
<p><b>B4</b></p>	<p>(Ref. B 4 Prop to Shaft Mounting System) Findings /Recommendations Cutlass bearing was dry at time of inspection, appears to be within norms. Vessel is equipped with a 3 bladed fixed Prop appears functional and in need of proper cleaning / polishing.</p>	<p>All Prop Shaft Anodes in need of replacement as does the Vessels Main Anode on bottom of hull aft of keel See  <b>SEE PICTURE (B004 and B005 )</b></p>

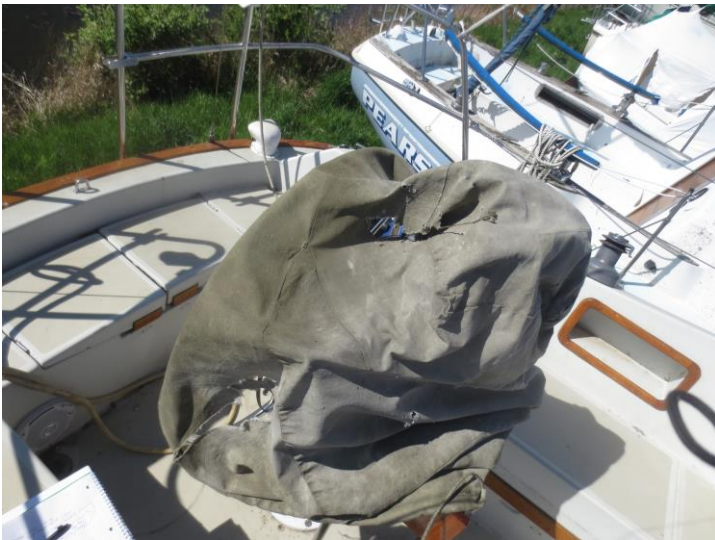
**PICTURE C001**

Helm Cover Canvas – Very Poor condition, needs replaced. See Photo C001

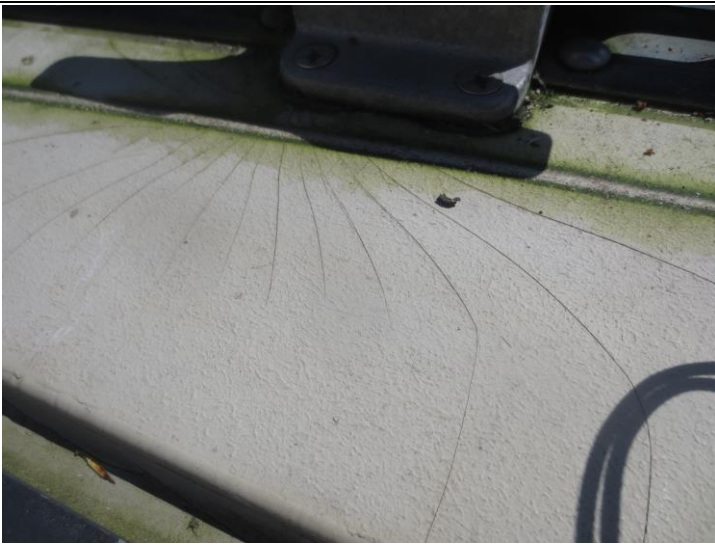
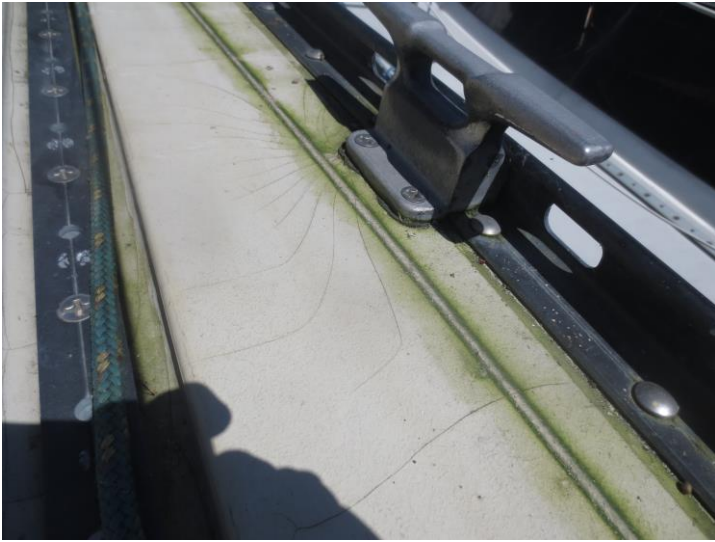
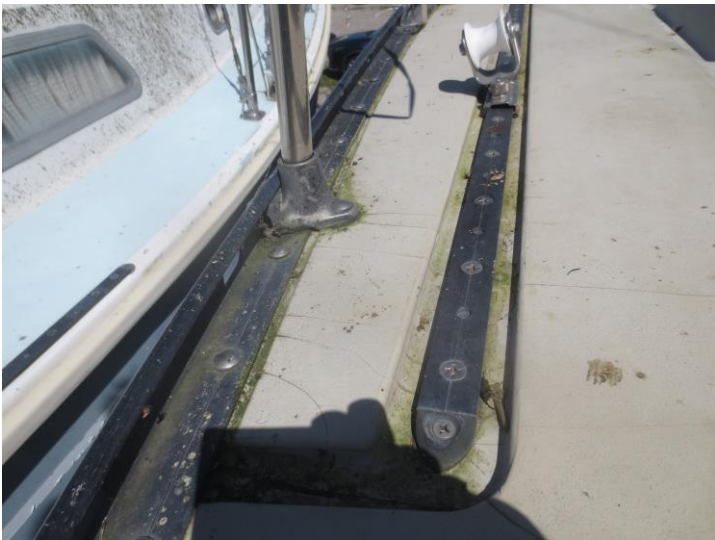
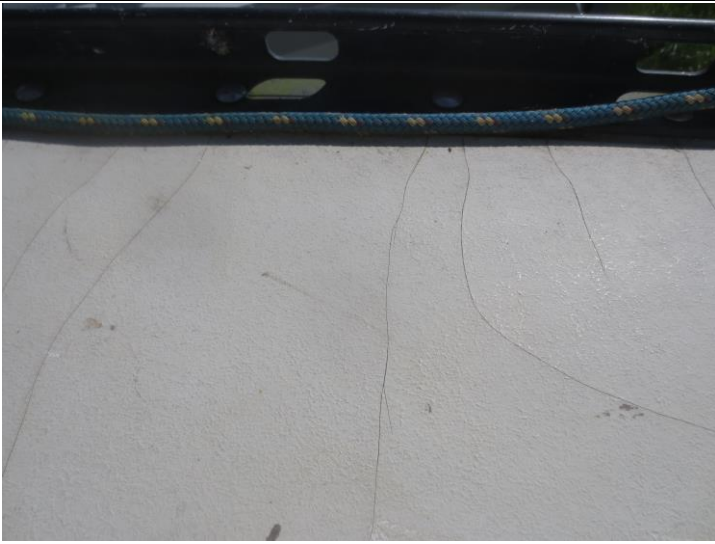
C6 -Numerous Deck Cracks which can and may lead to water leaking into vessels decking.

See Photos C002, C003, C004 and C005, NOTE moisture Meter Reading indicate deck

Mid Ranges Reading where cracking is present and LOW where cracks were repaired

(Ref C Findings /Recommendations: Repair and seal ( NOT SOME repairs have already been completed on the Port Aft Deck by cockpit combing

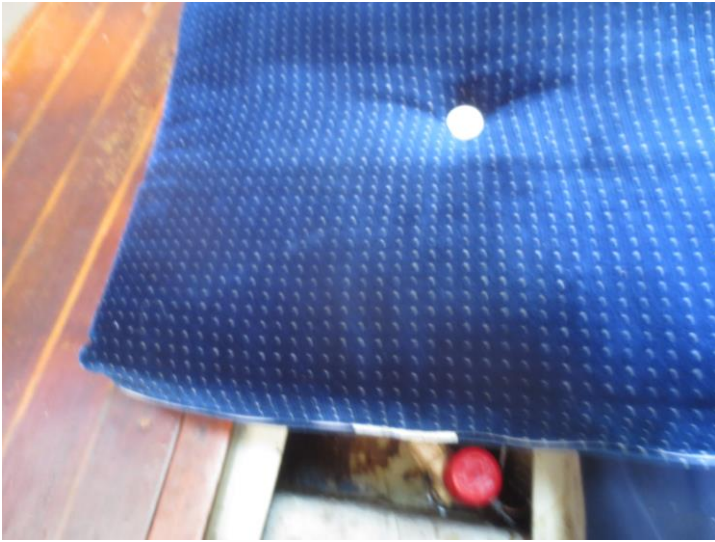
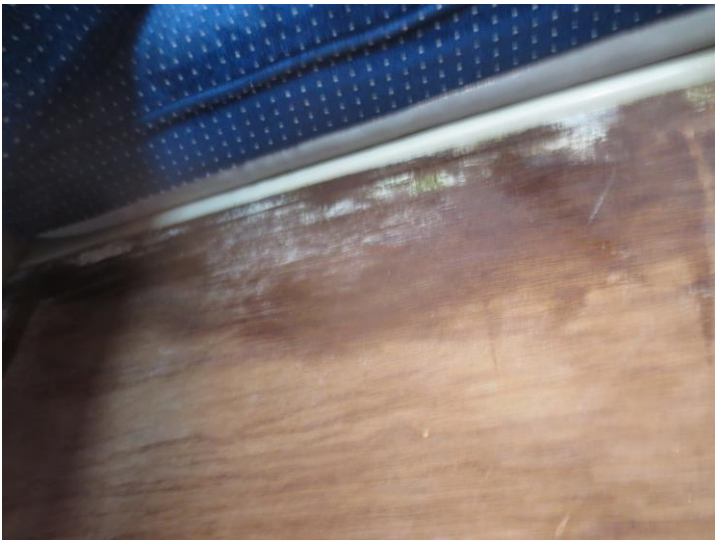
Port and Starboard Main Solon cushions were wet in areas along with storage cushion s upport wood show water stain areas See Photos C006 and C007
