**THIRD COAST MARINE SURVEYING, LLC**  
MARINE SURVEYORS AND CONSULTANTS

## **Report of Marine Survey**

**1999 Sea Ray 280 BR**

**June 4, 2024**

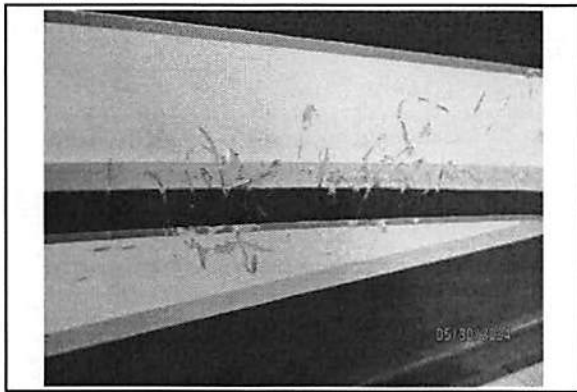
\* **OTHER: [C1]** Sighted gouges in gel-coat at aft stbd hull side and port midship.

Gouges in hullside, port aft

FINDINGS	RECOMMENDATIONS
<b>C.1 (PAGE 5) OTHER:</b> Sighted gouges in gel-coat at aft stbd hull side and port midship.	<i>Repair as necessary.</i>
<b>C.2 (PAGE 5) DECK HATCHES/VENTILATION:</b> Ski locker hatch not secured at hinge, missing and loose hardware.	<i>Repair as necessary.</i>
<b>C.3 (PAGE 6) ENGINE MOUNTS AND BED:</b> Sighted stbd engine mount with excessive rust caused from leak at exhaust manifold.	<i>Recommend to clean mount of all rust/corrosion and further inspect, repaint or replace.</i>
<b>C.4 (PAGE 7) OUTDRIVE:</b> Trim gauges appears not to read correctly, suspect a bad trim sending unit.	<i>Repair or renew as necessary.</i>
<b>C.5 (PAGE 7) VOLTAGE/BATTERIES:</b> Sighted wing nuts installed on battery posts.	<i>Replace with hex nuts as per ABYC E-10 sec.10.8.3.</i>
<b>C.6 (PAGE 7) VOLTAGE/BATTERIES:</b> The Batteries were dead during inspection.	<i>Charge up or replace batteries.</i>

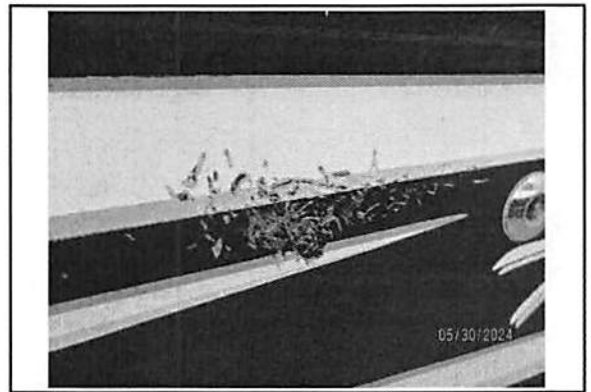
Gouges in hullside, stbd midship

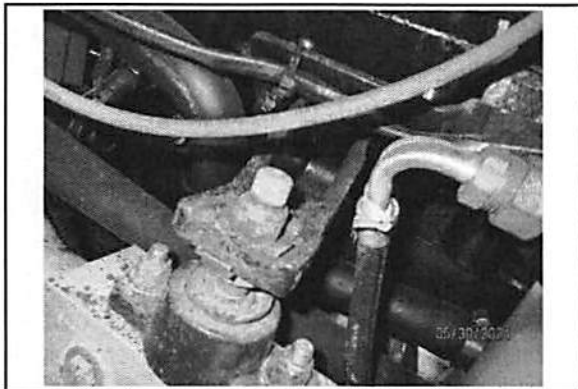
- \* **ENGINE MOUNTS AND BED:** [C3] FRP over wood stringers, Sounded with a percussion mallet, no deficiencies sighted. Fabricated factory engine mounts through bolted to engine hull stringers. Sighted stbd engine mount with excessive rust caused from leak at exhaust manifold.

Stbd engine mount, corroded

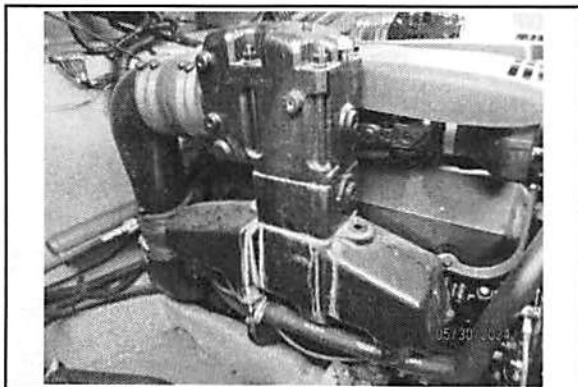
- \* **EXHAUST SYSTEM:** [B1] Raw water cooled with cast iron risers, flexible hoses to exiting exhaust fittings through Y transom. Sighted the stbd exhaust manifold and riser with evidence of previous overheating and leaking, manifold cast is in poor condition.

Exhaust manifold, stbd side

FINDINGS	RECOMMENDATIONS
<b>B.1 (PAGE 6) EXHAUST SYSTEM:</b> Sighted the stbd exhaust manifold and riser with evidence of previous overheat and leaking on sea trial, manifold cast is in poor condition.	<i>Replace stbd exhaust manifold and gaskets, further inspect stbd riser and replace if needed.</i>
<b>B.2 (PAGE 7) OUTDRIVE:</b> Sighted contamination in the gear lube bottle for outdrive.	<i>Recommend to have outdrive gear lube flushed and serviced ASAP.</i>
<b>B.3 (PAGE 7) OVERALL CONDITION:</b> Engine needs a ignition tune up and service(sighted multiple original spark plugs).	<i>Further investigate and repair. Recommend a service and tune up, cap/rotor/spark plugs and fresh fuel.</i>
<b>B.4 (PAGE 10) NAVIGATIONAL LIGHTS:</b> All around "360*" white light(anchor light), aft is not operational. Light pole is damaged.	<i>Replace aft Nav light pole/housing assembly before vessel is voyaged at night.</i>

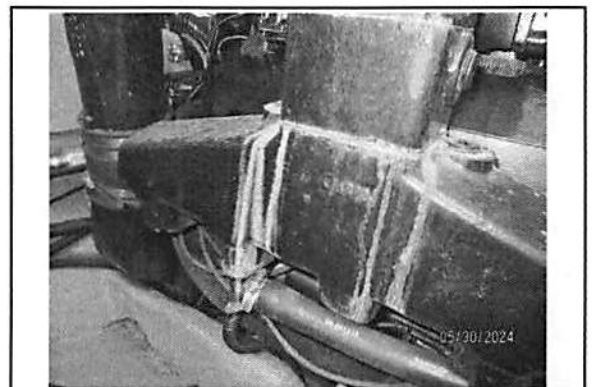
Appears to be a leak at the stbd exhaust manifold

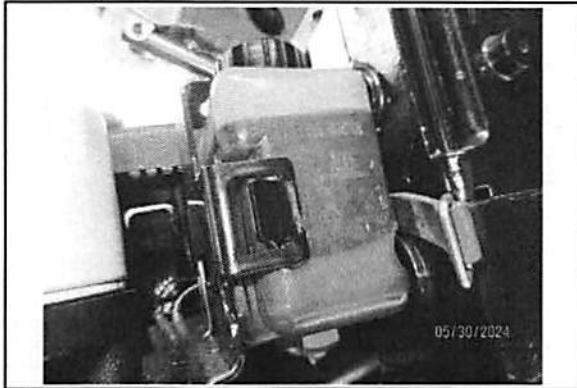
- \* **OUTDRIVE:** [B2, C4] Mercruiser Bravo 3, sighted contamination in the gear lube bottle. Recommend to have outdrive gear lube flushed and serviced. Trim gauges appears not to read correctly, suspect a bad trim sending unit.

**Gear lube monitor bottle, contaminated**

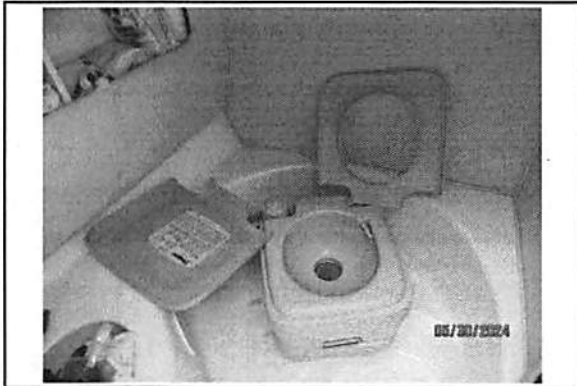
\* **TYPE/MANUFACTURE: [C8]** SeaLand Sanipottie, portable style unit. 5 gallon capacity. Sighted lid and toilet seat broke off at hinge, also appears possible leak at base of unit(blue toilet water).

Toilet lid and seat broke at hinge

**NOTE:** Replace portable toilet assembly as necessary.

<b>C.7 (PAGE 8) OTHER:</b> Sink drain is leaking on the underside at wetbar.	<i>Refit or replace as necessary.</i>
<b>C.8 (PAGE 8) TYPE/MANUFACTURE:</b> Sighted lid and toilet seat broke off at hinge, also appears possible leak at base of unit(blue toilet water).	<i>Investigate further and repair or renew as necessary.</i>
<b>C.9 (PAGE 9) SPEAKERS:</b> Two speakers not operational, port bow and port aft cockpit.	<i>Repair or renew as necessary.</i>
<b>C.10 (PAGE 10) NAVIGATIONAL LIGHTS:</b> Stbd(green) navigational light lenses loose in housing, recommend to replace.	<i>Investigate further and repair or renew as necessary.</i>

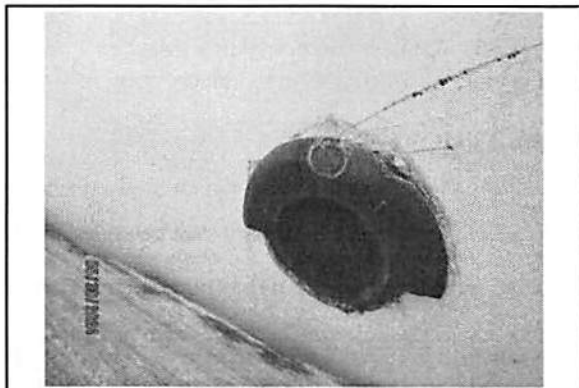
\* **BELOW WATER LINE:** [A1] Sighted transducer is damaged and seal is compromised, allowing water to enter bilge.

Transducer, needs replaced ASAP

FINDINGS	RECOMMENDATIONS
<b>A.1 (PAGE 9) BELOW WATER LINE:</b> Sighted transducer is damaged and seal is compromised, allowing water to enter bilge.	<i>Replace the transducer and seal with below-waterline compound.</i>
<b>A.2 (PAGE 9) FIRE EXTINGUISHERS:</b> Fire extinguishers sighted are out of date (2005). As per NFPA 10, 4-4.3 portable Type B:C 1 extinguishers must be removed from service 12 years after date of manufacturing.	<i>Renew and Comply with ABYC, NFPA and USCG Safety Regulation CRF 46 25.30.</i>
<b>A.3 (PAGE 10) LIST:</b> One bilge pump has pump out hose broke off at the fitting and didn't appear to operate. Recommend replacing both pumps due to age of over 10 years and unknown internal condition.	<i>Replace bilge pumps.</i>

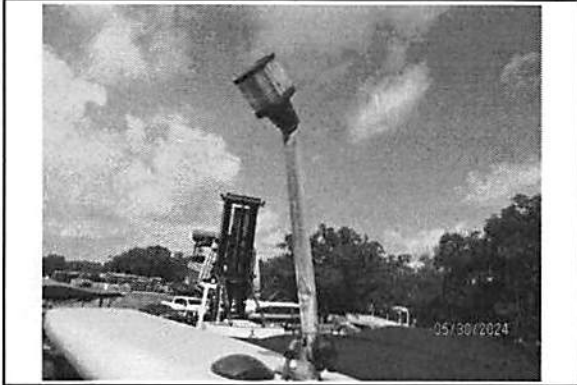
- \* **NAVIGATIONAL LIGHTS: [B4, C10]** LIGHTS NOT OPERATIONAL - anchor fwd and aft lights are not functional. Light pole is damaged.  
Stbd(green) navigational light lenses loose in housing, recommend to replace.

Anchor light, damaged and not operable

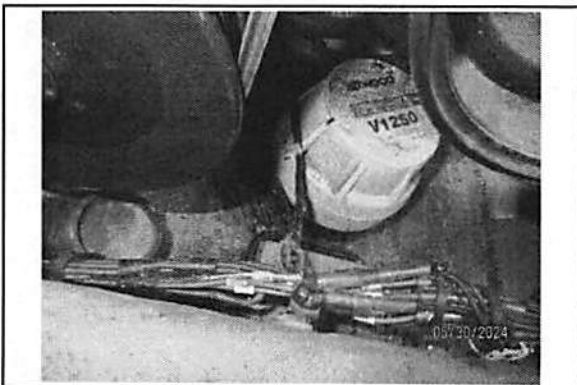
- \* **LIST: [A3]** Two bilge pumps(Atwood V1250) installed aft engine bilge. One bilge pump has pump out hose broke off at the fitting and didn't appear to operate.

Bilge pump has broke off hose fitting

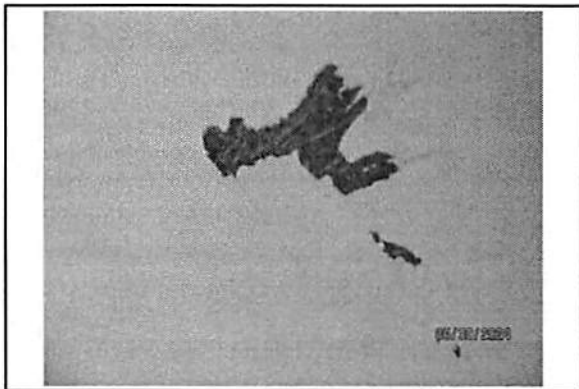
- \* **HULLS WETTED SURFACE:[B6]** In good condition other than one 2"x5" area of gel-coat damage down to bare fiberglass, port aft underside.

Gel-coat damage, port aft underside

FINDINGS	RECOMMENDATIONS
<b>B.5 (PAGE 10) FIXED FIRE EXTINGUISHING SYSTEM:</b> Fixed fire extinguisher serviceability unknown. Inspection tag not current.	<i>Comply with USCG regulation CFR 46 25.30, ABYC A-4, NFPA 302. Have unit weighed, condition verified and tag up to date.</i>
<b>B.6 (PAGE 11) HULLS WETTED SURFACE:</b> Sighted 2"x5" area of gel-coat damage down to bare fiberglass, port aft underside.	<i>Consult with Fiberglass Technician for repair.</i>

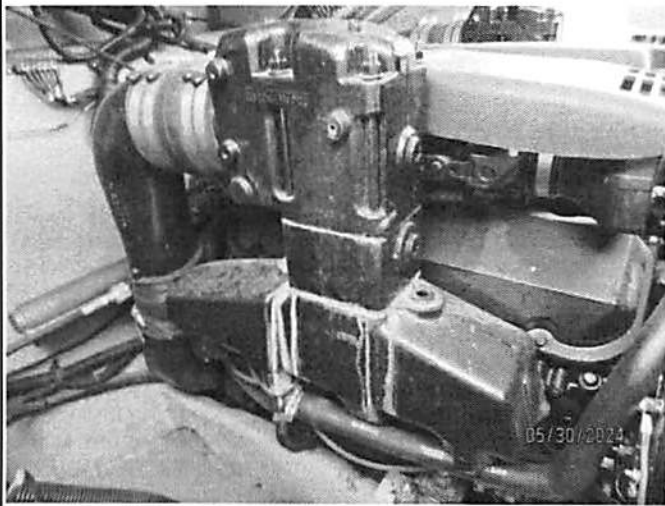
Exhaust manifold, stbd side

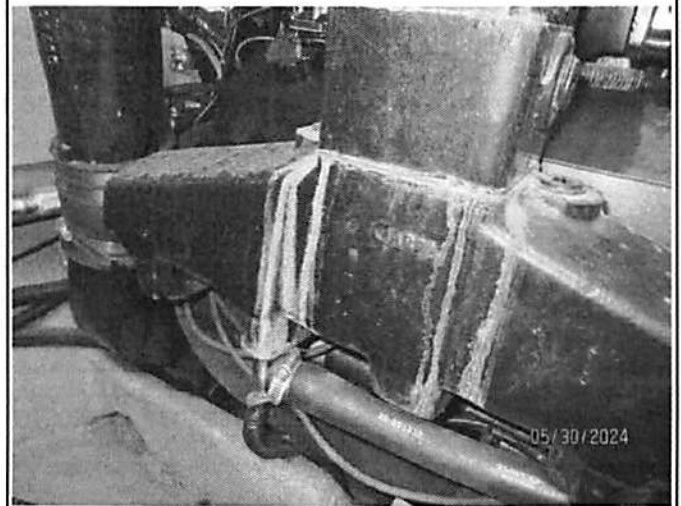
Appears to be a leak at the stbd exhaust manifold

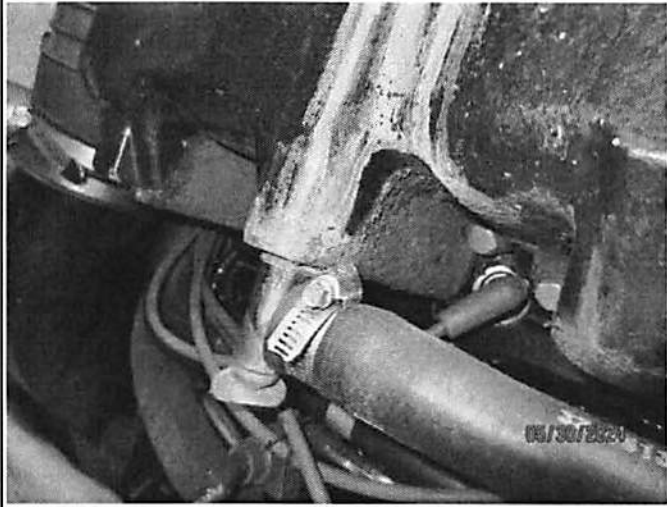
Corrosion at Stbd exhaust manifold

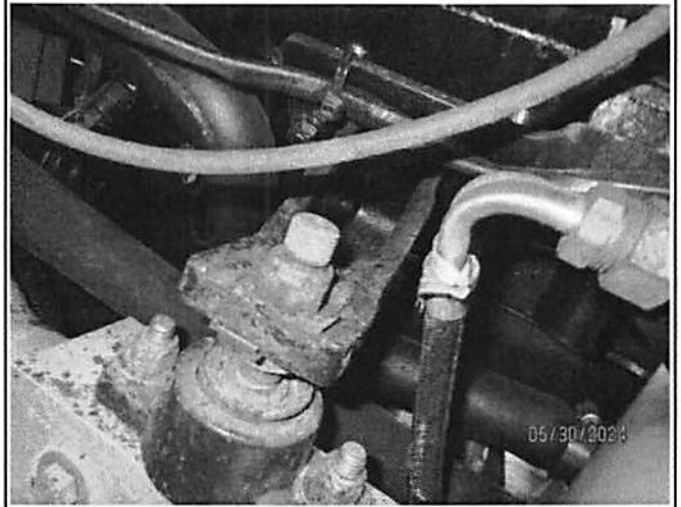
Stbd engine mount, corroded

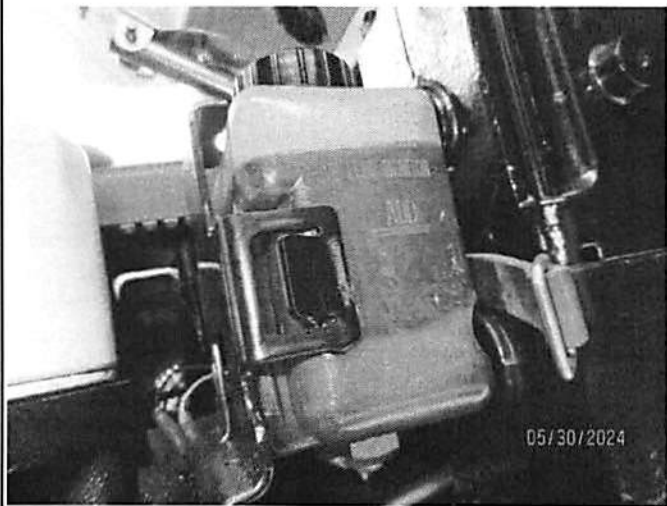
Gear lube monitor bottle, contaminated

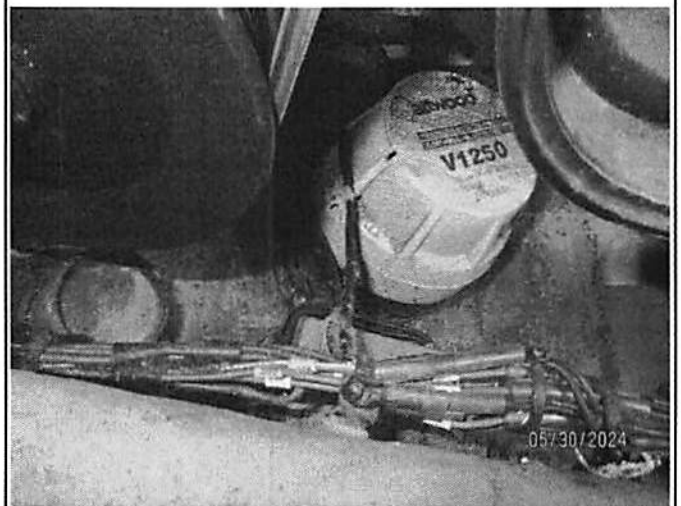
Bilge pump has broke off hose fitting

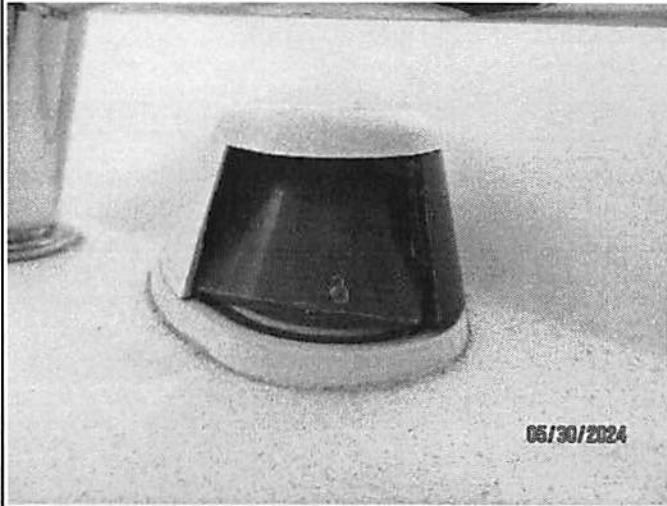
Stbd NAV light lense damaged

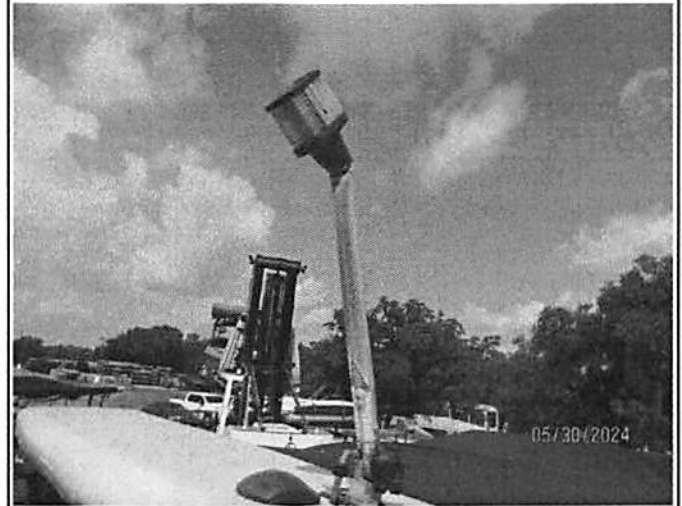
Anchor light, damaged and not operable

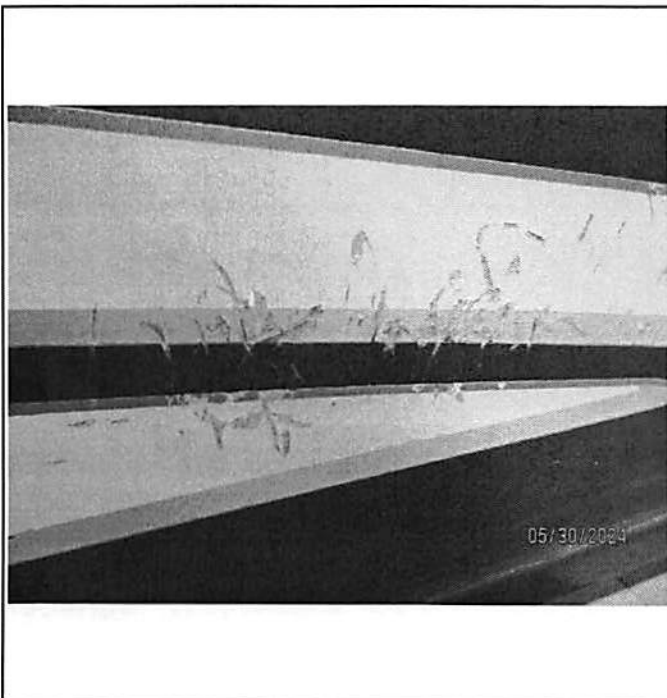
Gouges in hullside, port aft

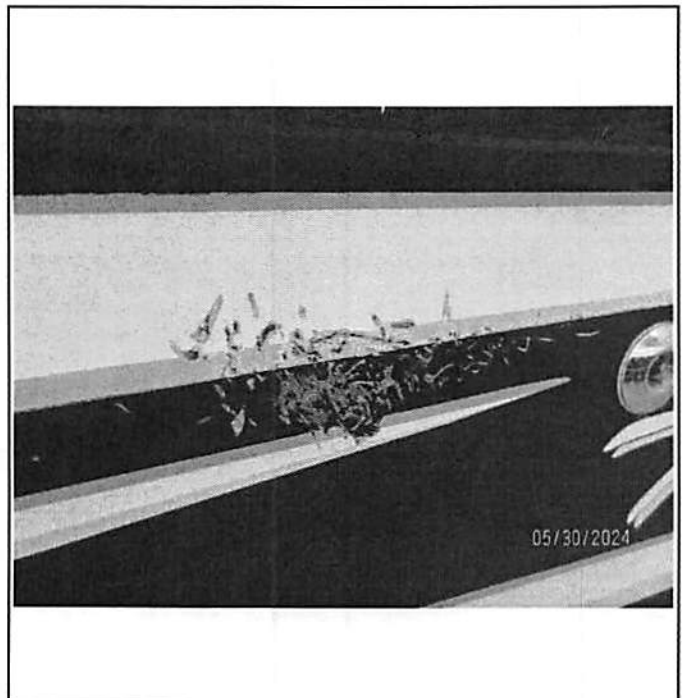
Gouges in hullside, stbd midship

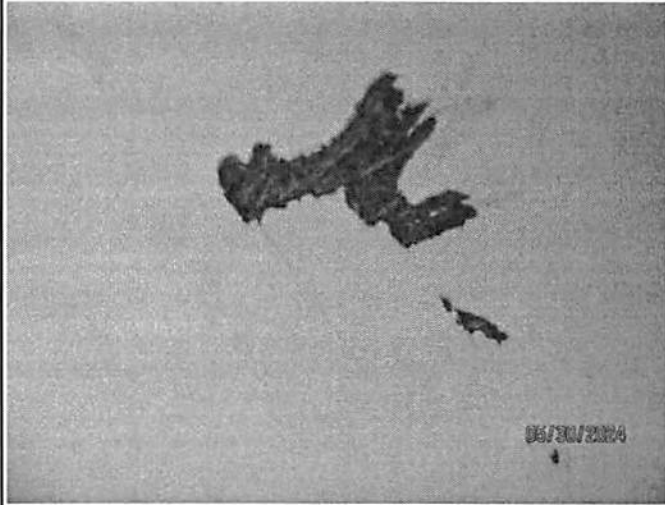
Gel-coat damage, port aft underside

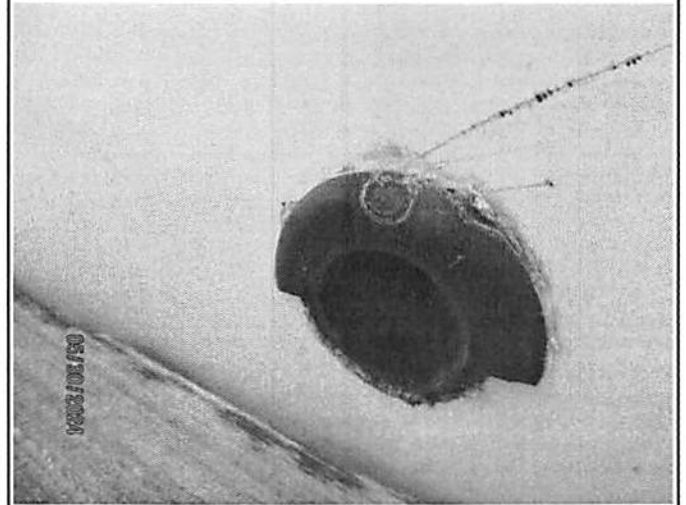
Transducer, needs replaced ASAP

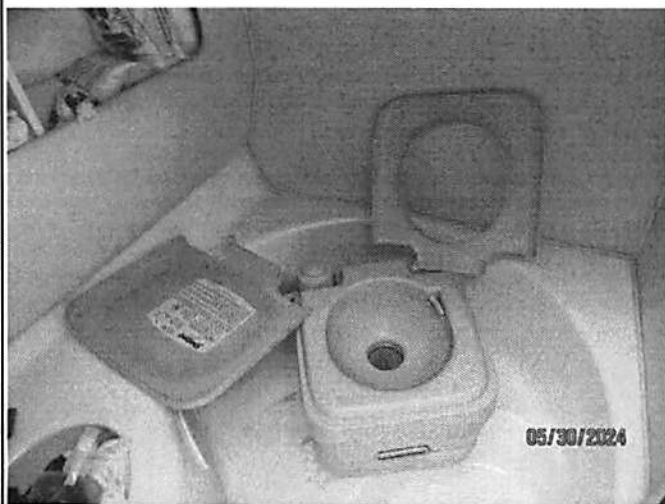
Toilet lid and seat broke at hinge
