Pre-Purchase C & V Report

1983 Bayliner 32

Prepared For: Thomas Rose
Prepared By: [REDACTED] Marine Surveyor, S.A.M.S. - SA

Date of Inspection: April 8th, 2024

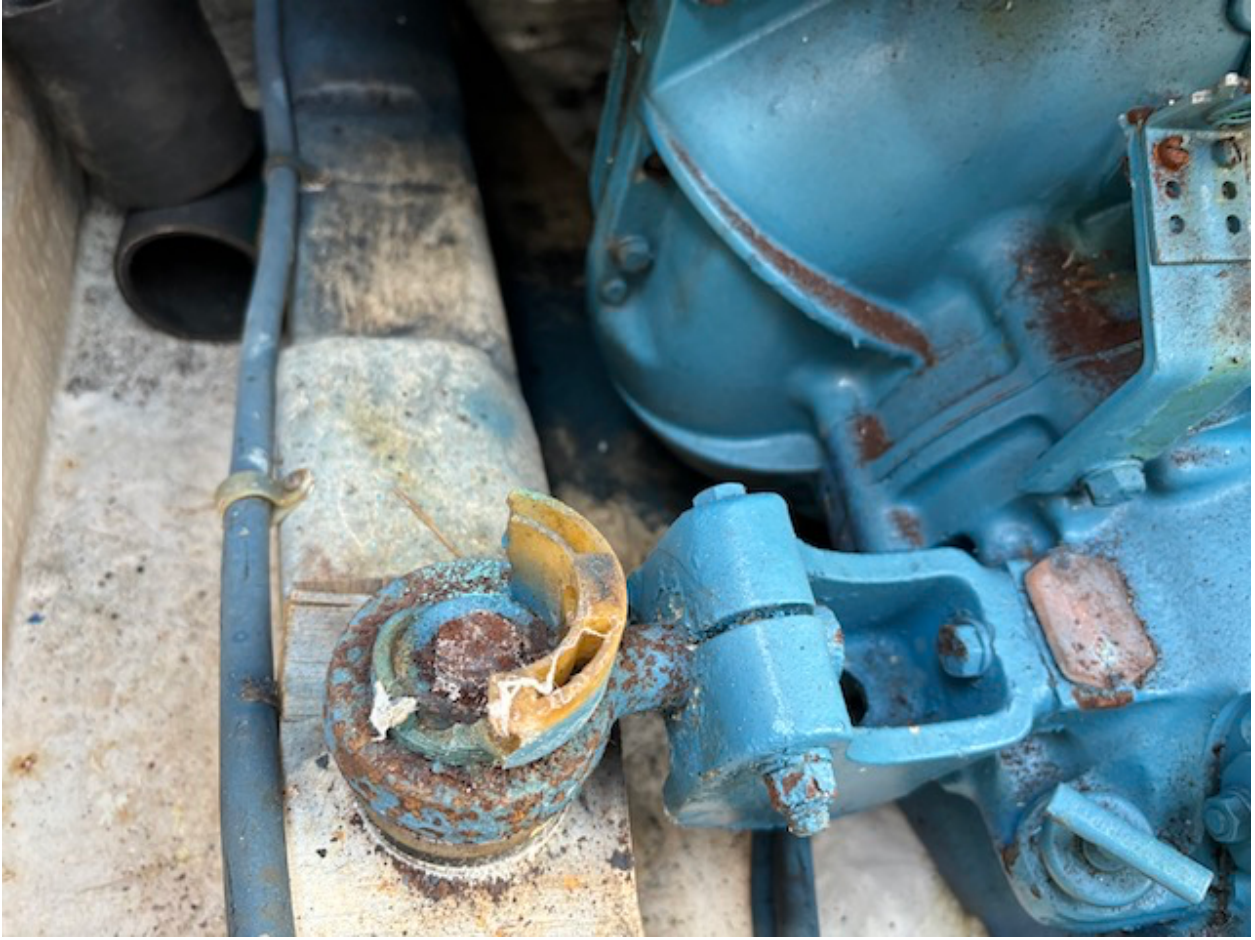
Port aft engine motor mount.

11. One of the starboard engine coolant hoses is cracked. Replace the hose to restore integrity.
12. The port and starboard engine motor mounts are rusted and part of the port aft mount on the port engine is cracked in half. Replace the motor mounts.

Rusted and broken port a

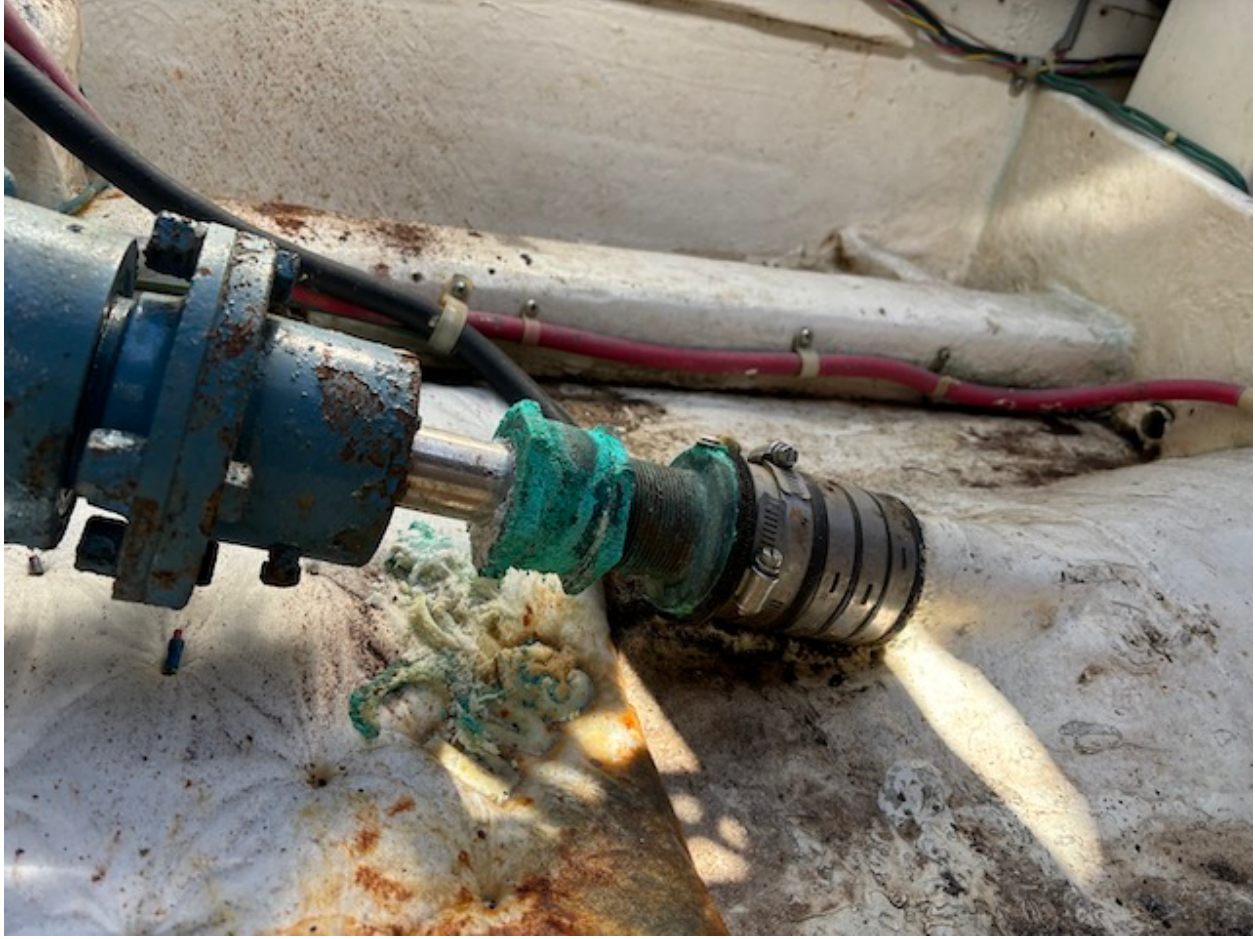
Starboard shaft seal.

24. There is heavy calcium buildup at the port and starboard shaft seals and the seal boot clamps are rusted. Descale, clean, protect and monitor the shafts and replace the boot clamps.

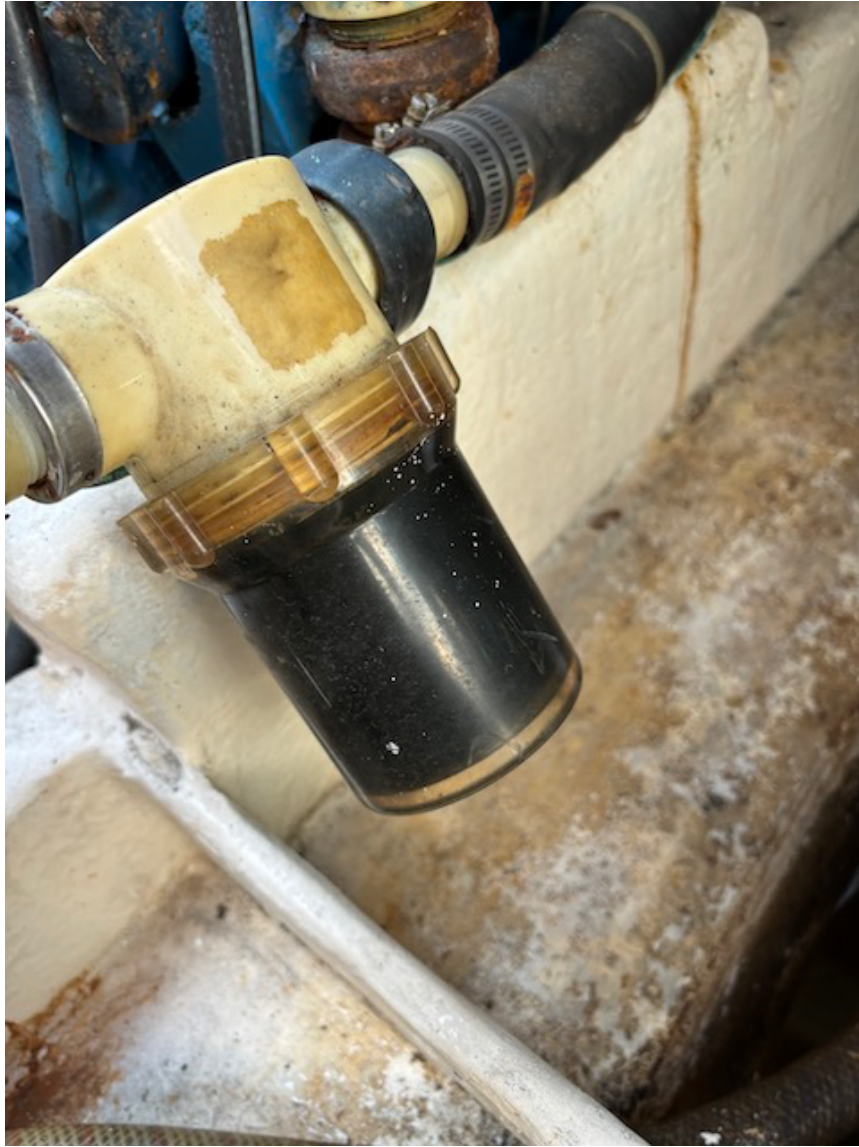
Starboard engine sea strainer

16. There is calcium build up on the port and starboard carburetor air filters. Descale, clean, protect and monitor.
17. There is heavy sediment in the port and starboard engine sea strainers. Clean the sea strainers to allow water to flow freely to the engines.

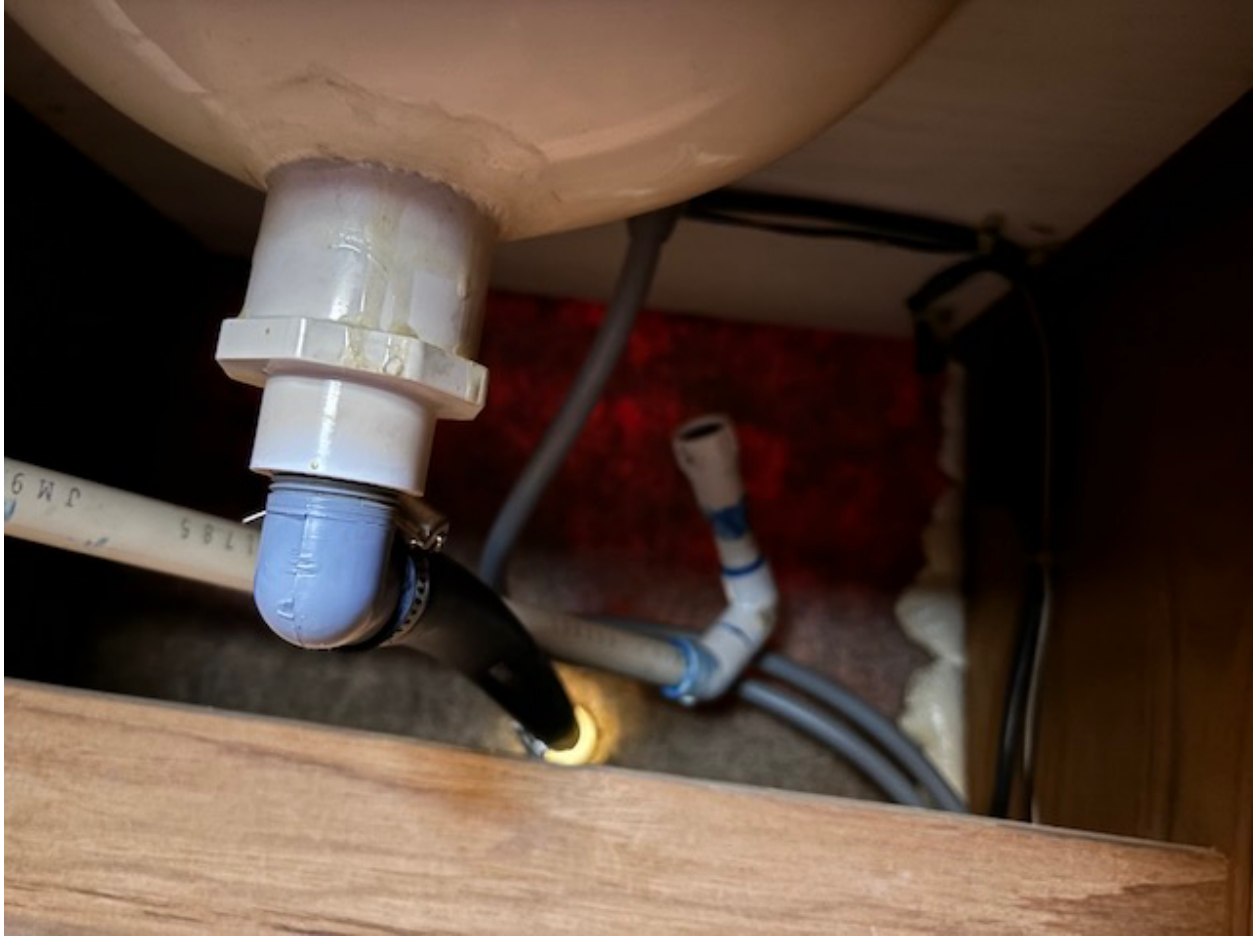
Under pilot berth sink

25. The steering hydraulic reservoir is at 11-psi. Fill to factory specifications of 25-30-psi.
26. There is a rigid plastic pipe with a valve that runs from the port cockpit cupboard to the under the sink in the pilot berth but is not connected to anything. Remove the pipe or connect to a system to prevent potential water ingress.

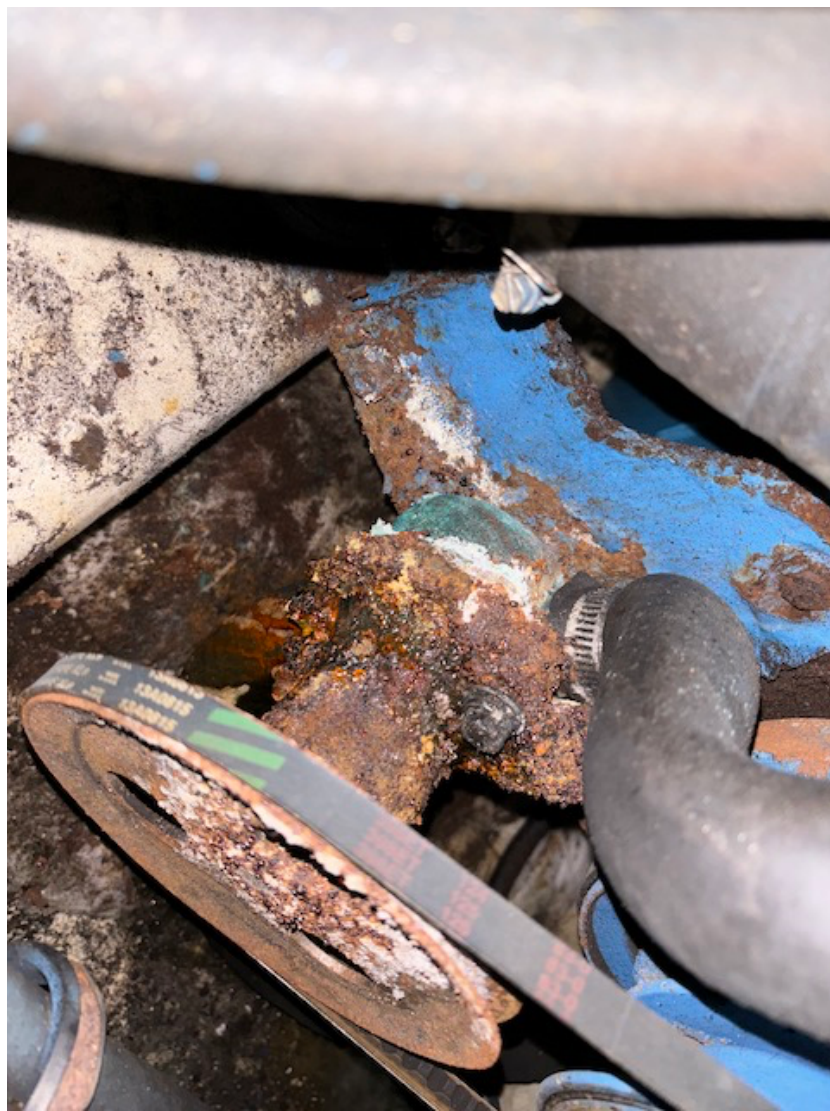
Starboard engine water pump

19. The starboard engine water pump is heavily rusted and the port engine water pump has heavy calcium buildup. Replace the starboard water pump as necessary. Descale, clean, protect and monitor the port engine pump. Assess the impellers and replace if necessary.
20. The starboard raw water intake hose is cracked and the clamps are rusted at the water pump. Replace the hose and clamps.
21. The stove burner control knobs are seized so the stove could not be tested. Repair or replace and prove operational.

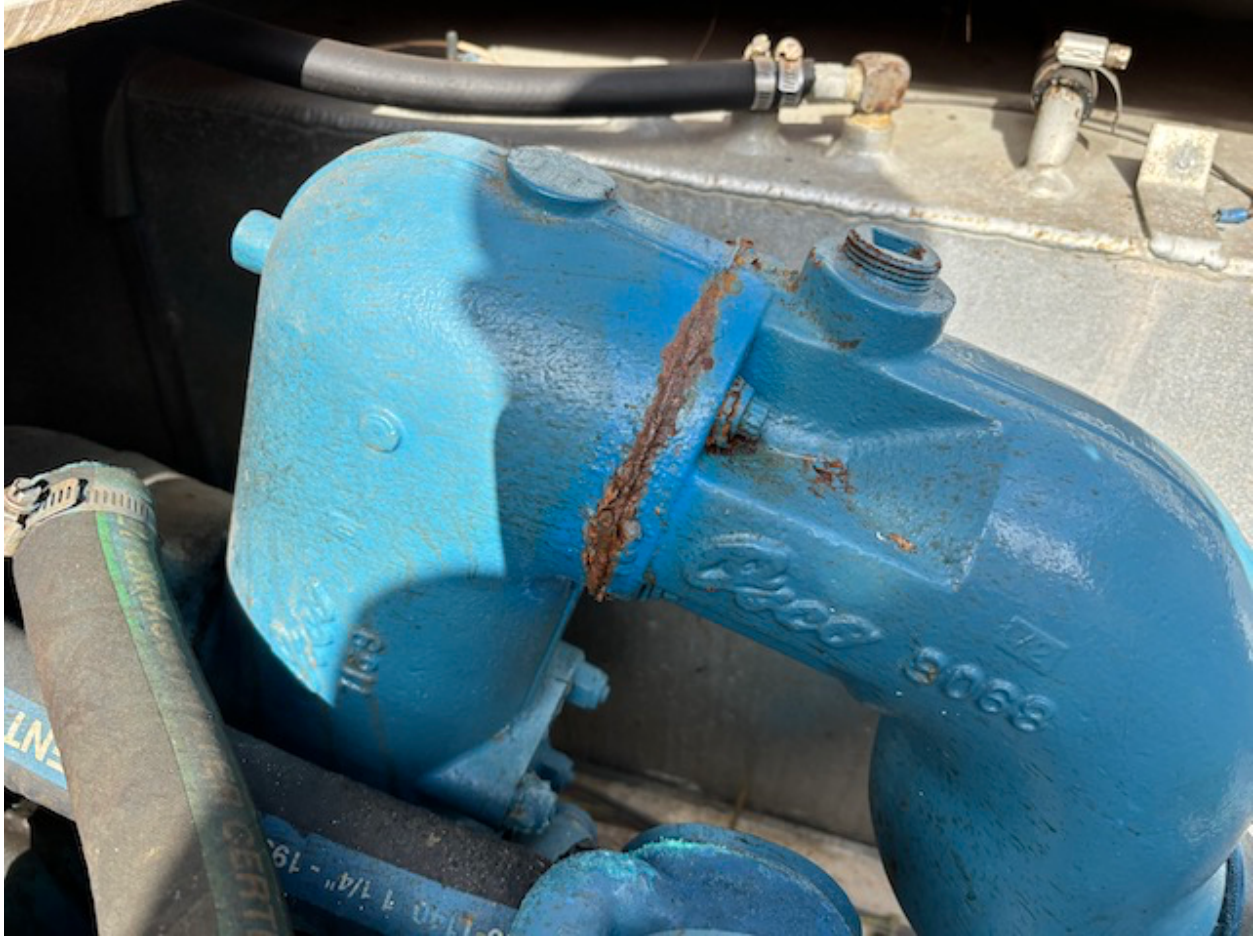
Starboard exhaust riser

9. One of the flybridge stanchion mounts is missing a screw. Install a screw to secure the mount.
10. The exhaust riser connection on the port and starboard engines are rusted. Have a reputable marine mechanic determine the significance and replace IF necessary.
