2004 Crownline 262 Bowrider

NANCYJO II

Report of Marine Survey

February 07, 2025

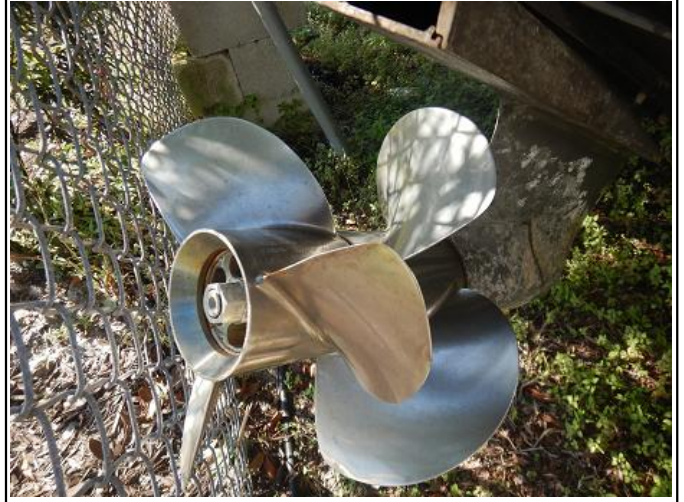
Props

CONDITION: Overall the exterior of the hull was sighted clean but in need of waxing. No bottom paint on hull exterior. Normal wear and tear sighted on bottom with some scuffs but no exposed fiber glass sighted. Topside the vessel was open, no cover. The soft cushions were noted to be dirty with some mildew starting to show. The decks and windshield were sighted intact with no signs of stress or cracking. The bilges and engine room were sighted clean, engine room was neat and uncluttered. The head compartment was sighted cluttered with stored soft goods. The engine and major components were noted to be clean, corrosion free. Electrical components, batteries and wiring appeared fit for intended use. The out drive and propellers were sighted intact, no pieces missing or ding's.
