2012 19 Sea Ray 190 Sport

Appraisal

Of the Vessel

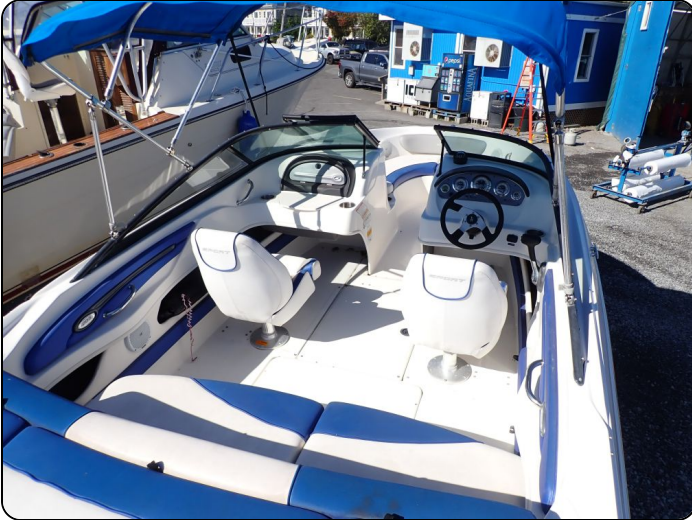
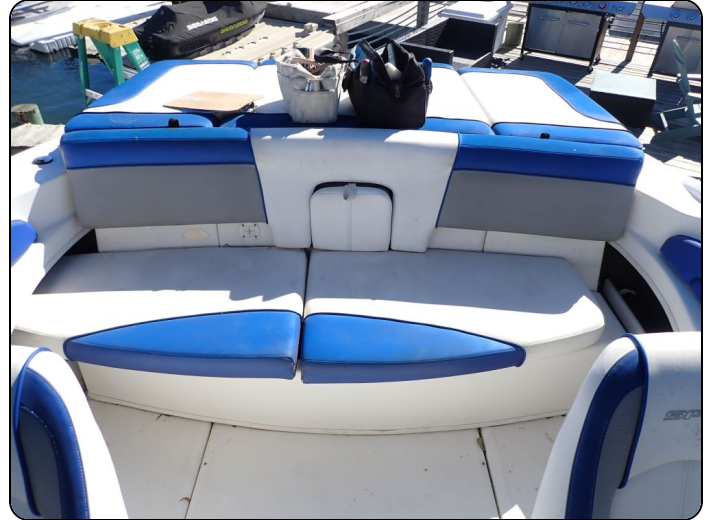
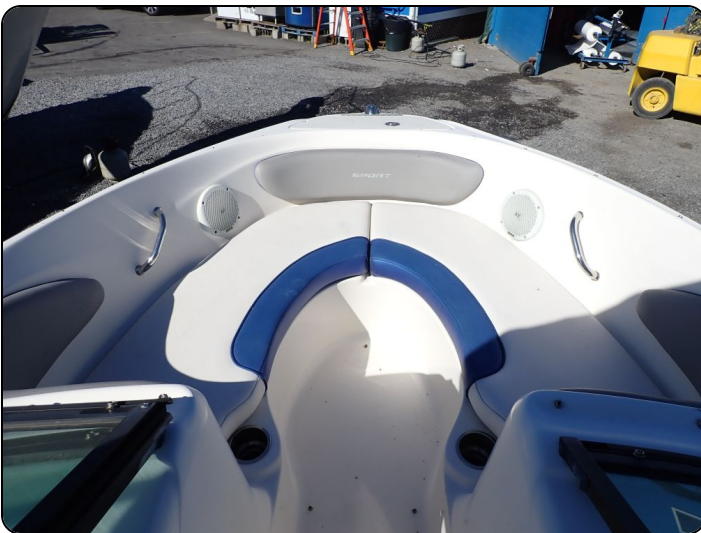
The vessel was in average condition overall. The outdrive was clean and not showing signs of galvanic corrosion with no cracks on the exhaust boots. The engine was reportedly operational, however this could not be confirmed as the vessel was on the hard and winterized. The hull, topsides and decks were free of moisture and signs of delamination.
