# Underwriter's C&V Survey Report

## "SEA CHASE"

**1984 32' Carver Convertable**

**Date Of Survey:** 07/31/2024

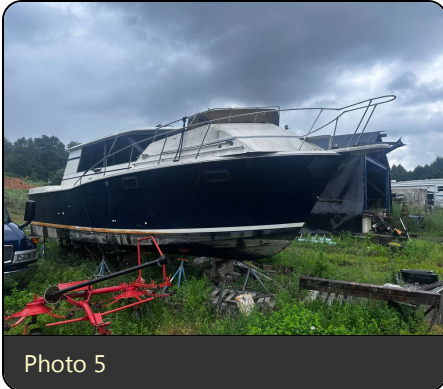
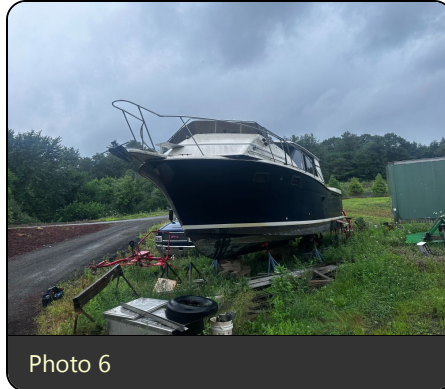
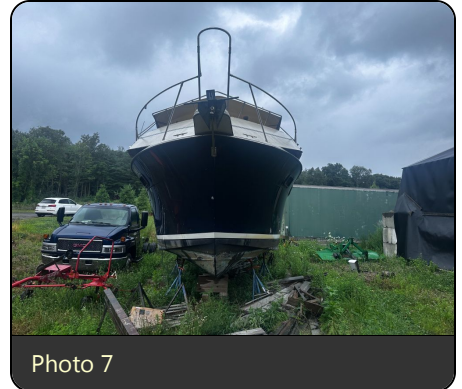
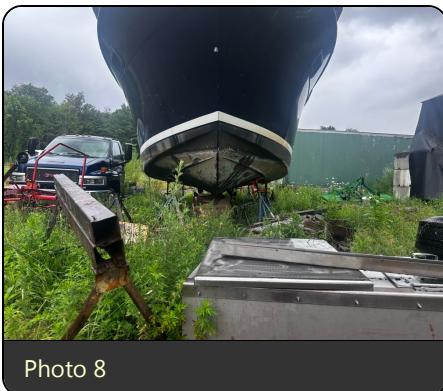
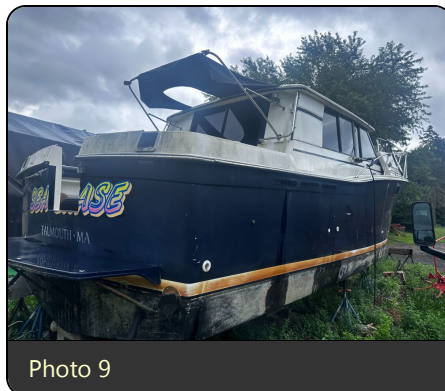
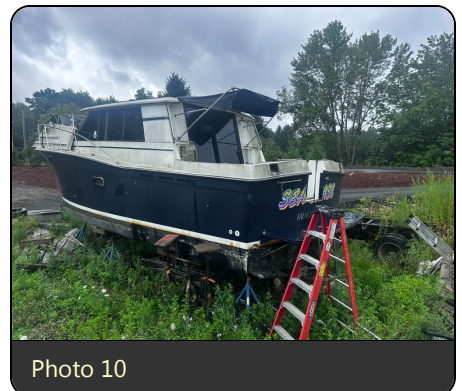
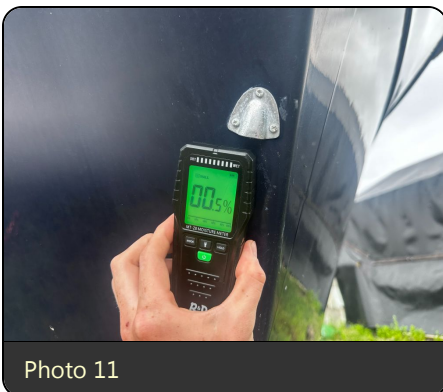
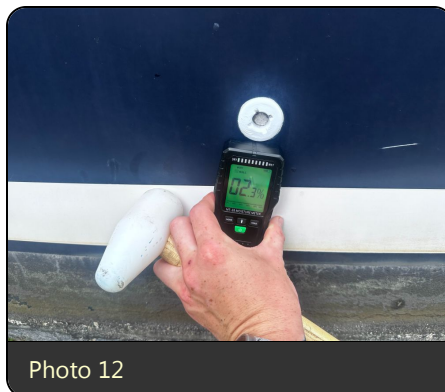
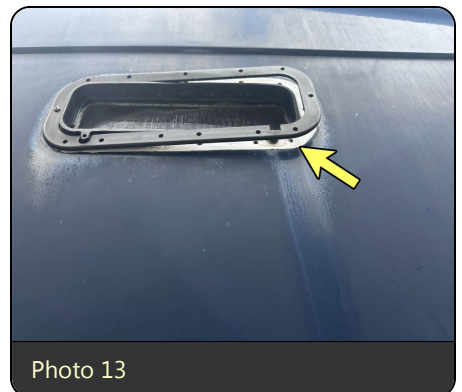
The vessel has a Modified V type hull with hard chine and a molded in keel. The vessel has a conventional sheer line from the bow to the transom. The hull is fiberglass, but coring is not known. Hull stiffness was provided by FRP-encapsulated stringers and Bulkheads (core material not determined). The hull and topsides were percussion tested utilizing a phenolic hammer approximately every six inches where accessible to identify any anomalies; none were detected. Conductivity readings were low throughout the hull. No evidence of structural failure or indication of damage to the hull were noted unless otherwise specified\*. Damage to the fiberglass was sighted in multiple locations on the STBD topside, conductivity readings were low. No blistering of the hull was observed. The wetted areas were painted black with copper ablative bottom paint that needed servicing.

Damage to the STBD top side laminate was sighted mid hip and at the transom corner

Have a qualified Fiberglass technician Investigate further, and repair as necessary.

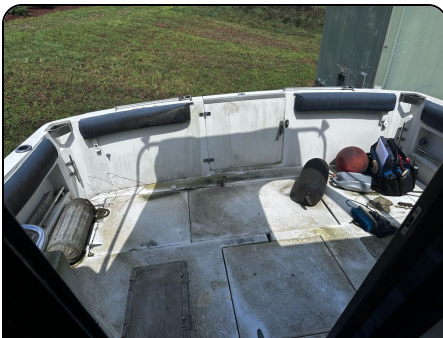
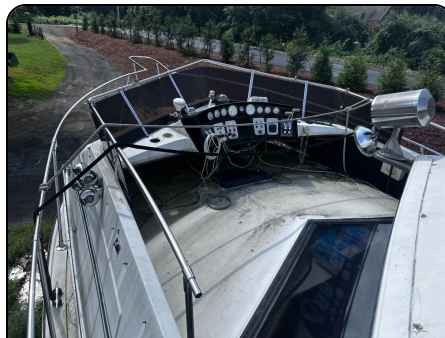
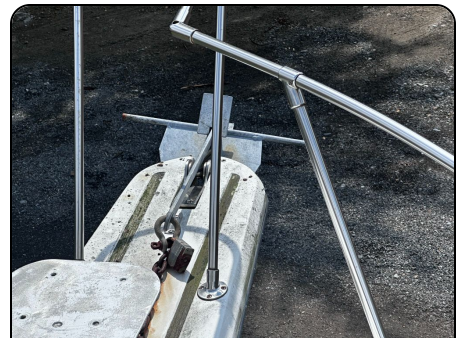
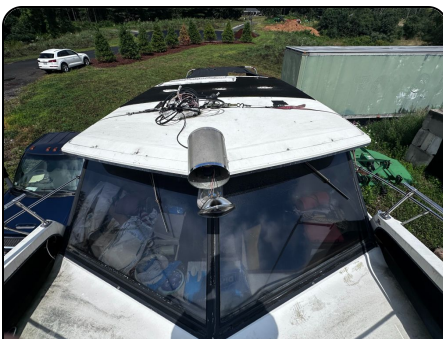
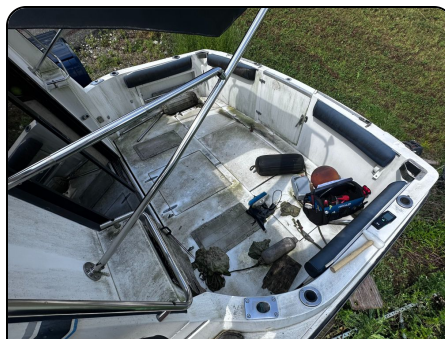
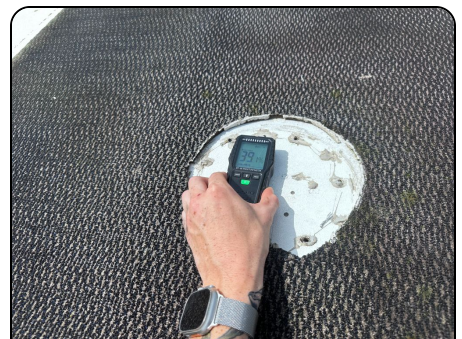
The cockpit deck was constructed of fiberglass (the presence of a coring material is not known) and covered with a diamond pattern with a textured non-kid gel coat. The deck was visually inspected and periodically sounded with a phenolic hammer with no indications of voids or delamination noted. Conductivity (moisture) did show high readings along the bow toe rail from the midship to the anchor roller. The flybridge deck was soft, and conductivity readings were high.

Have a qualified fiberglass technician investigate further and repair in accordance with good marine practice as necessary.

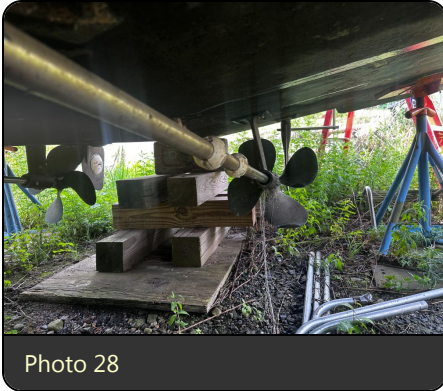
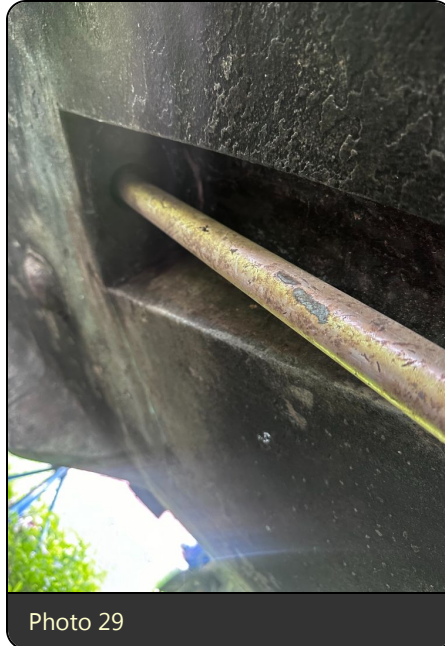
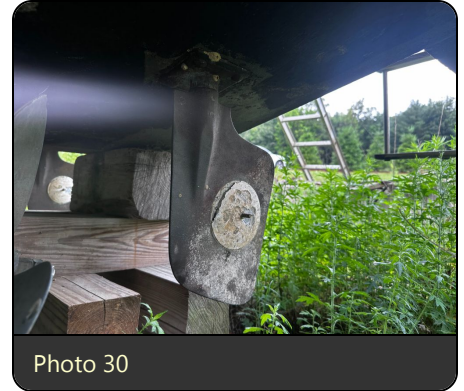
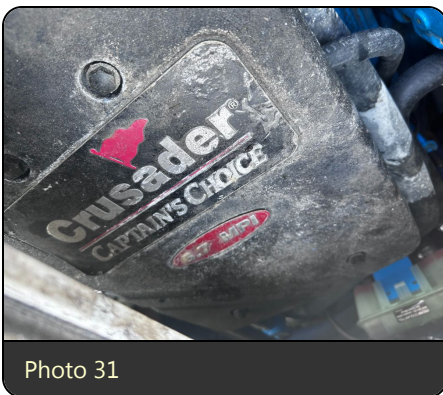
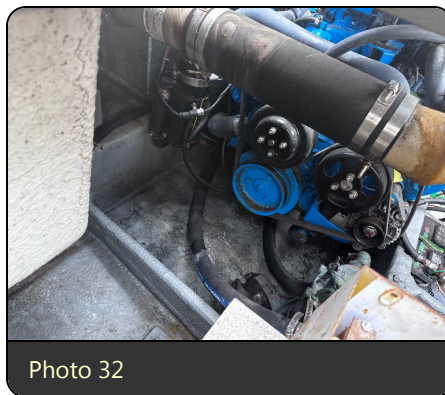
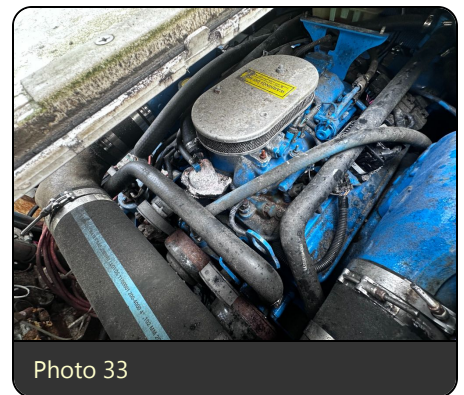
The vessel has twin Cruisier 6.7L MPI Inboard gasoline powered naturally aspirated engines with freshwater cooling. Both engines had minimal surface rust throughout. The engines did not show signs of overheating, as the manifolds and risers were in good condition. The engine mounts were serviceable. Engine oil was clean; Metal shavings or water was not sighted. The spark arrestors were not clogged. Both transmissions are equipped with 1" prop shafts, and bronze alloys 18"x18 props that are correctly secured to the shaft. Both the prop and shaft were in good condition and did not show signs of corrosion or pitting. The Shaft packing seal did not show signs of water intrusion or corrosion. Both prop shafts were noted to be aligned coming through the shaft seal and spun freely.
