2008 51 Heritage Boatworks

Renegade

Report of Marine Survey

Conducted by
AMEC Marine Surveyors

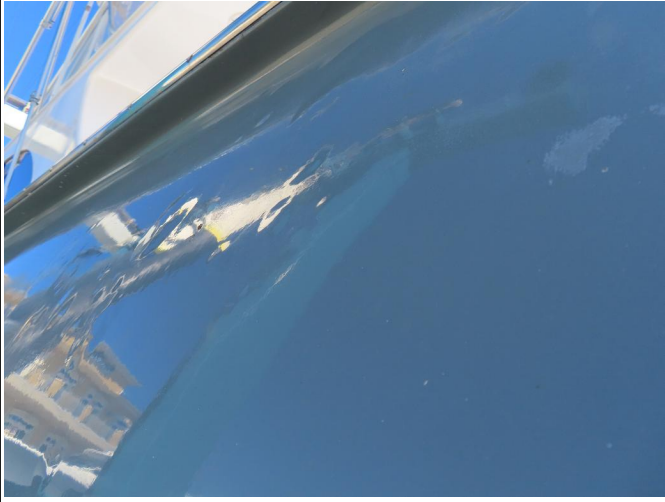
* **HULL: [B1]** Modified deep-v planing type hull. Cold molded hull painted gray with maroon/gold boot stripe and black bottom paint. The hull sides have some blisters in the paint in various areas with paint fading and discoloration with the bow hull having some paint scratches. The bottom paint is in poor condition with bottom paint wearing off in several areas. There are areas on the bottom where the fiberglass is starting to chip off as well. The stainless steel rub rail screws are rusting in various areas.

Hull sides blisters
