**MARINE SURVEY REPORT ABOARD THE VESSEL**

**2006 Bennington 2275 FSi**

<b>FILE NUMBER &amp; STATUS</b>	No. 1402   Complete As Of 05/16/2024
<b>MARINE SURVEY INSPECTION TYPE</b>	Condition & Valuation Survey
<b>MARINE SURVEY REPORT PREPARED EXCLUSIVELY FOR</b>	[REDACTED]
<b>DATE OF MARINE SURVEY INSPECTION(S)</b>	05/13/2024
<b>VESSEL YEAR, MAKE, MODEL &amp; HULL IDENTIFICATION NUMBER</b>	2006 Bennington 2275 FSi   ETW43240B606
<b>VESSEL NAME, HAILING PORT, GROSS &amp; NET TONNAGE</b>	N/A
<b>US COAST GUARD DOCUMENTATION &amp; REGISTRATION NUMBERS</b>	SC 9088 BV
<b>OVERALL VESSEL RATING</b>	<b>POOR CONDITION</b>
<b>FAIR MARKET VALUE OF VESSEL</b>	<b>\$8,000.00 USD</b>
<b>ESTIMATED REPLACEMENT COST OF VESSEL</b>	<b>\$60,000.00 USD</b>
<b>MARINE SURVEY INSPECTION &amp; SEA TRIAL LOCATION(S)</b>	[REDACTED], North Charleston, South Carolina 29405, USA
<b>MARINE SURVEY DAY WEATHER &amp; SEA STATE CONDITIONS</b>	78°F, partly sunny, zero precipitation, wind S @ 4 MPH, calm sea state, 74°F sea water and excellent visibility

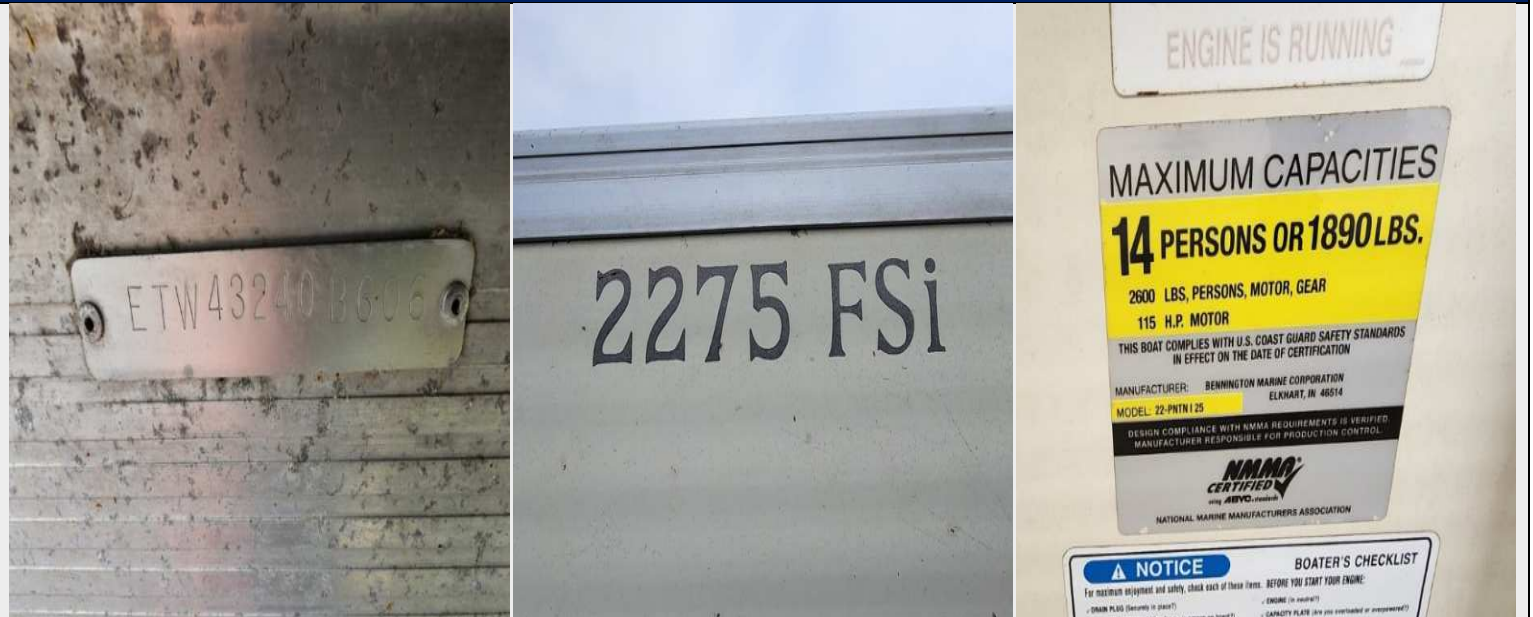
Hull identification number (HIN: ETW43240B606) & Bennington Pontoon model designator & capacities plate aboard the 2006 Bennington 2275 FSi

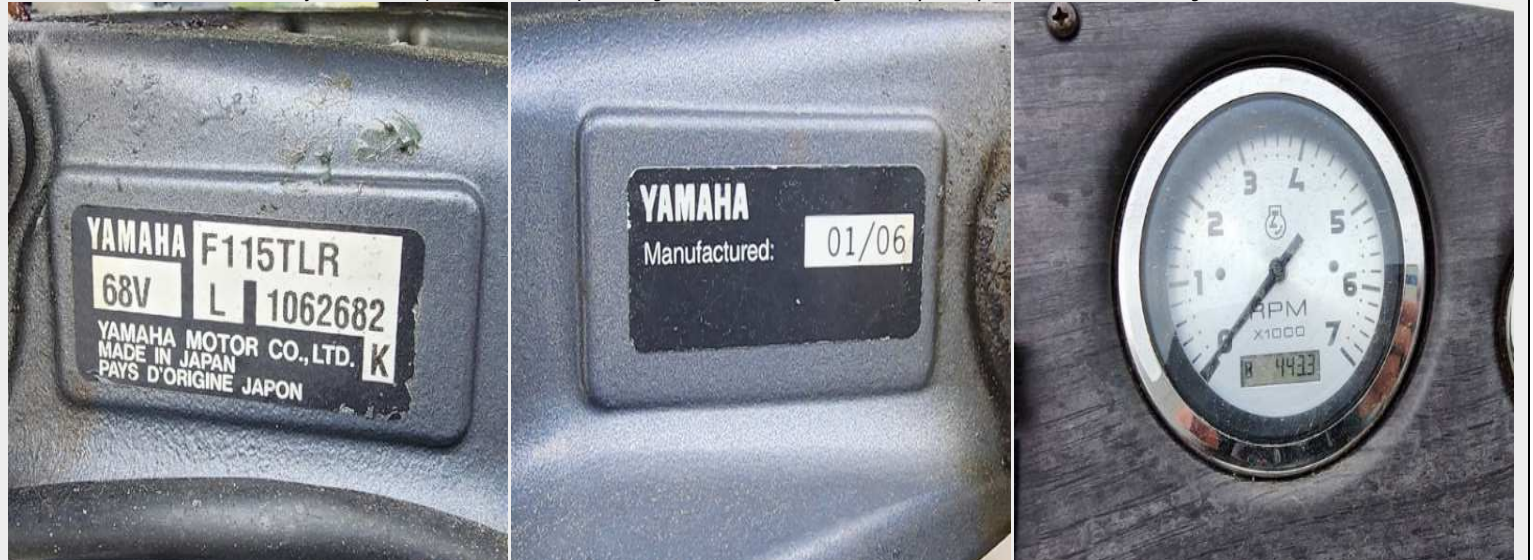
1x Yamaha 115HP engine serial number tag, date of manufacture tag, and digital hour meter displaying engine hours on 05/13/2024.
