EBB TIDE SERVICES

VALUATION / APPRAISAL SURVEY

"Surfs Up"

2002 Rinker 270 Fiesta Vee.

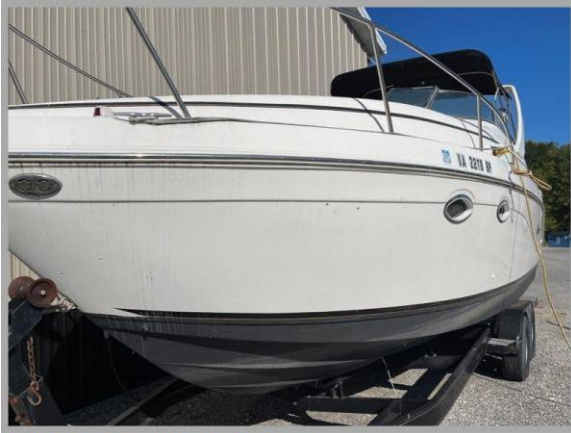
Hull on port side looking aft

Very few and minor gel coat fractures were noted and as these are cosmetic in nature, no further comment is offered.

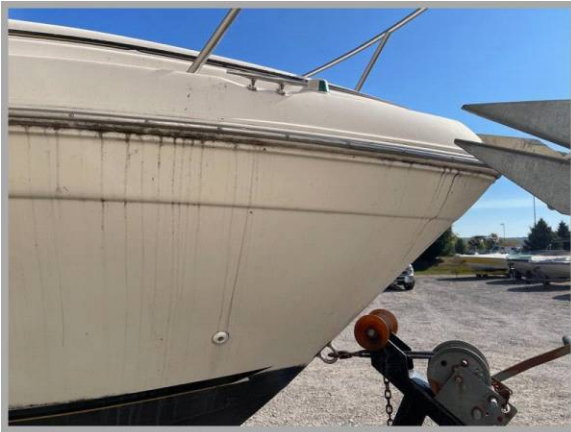
Starboard side of stem

Solid, no cracks on external inspection. Moisture readings relatively Dry. Bow eye is secure.

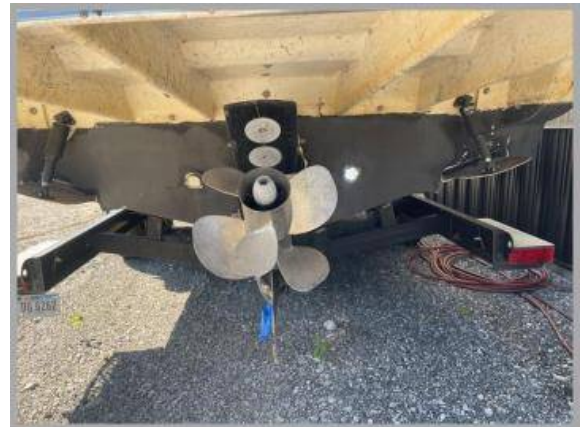
Swim Platform

Extended Fiberglass. The swim platform is properly attached and well secured.

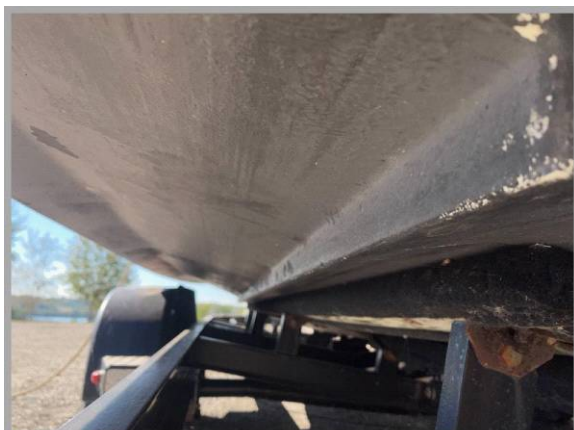
Hull bottom on port side looking forward

Solid GRP (Fiberglass), No cracks or separation sighted on any portion of hull bottom.

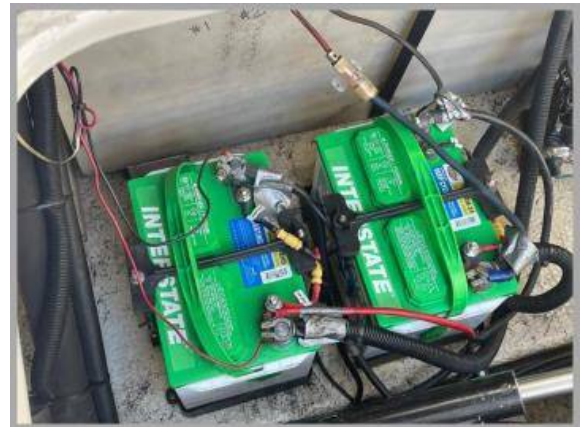
Located on tray, Secured with hold down bracket/brace.

Positive terminal(s) are Not covered. RECOMMENDATION: Code of Federal Regulations - 33 CFR 183.420 mandates that positive terminals be protected against accidental shorting by the use of insulation barriers or sleeves. Recommend compliance with Code of Federal Regulations.

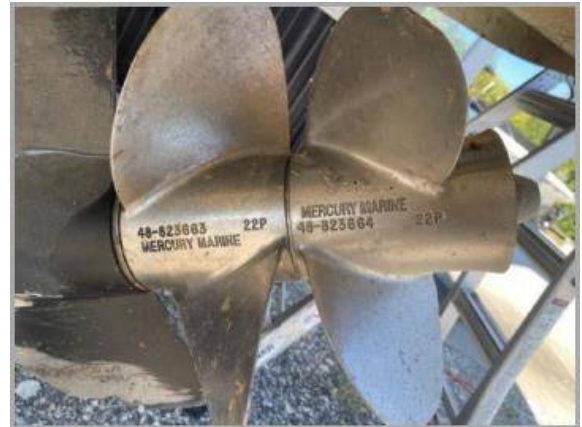
Prop blades are nicked or bent and should be serviced. RECOMMENDATION: Have prop(s) repaired and balanced to prevent excess vibrations.
