MARINE CONDITION & VALUATION SURVEY

FINAL REPORT
Condition and Valuation for Donation
S/V: 1984 29' C&C Sloop Rig MK II

“MANA KAI”

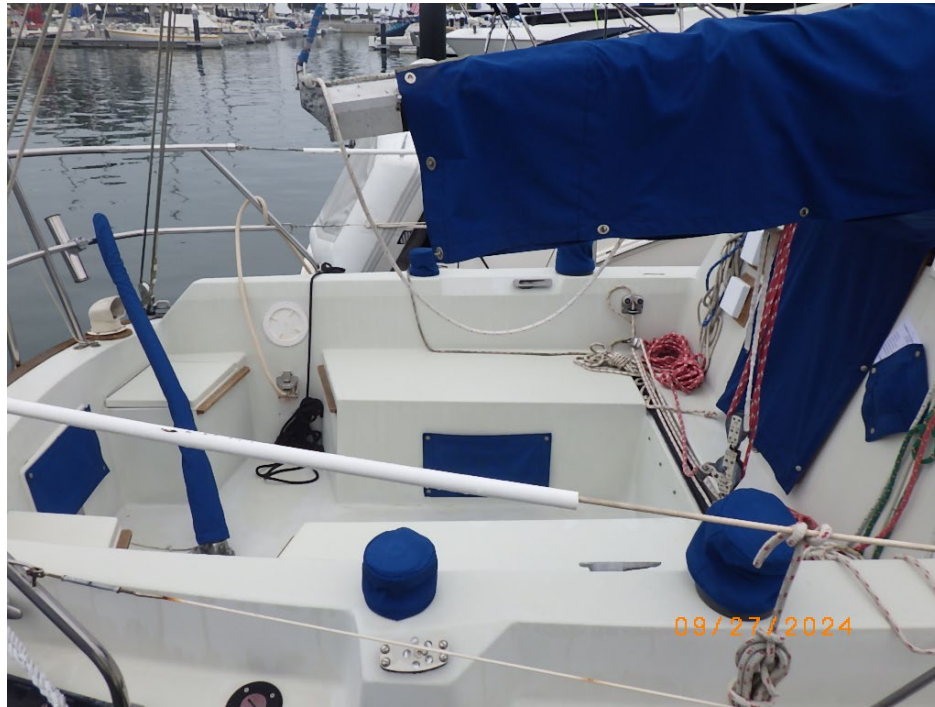
The vessel was suitable for harbor and coastal use. Spare sails were in the sail bags, and the bilge was dry. The Overall Current Condition was in **Average to Above Average Condition**
