# REPORT OF MARINE SURVEY

**1986 30 Ticon Sailboat**

**JOHN BOMMARITO**  
ACCREDITED MARINE SURVEYOR

May 2, 2024

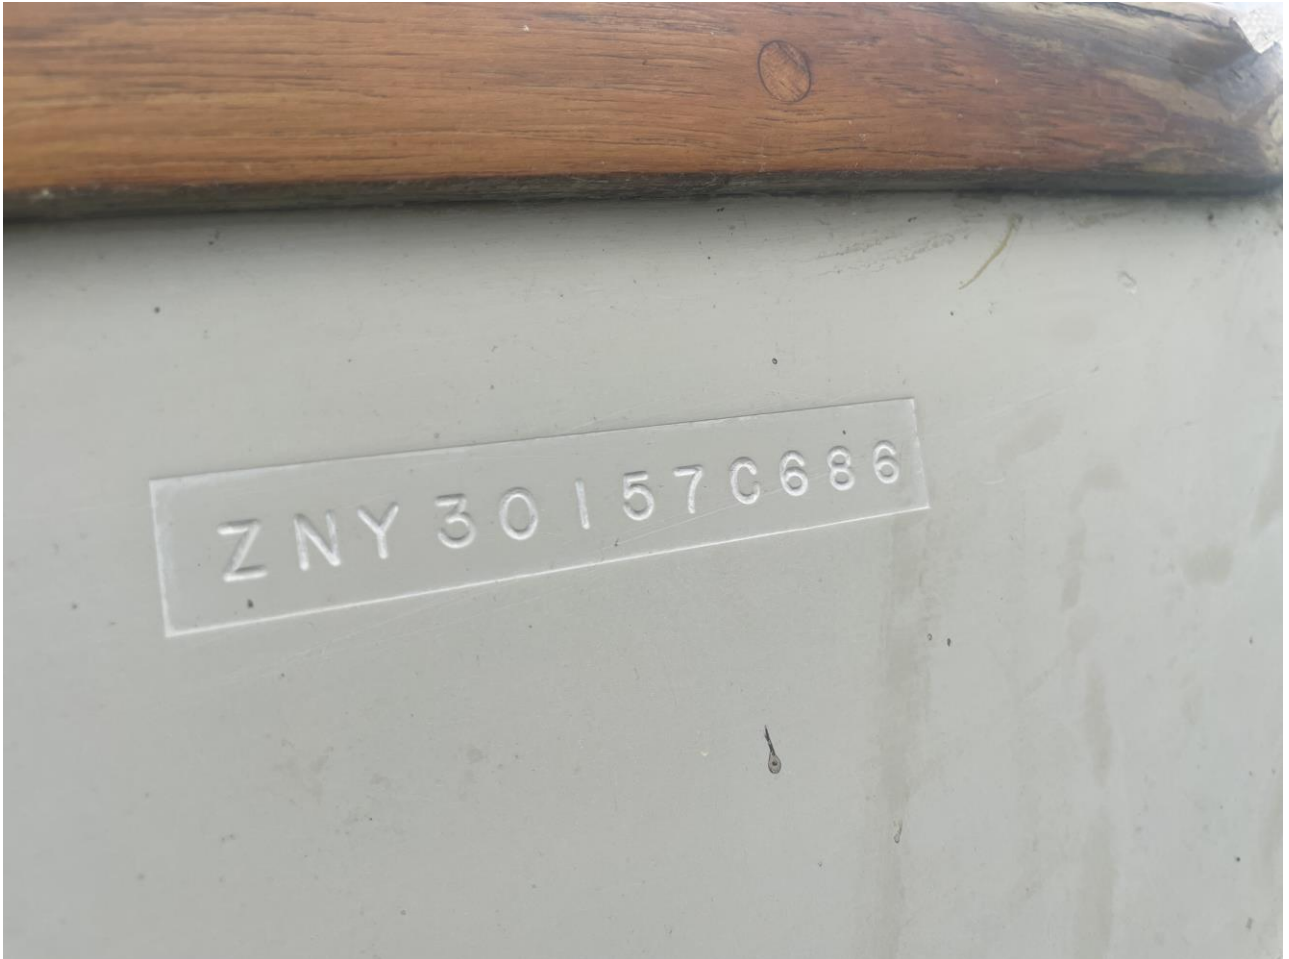
## **HULL IDENTIFICATION NUMBER**

I certify that the picture of the Hull Identification number which appears above on the document was personally taken by the undersigned on the date indicated below. The Hull Identification Number is in agreement with the vessel's papers.
