"SUNSHINE" 1971 HATTERAS 38 CONVERTIBLE

CONDITION & VALUATION REPORT OF MARINE SURVEY FOR DONATION

"SUNSHINE"

1971 HATTERAS 38 CONVERTIBLE

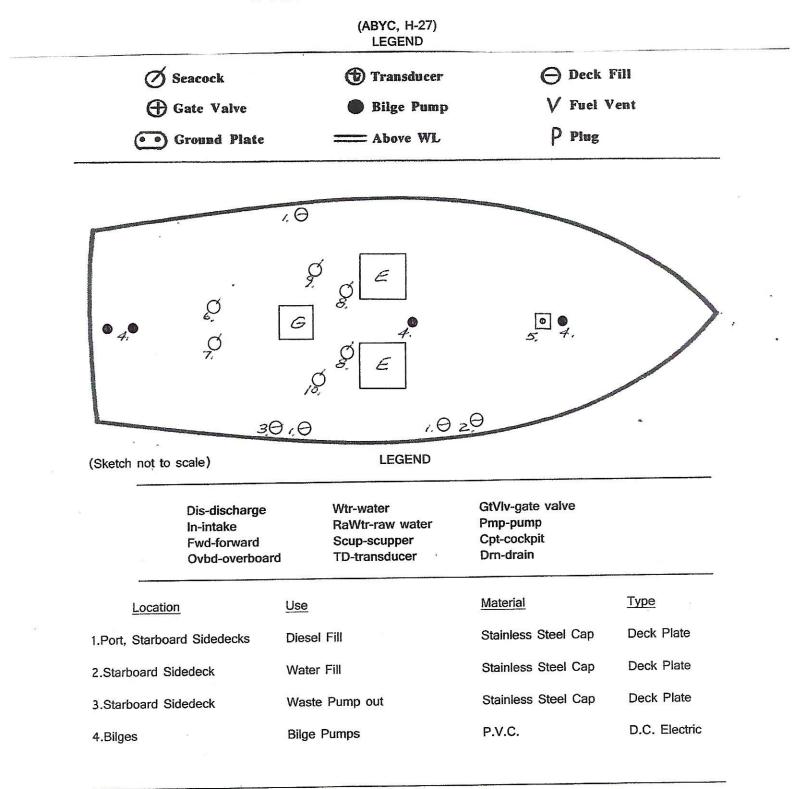
K. THROUGH-HULL FITTINGS WHERE SIGHTED

Location	Use	Material	Туре
5.Forward Bilge	Sump Pump	P.V.C.	D.C. Electric
6.Aft Bilge, Bottom	RaWtr In, Well	Bronze	Lever Valve
7.Aft Bilge, Bottom	RaWtr In, Wash	Bronze	Lever Valve
8.Engine Bilge, Bottom	RaWtr In, Engines	Bronze	Lever Valve
9.Engine Bilge, Bottom	RaWtr In, Gen Set	Bronze	Lever Valve
10.Engine Bilge, Bottom	RaWtr In, A.C.	Bronze	Lever Valve
