# Vreyheyt II

Vreyheyt II is a 37 foot Dutch river barge built in 1920 in the Netherland. Her hull is constructed of riveted iron sheets and has a Mercedes OM617 5 cylinder diesel for propulsion. She is fully navigable and has a modern solar and electrical system.

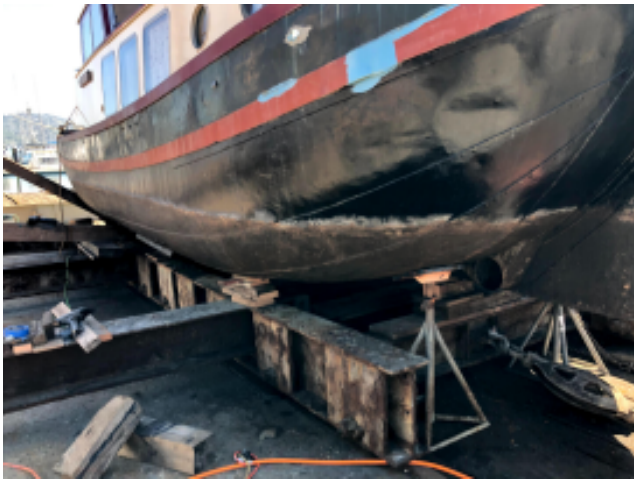
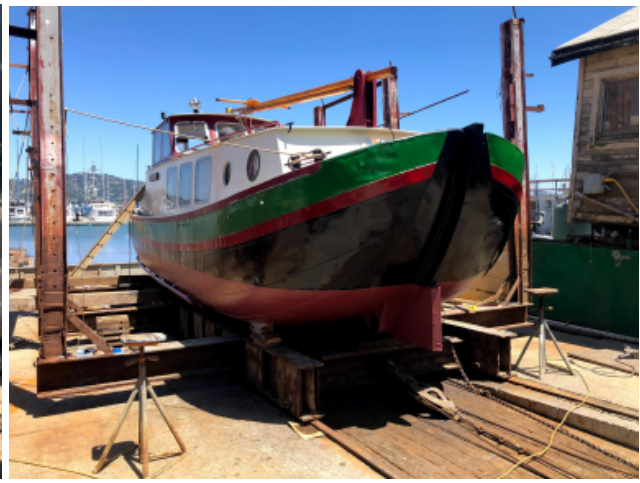
In 2021 she was hauled out at [REDACTED] in Sausalito where she had her keel cooler replaced and hull stripped and repainted below the waterline. Additional top side paint was also applied up to the gunnels

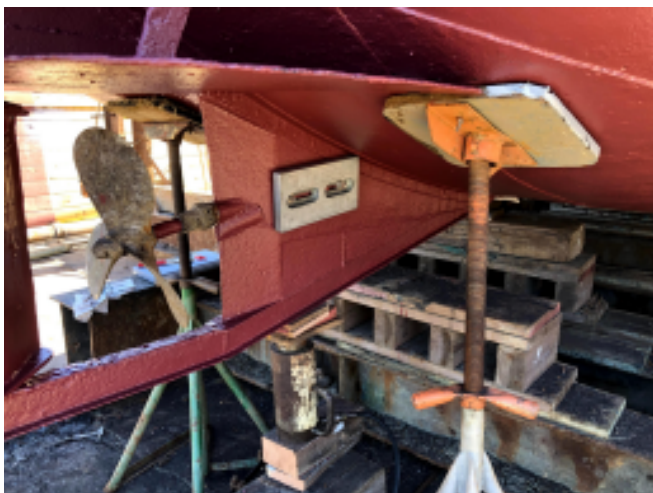
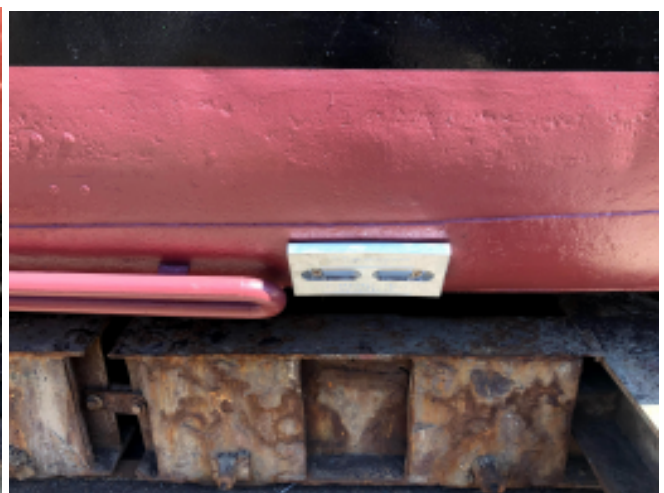
Below the gunnels is mostly original to the vessel and is riveted iron plate. She has a flat bottom with no keel other than the "log splitter" on the front and two thin metal strips where the hull rises. Along the bottom of the hull there is a plate that appears to have been added later in the boat's life.

The vessel has six "Divers Dream" 6"x12"x1" for cathodic protection for the hull. One located each side aft of the bow flare, forward of the stern taper, and alongside the shaft.

*A small "Splash Zone" patch is located under the head and care should be taken in this region when cleaning the bottom*

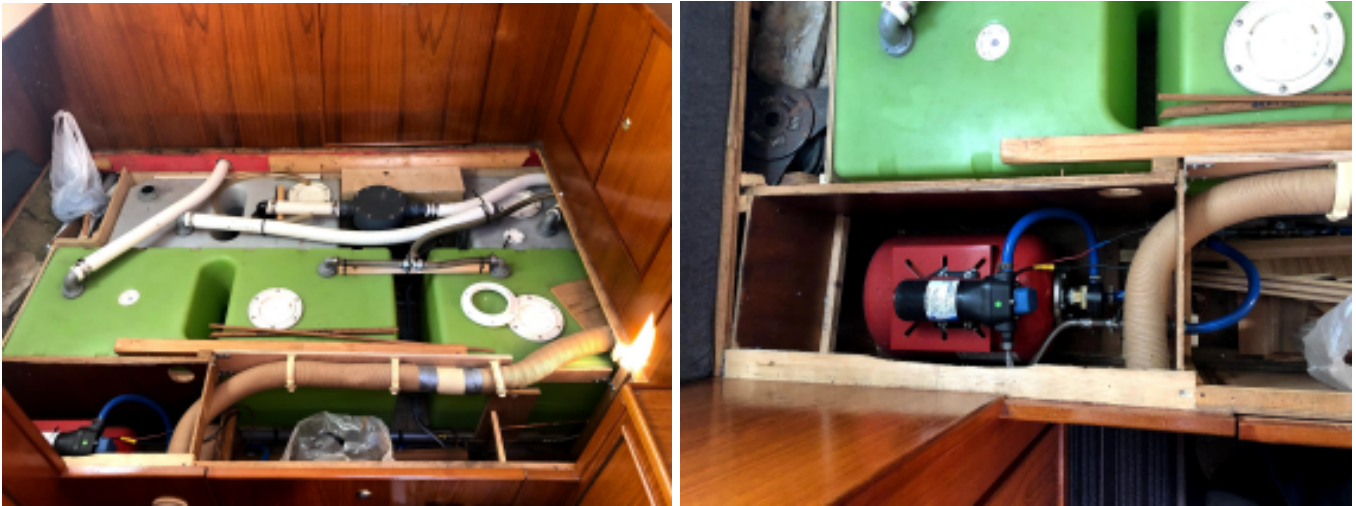
## Freshwater

Two ~25 gal freshwater tanks are located under the main berth and can be filled via a deck port on the bow. Both tanks supply a pump and accumulator behind the tanks to port, and which distributes to the head, galley, and water heater via brazed copper pipe. Water was heated with a propane heater located in the head.

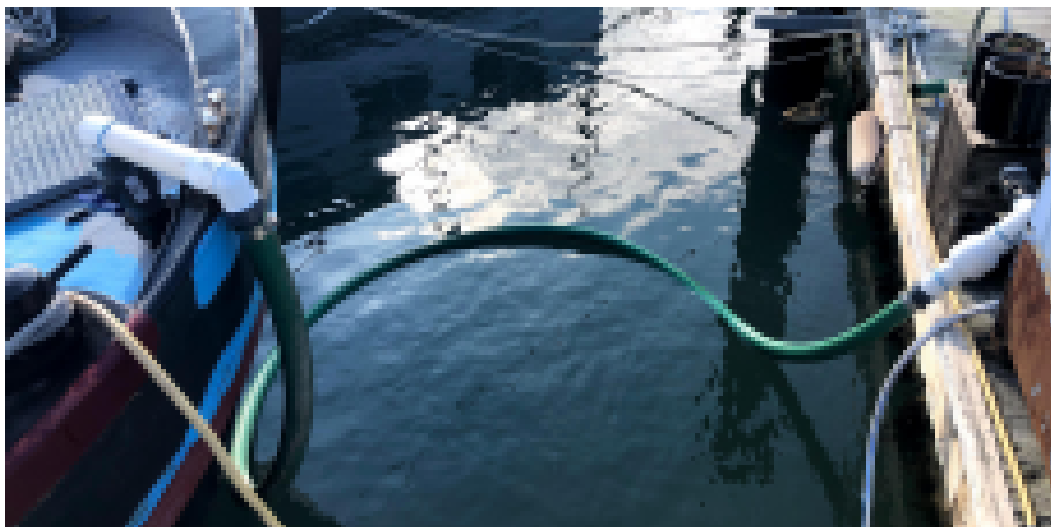
Two ~40 gal waste water tanks are located forward of the freshwater tanks under the main berth. All utilities discharge into the starboard tank.

An electric diaphragm pump located between the waste water tanks can be used for discharge to a 2" cam-lock deck connection on the bow or to a thru hull outboard of the head. A 2" hose can be connected to the deck fitting to discharge waste water if an appropriate connection is available, however the pump must still be controlled manually.

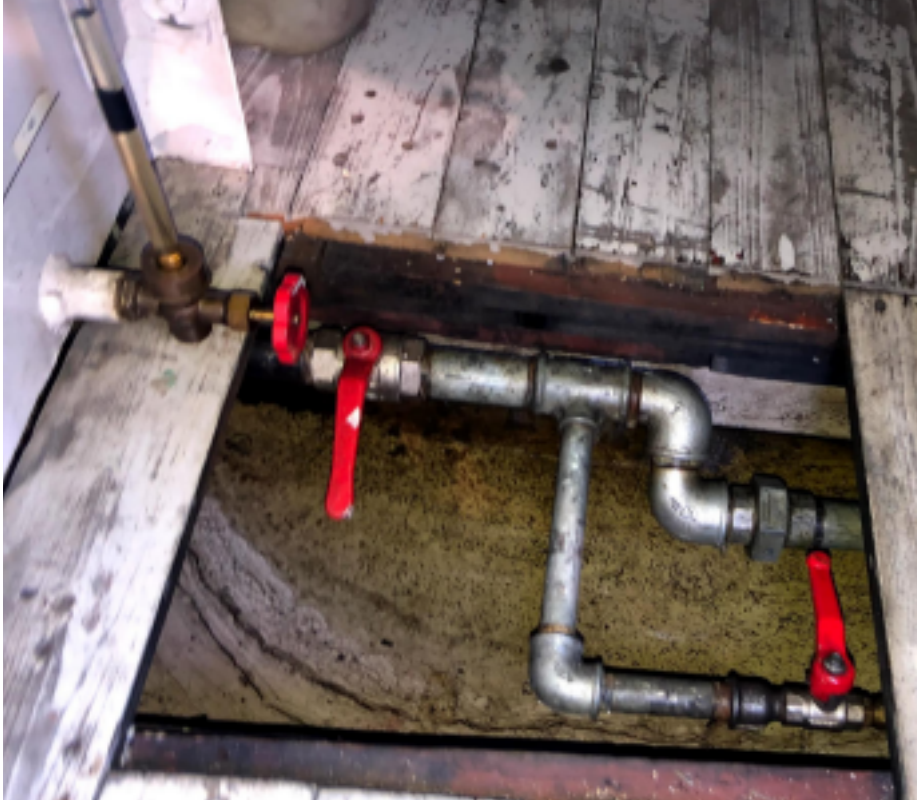
## Fuel

One 120L fuel tank is located on the port side of the engine room with a sight glass as means to indicate level. The fuel manifold is located beneath the floorboards and controls fuel to the engine and heater.

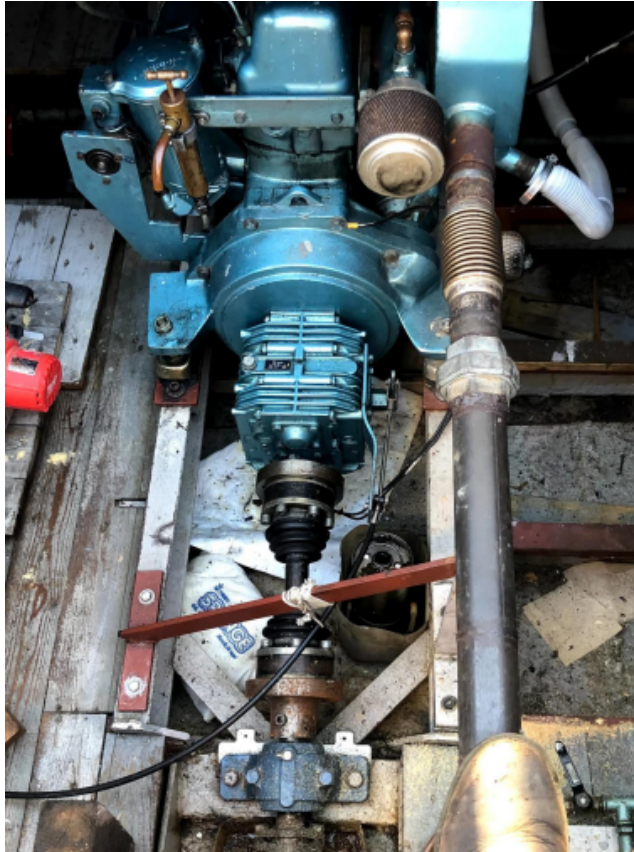
## Engine

The vessel is powered by a Mercedes OM617 five cylinder naturally aspirated diesel engine. The exhaust manifold was replaced with wet type, likely when the engine was installed. Engine cooling is provided by a keel cooler external to the hull along the starboard board with both inlet and outlet on the same side of the ER. The keel cooler was replaced in 2021 and is consists of two 18 foot length of 2" schedule 80 steel pipe with a U-fitting connecting the forward ends with small connecting tabs along the length.

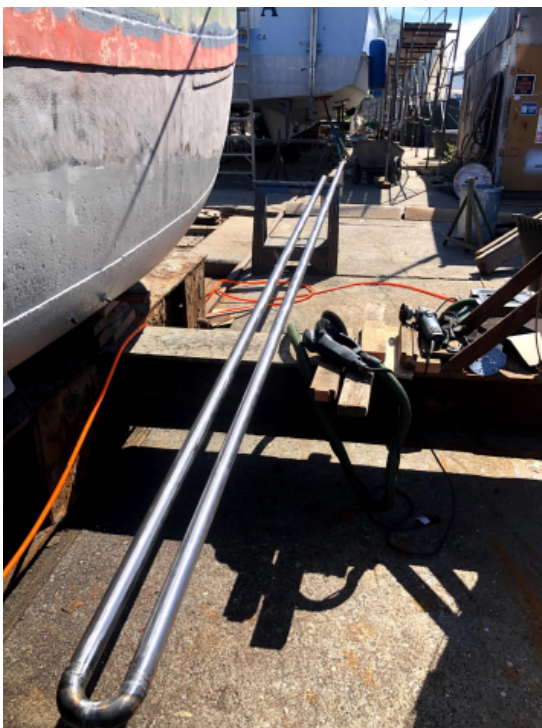
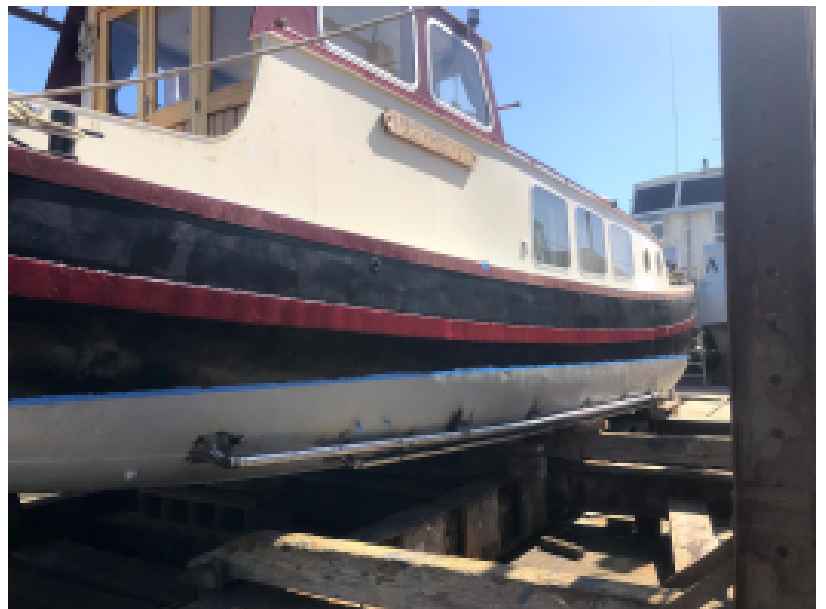
Engine oil is cooled by a inline cooler on the return of the keel cooler and a hand operated pump on the aft of the engine can be used to remove oil from the engine.

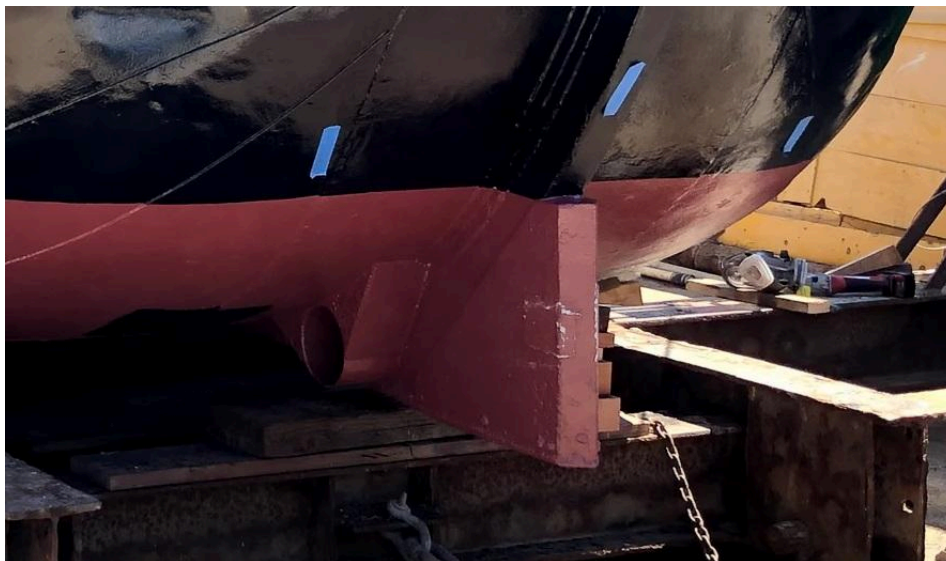
## Bow Thruster

The vessel has a "Side Power" 12v bow thruster located in a tube in the "log splitter" with the head of the unit just forward of the waste water tanks under the bow locker and is powered by the lithium house batteries with heavy gauge cables run beneath the center of the cabin. The controller is a push-button type on the helm and the bow thruster can be isolated with a disconnect located by the main bus bar in the engine room.

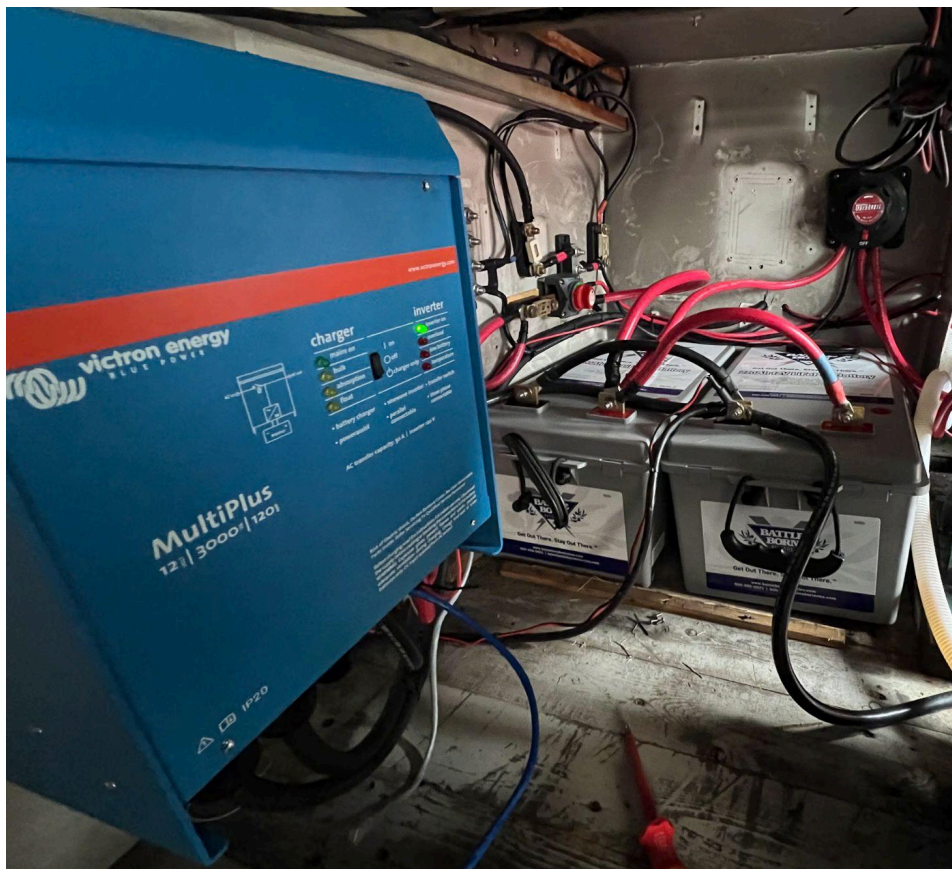
The main house batteries are two "Battleborn" 220ah 12v Lithium (LiFePO4) in parallel that were installed in January 2023.

The engine start battery is a 12v Lead Acid Battery that was replaced in 2022 and is maintained with a trickle charge from the inverter/charger.

A selector on the starboard bulkhead above the batteries is used to select the start battery.

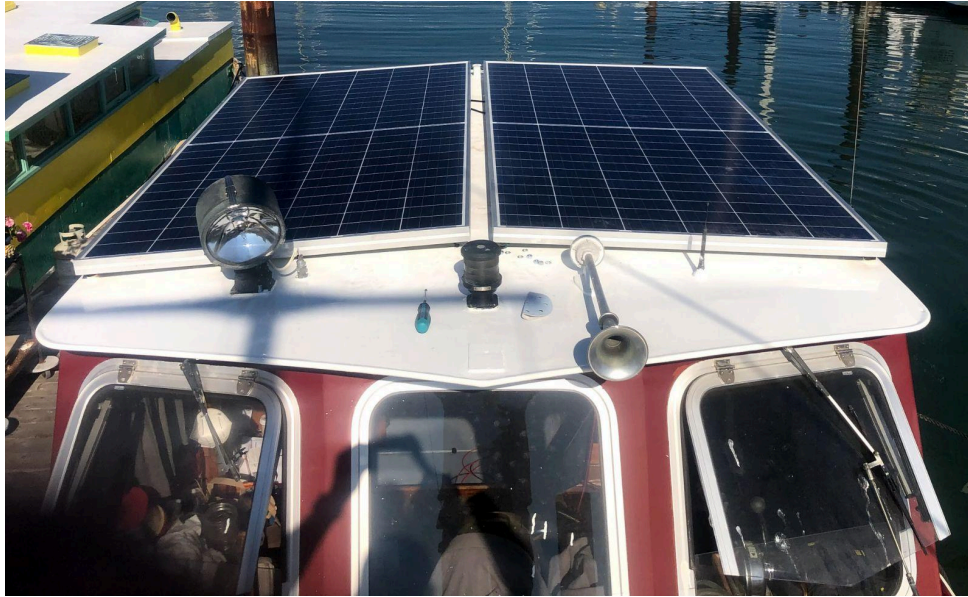
## Solar

Two Canadian Solar 340W solar panels are installed on the roof of the wheel house and are connected to a Victron MPPT Solar Charger providing power to the house batteries. This system is capable of providing up to 5kWh during the summer.

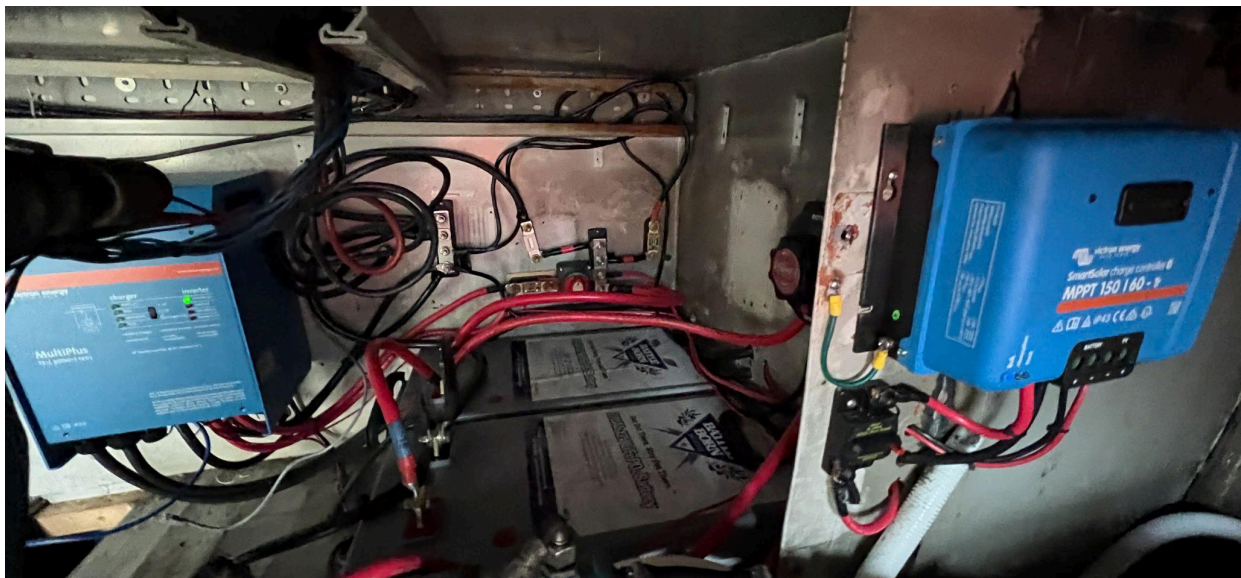
The Victron Multiplus 3kVA inverter/charger can select between using battery or shore power seamlessly to provide AC services and has advanced control functions to connect to shore power if a specified load is exceeded or battery charge falls to low.

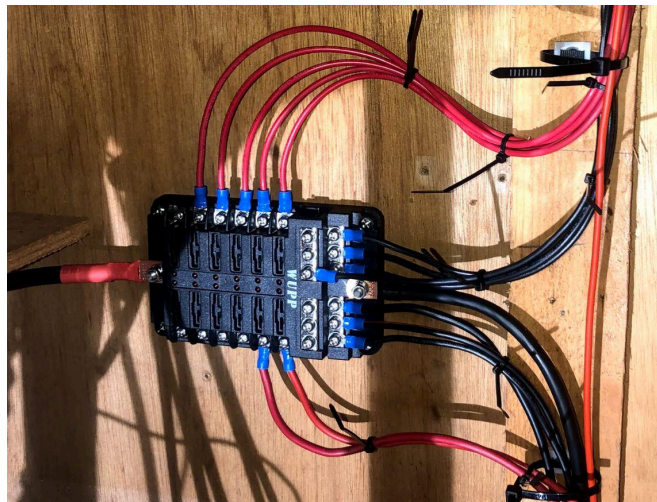
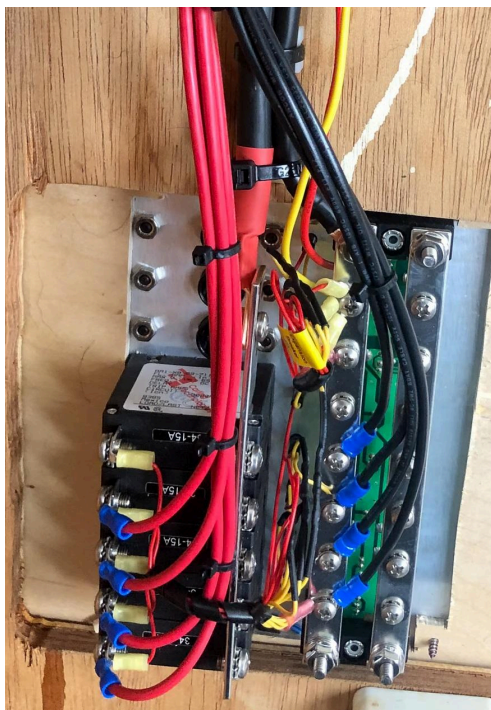
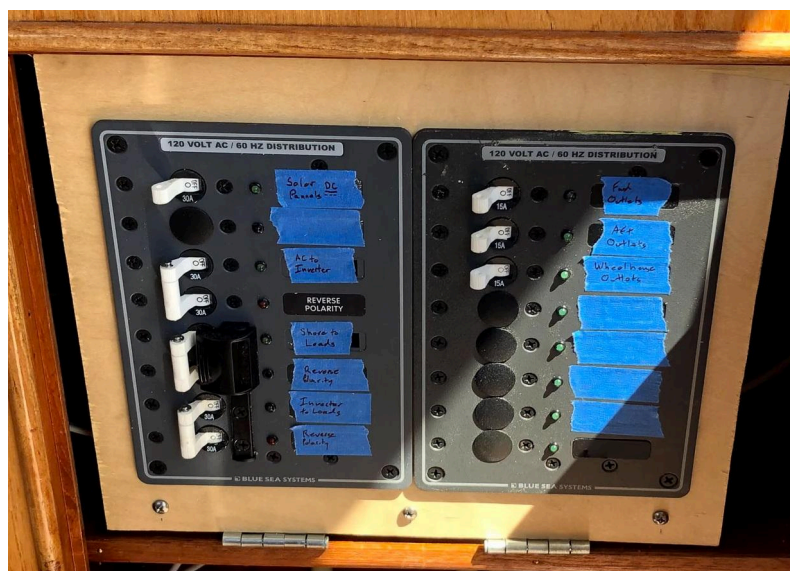
The main bus bar is near the batteries and chargers in the engine room and includes the main disconnects and primary fuses for the system and feeds the bow thruster, fuse block, and DC breaker panel.

The fuse block is located under the helm and distributes power to the pump and lighting inside the vessel.

The DC Breaker Panel is to port of the helm and distributes power to navigation and propulsion systems.

The AC Breaker Panel is aft on the starboard side of the wheelhouse and controls solar power, shore and inverter power and distribution to AC sockets.

A sliding mechanical interlock is in place on this panel to prevent accidental connection of the Multiplus Inverter charger to shore power.

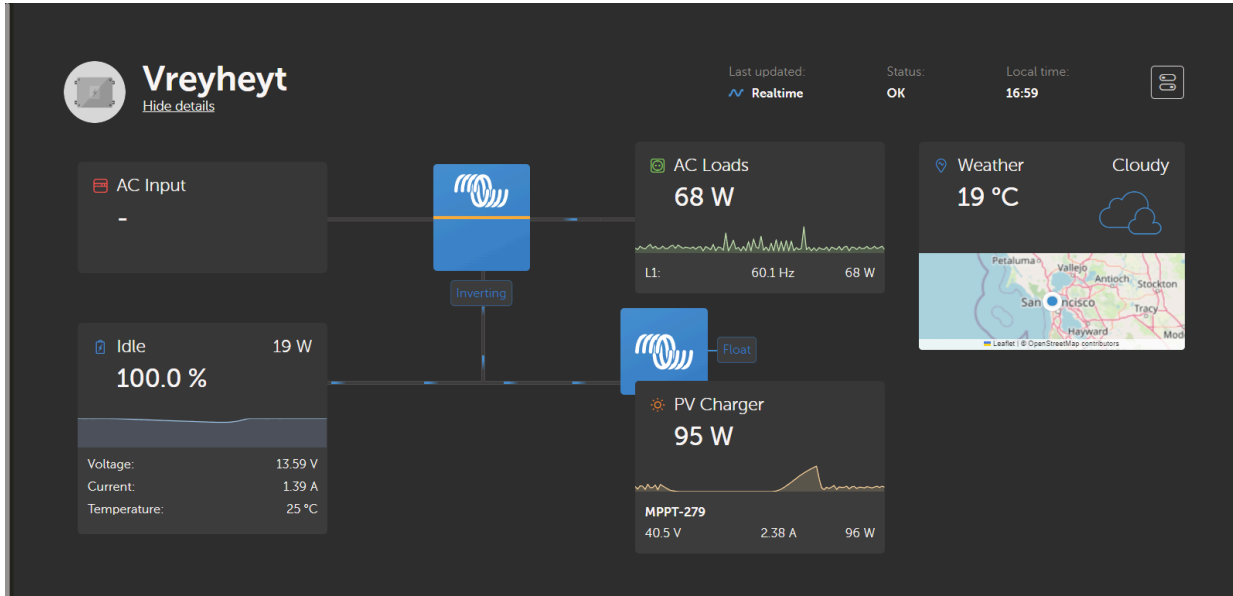
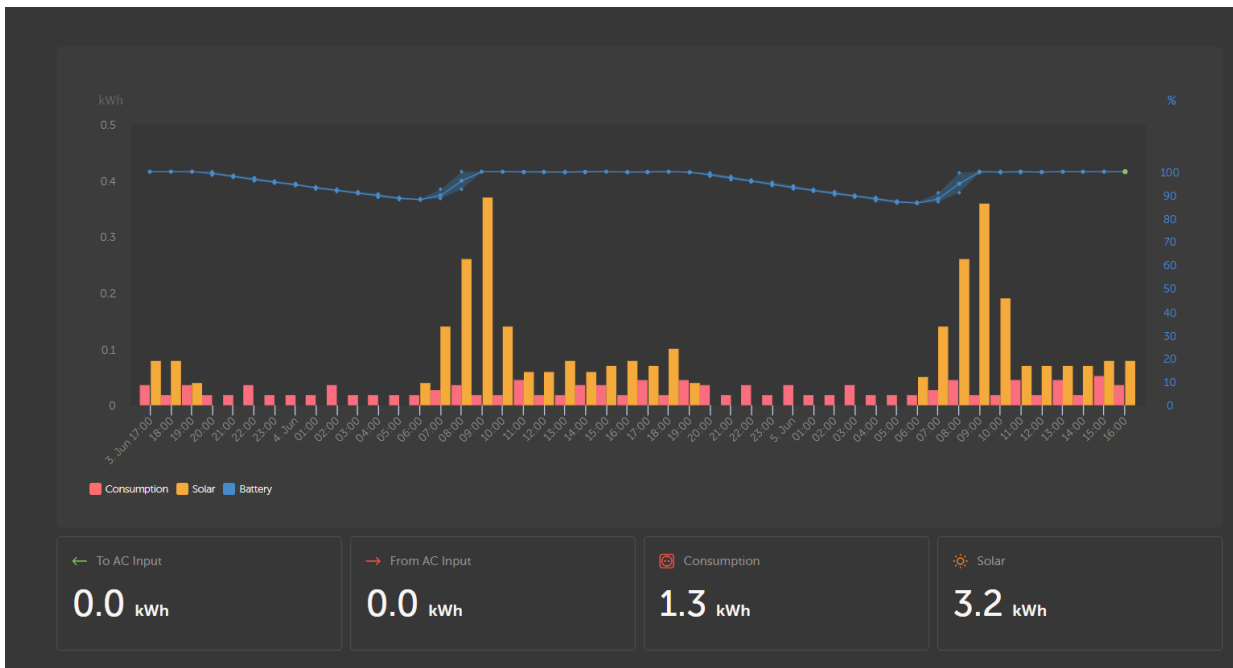
# Monitoring

Victron Cebo GX system management allows comprehensive and remote monitoring of the solar and electrical system.

*Note the solar is able to keep up to moderate use during most of the year but can require supplemental shore power in December/January.*
