2008 51 Heritage Boatworks

Renegade

Report of Marine Survey

Conducted by
AMEC Marine Surveyors

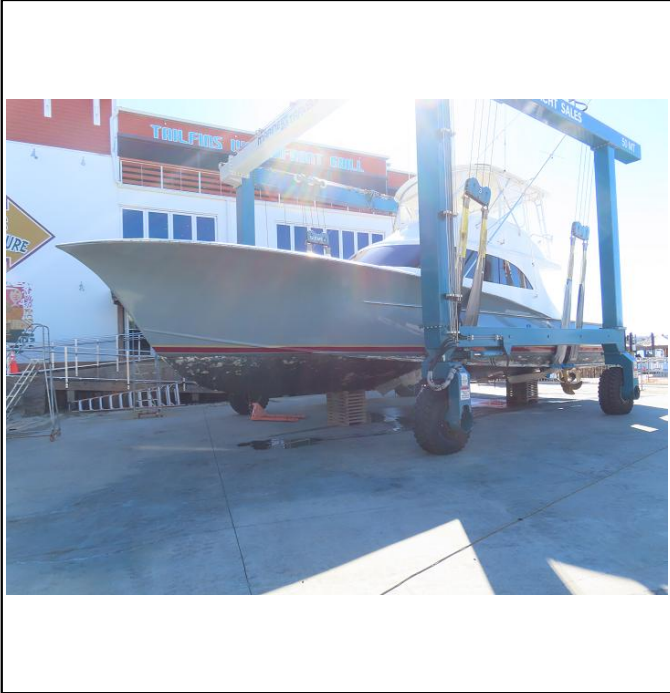
Port side view

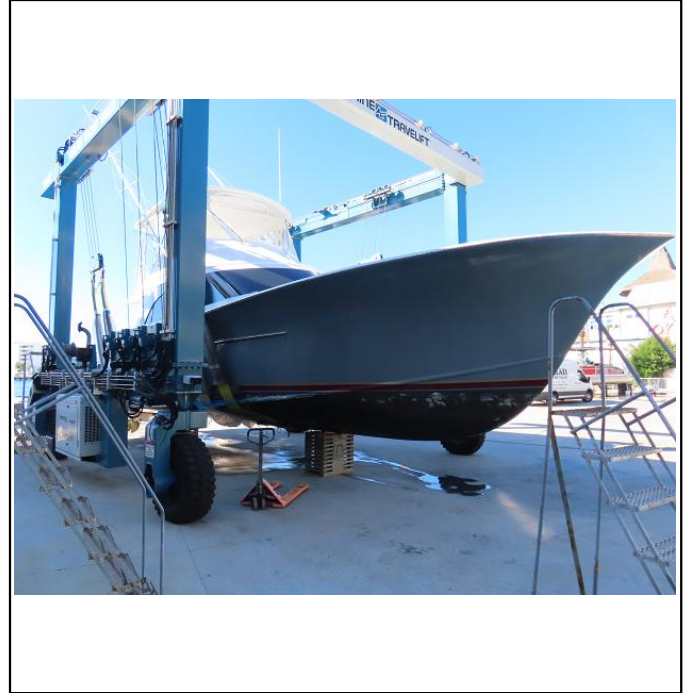
Starboard side view

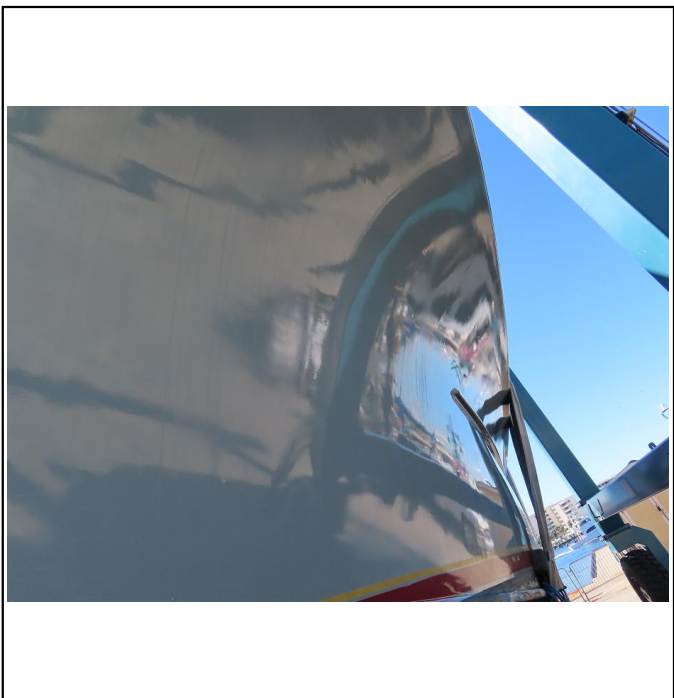
Hull sides

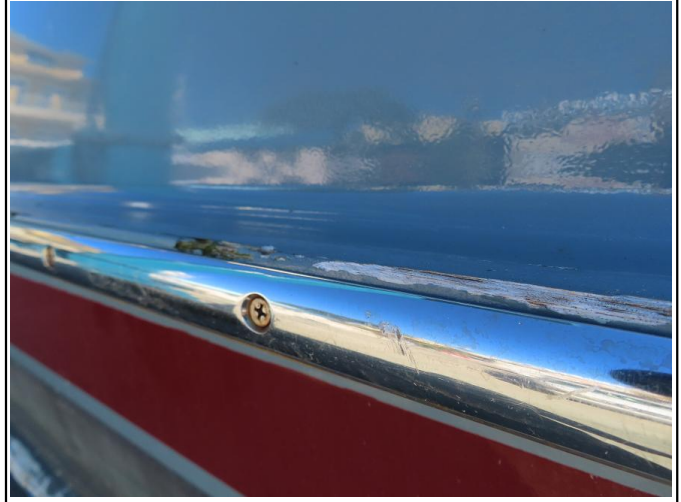
Aft hull spray rail

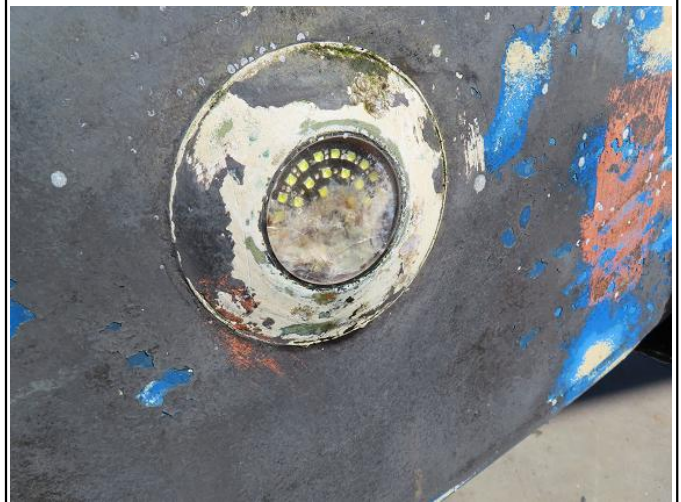
Aft underwater light

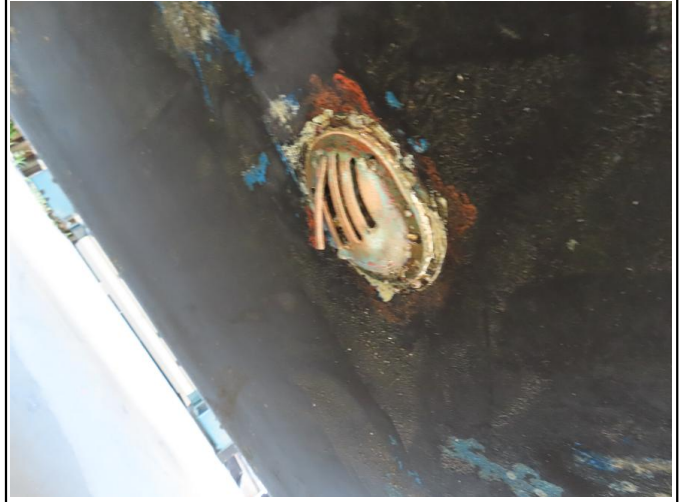
Raw water pickup

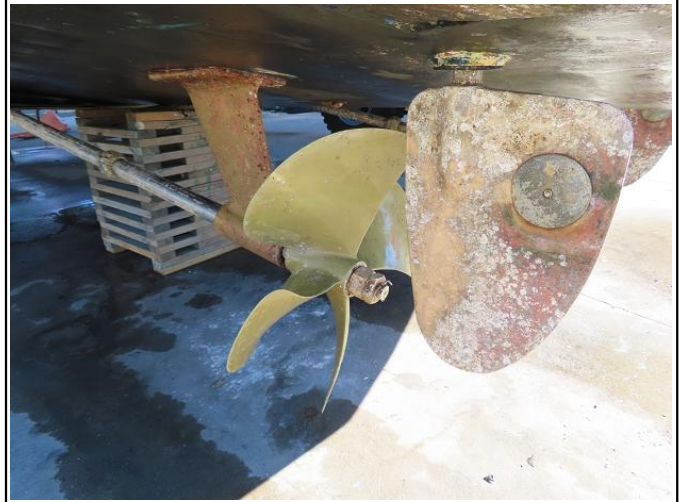
Port running gear

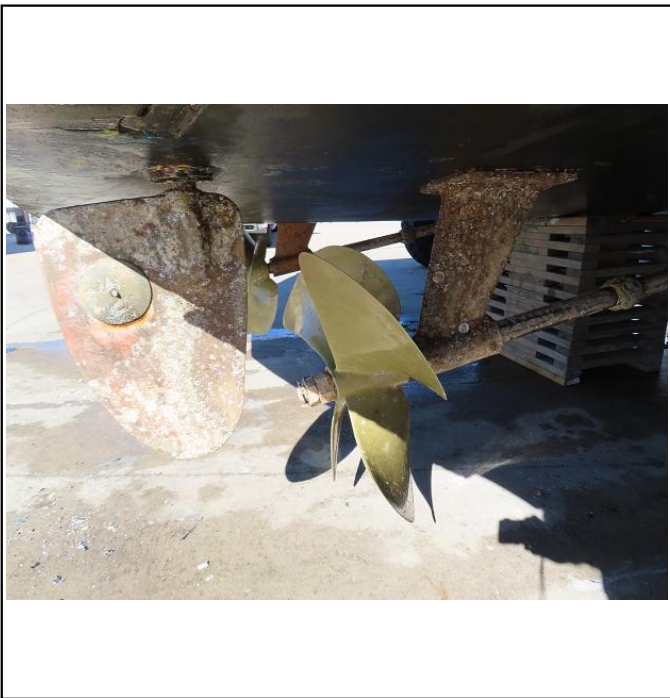
Starboard running gear

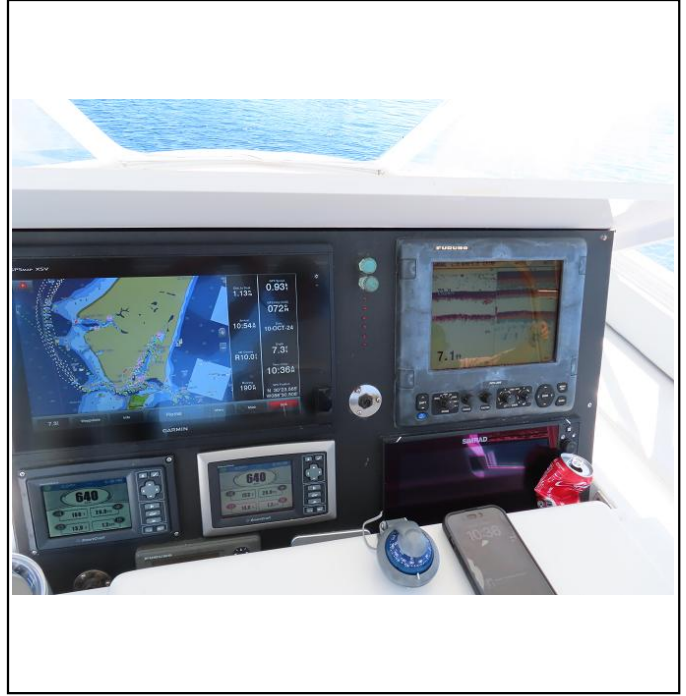
Bridge helm

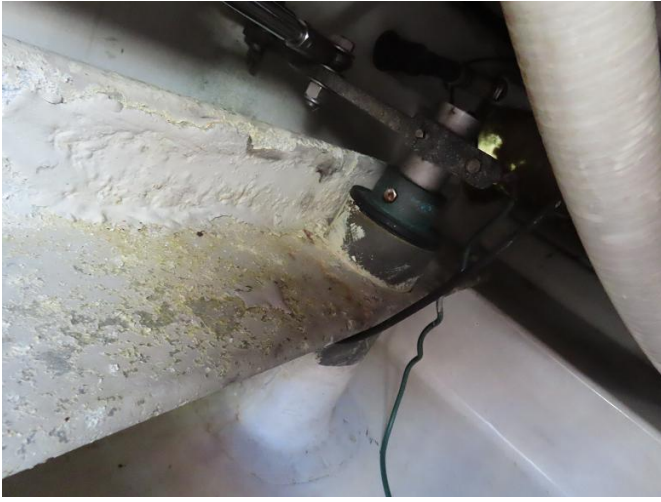
Port rudder seal

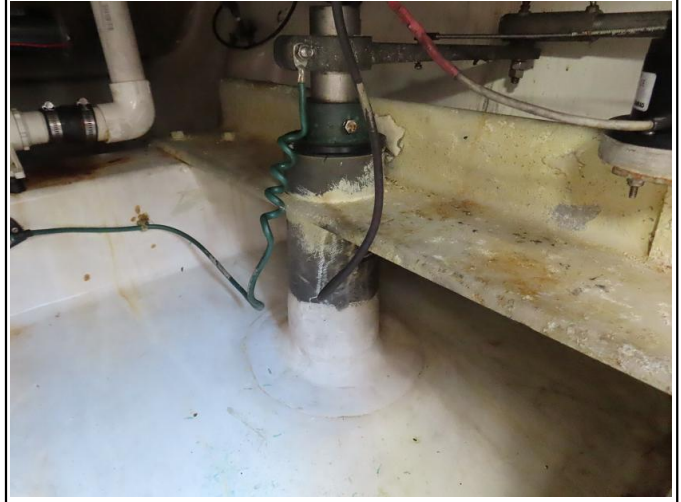
Starboard rudder seal

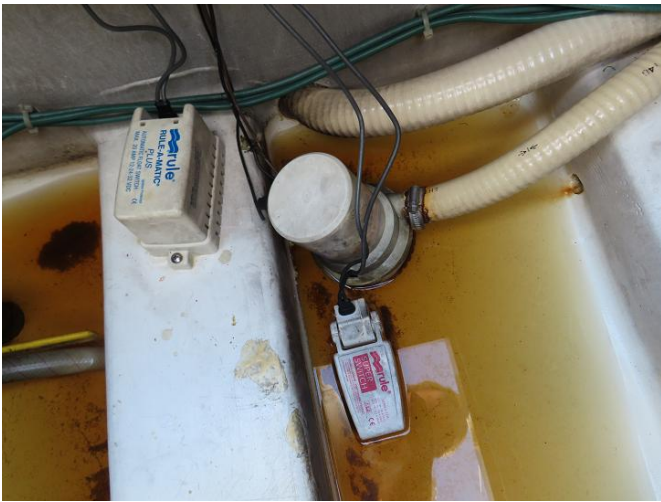
Aft bilge

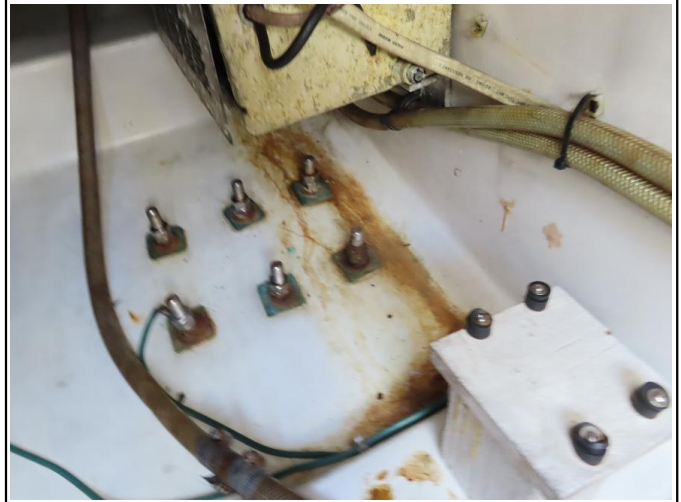
Aft bilge

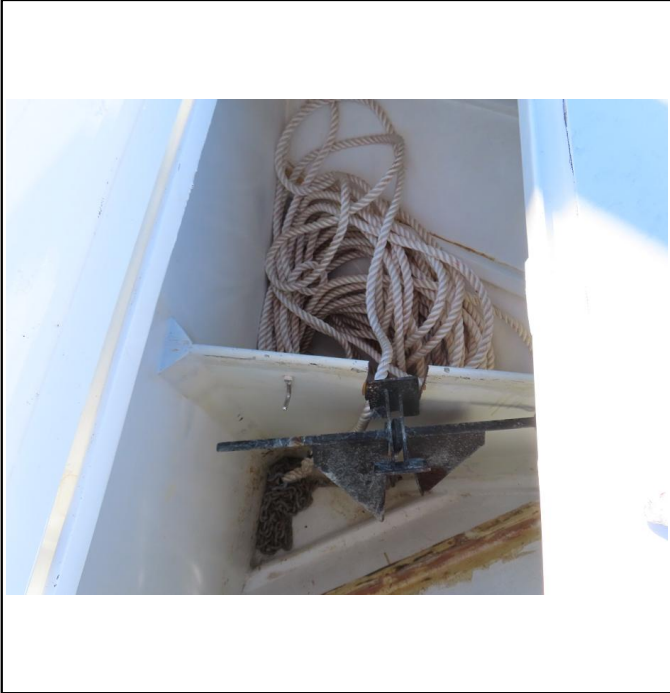
Anchor locker
